2015 ANNUAL ENVIRONMENTAL MANAGEMENT REPORT

SPRING FARM SAND AND SOIL EXTRACTION AND PROCESSING OPERATION (DA 75/256)

MACARTHUR ROAD, SPRING FARM

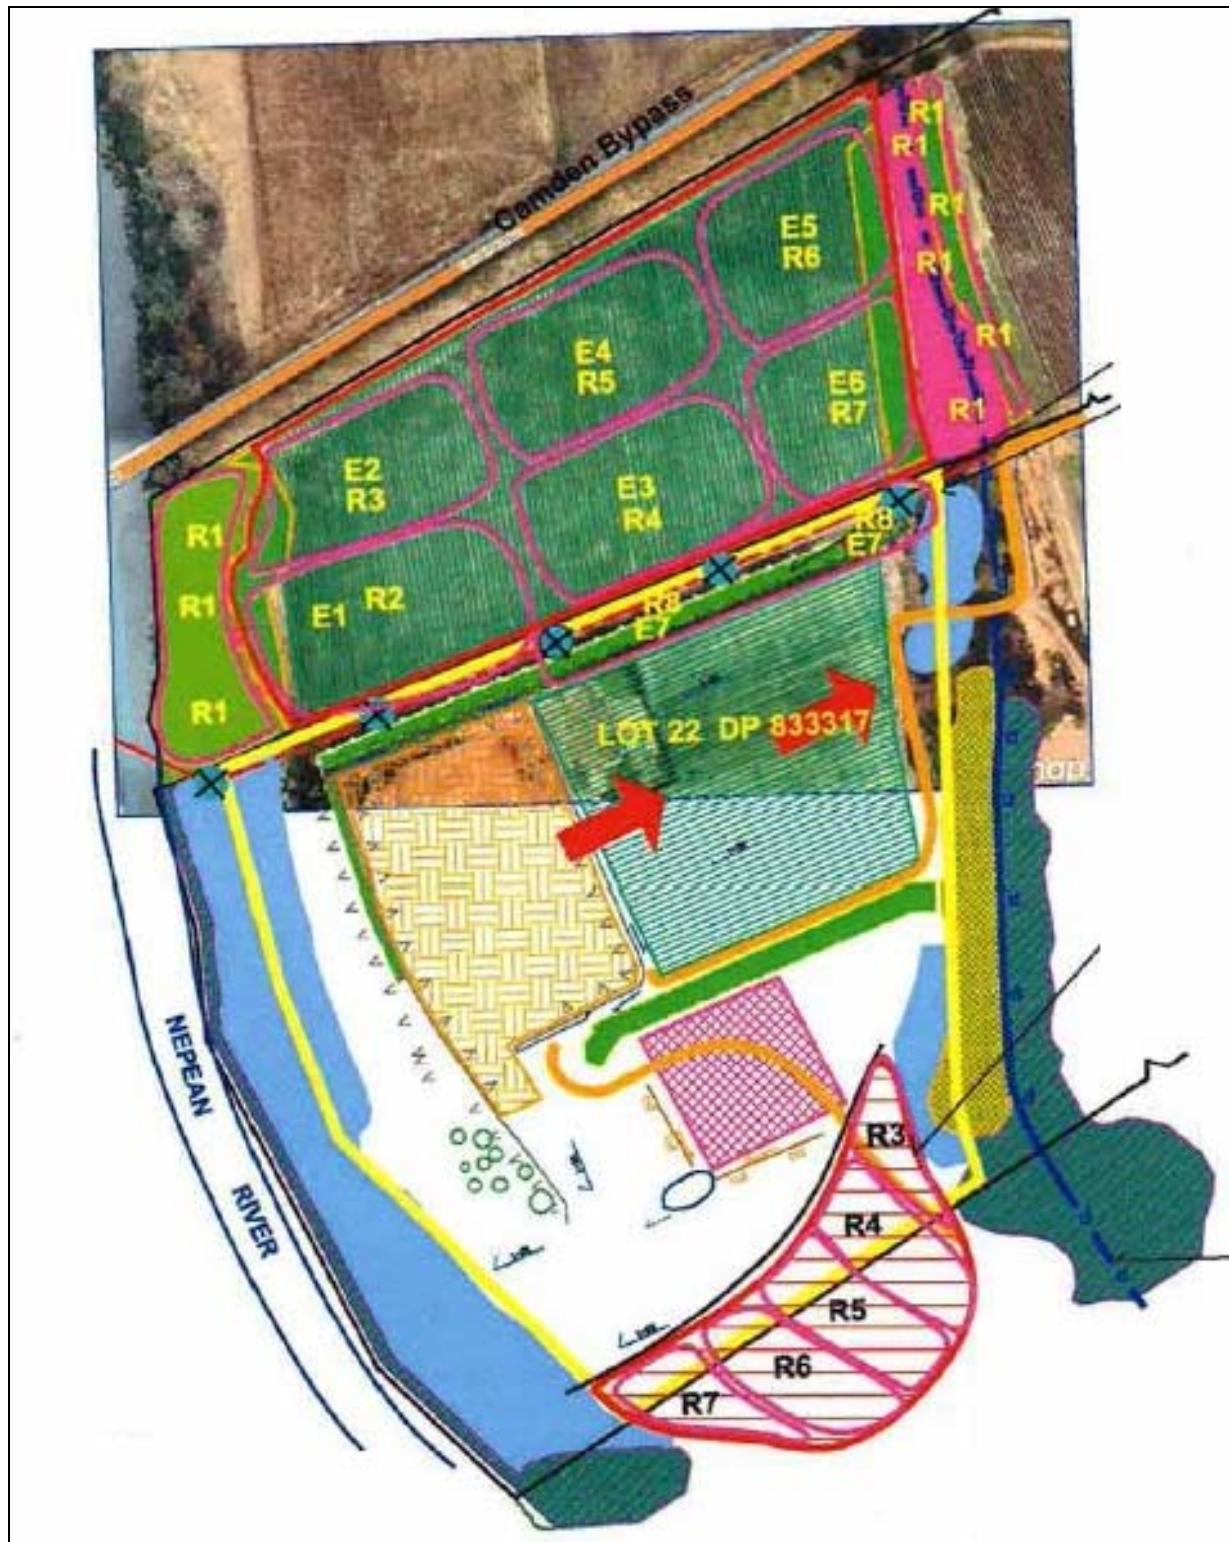
Figure 4: Approved extraction and rehabilitation sequence

1. Recommence extraction from Area 5 of Lot 22 (DP 833317);
2. Continue extraction on Lot 32 (DP 635271) proceeding north as illustrated in Figure 4 into E2 after exhaustion of E1. It is estimated that total extraction and production figures for the 2016 reporting year will be similar to that of 2015 (Table 1).

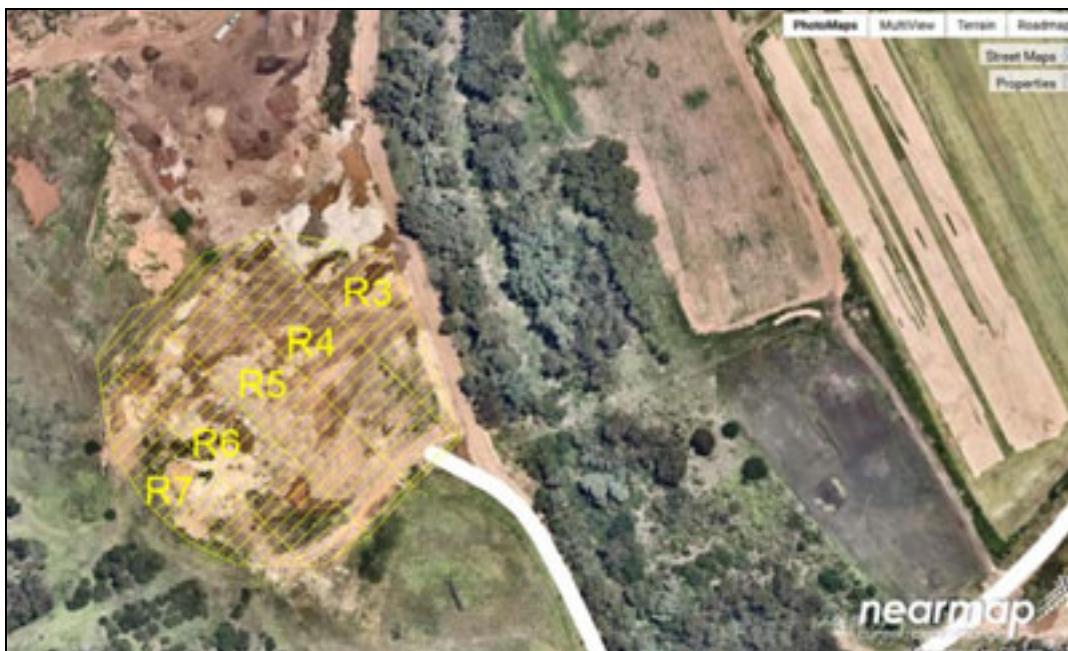
Figure 5: Aerial photo of the site denoting rehabilitation cells on Thursday 8 January 2015.

With the exception of minor trimming, final levels (RL66 as confirmed by Keatley Surveyors) were largely achieved within Rehabilitation Cells R4 and R5 denoted on Figures 5 and 6 (Lot 1 DP 587631). At the time of inspection revegetation in the form of pasture grass was establishing well over approximately half the area.

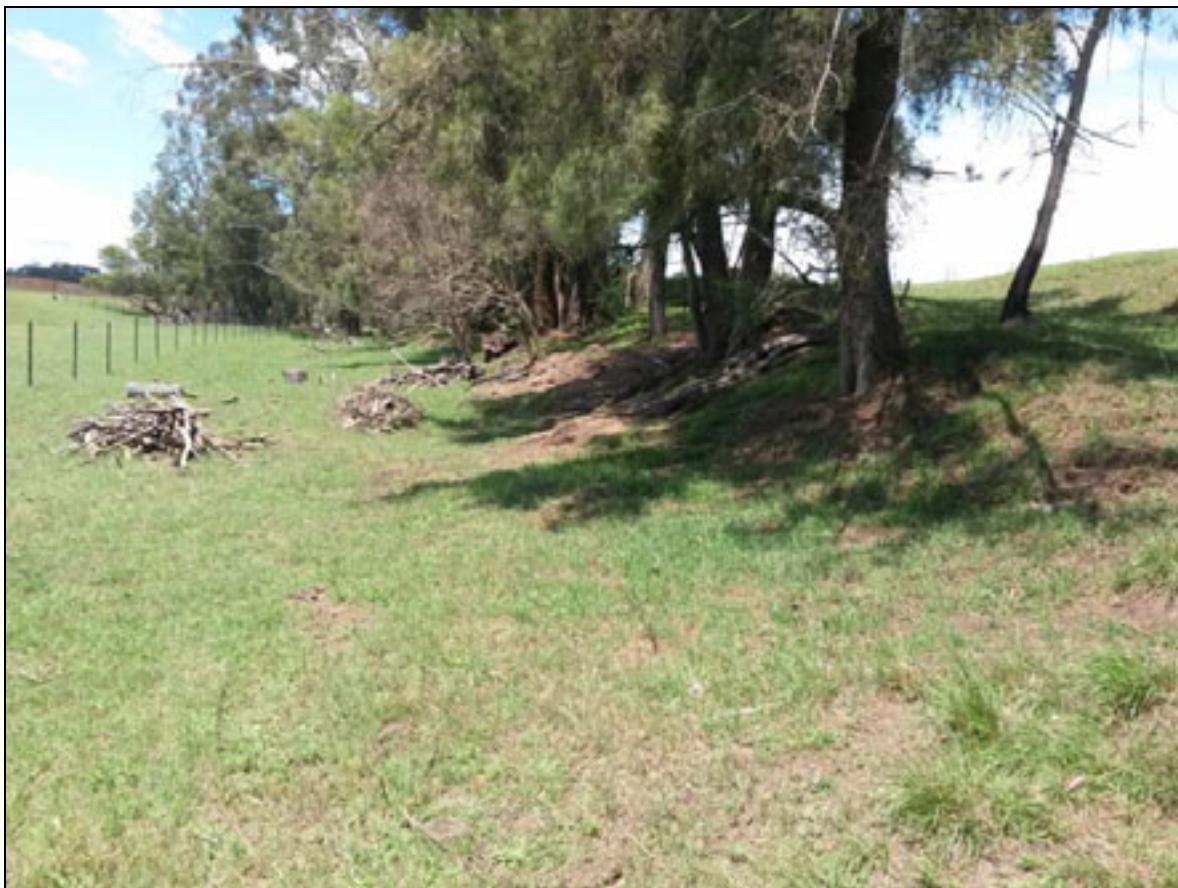
Figure 7: Dry anabanch recently cleared of woody weeds and fenced

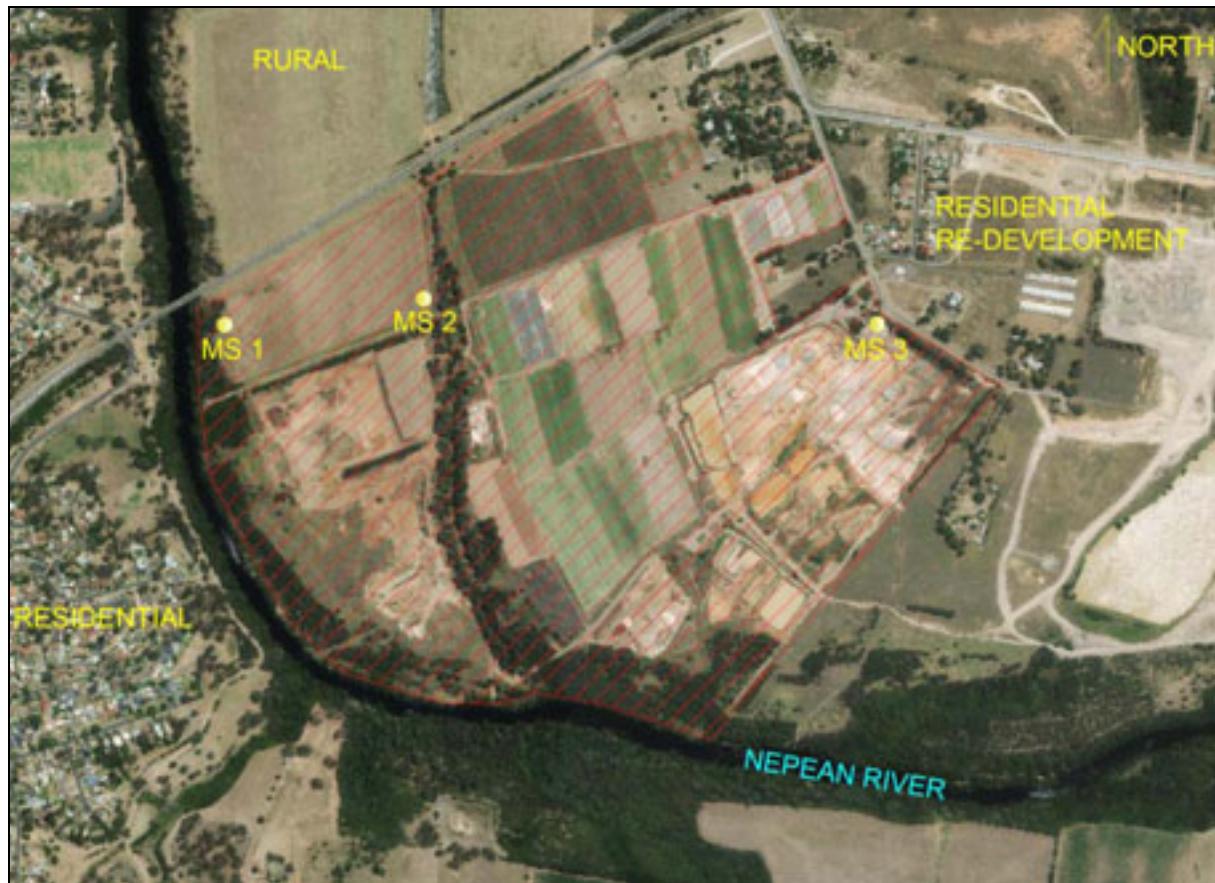
Figure 9: Collins Spring Farm Monitoring Sites

There are three monitoring sites across the Collins Spring Farm Quarry; MS1 (*Penman*), MS2 (*Turf Farm*), and MS3 (*Wash Plant*). They can be identified on the western boundary of the site, central to the site and nearest the front gate respectively (Figure 9). Monitoring Stations 1 and 3 consist of a dust deposition sampler. Monitoring Station 2 consists of a dust deposition sampler and groundwater monitoring bore.

- As recommended by the NSW EPA, MS1 and MS2 were relocated to their current positions in September 2015 (Figure 10).

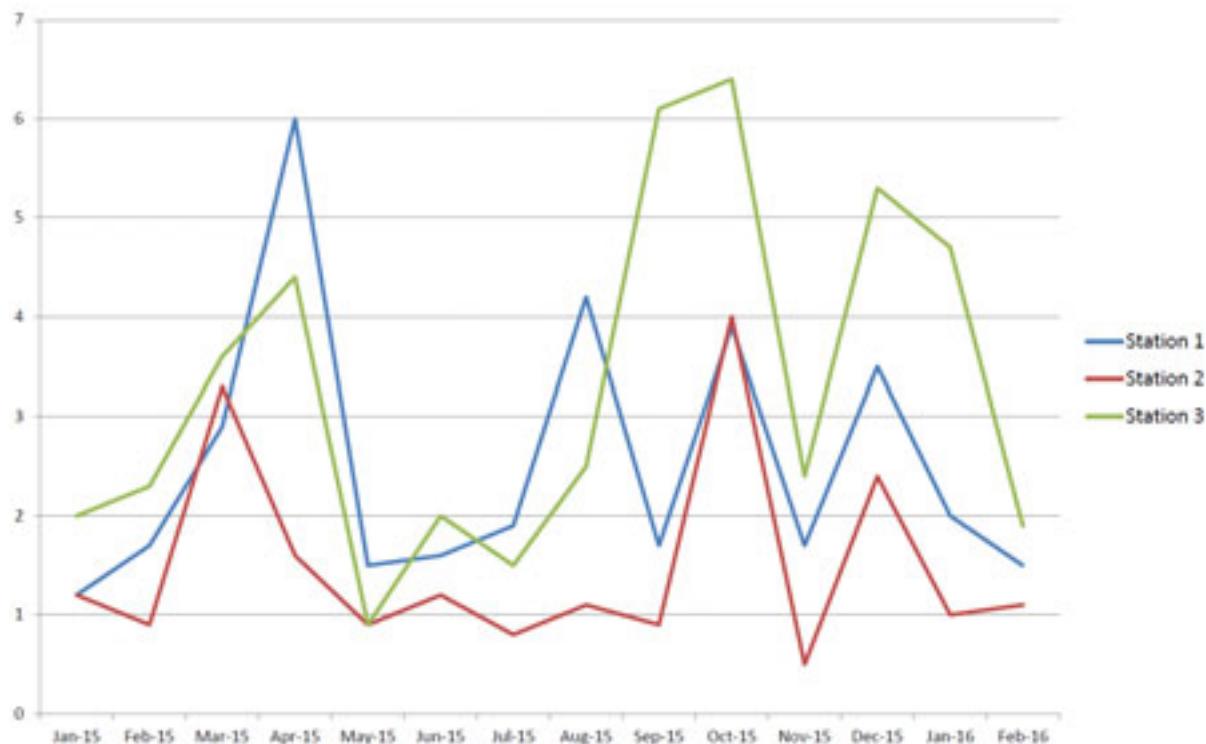
**Figure 10:** Results of 2015 Routine Dust Deposition Monitoring

1. MS1 (April and August 2015). These exceedances were attributed to the expansion of the quarry extraction area into Lot 32 and within 10 m of MS1. Subsequently, and as recommended by the NSW EPA, MS1 (and MS2) were relocated to their current positions in September 2015.
2. MS3 (April, September, October and December 2015). These exceedances were largely attributed to earthworks associated with expansion of the nearby Spring Farm urban development site which activities are beyond the control of Collins and Sons. It is considered that mowing and site clean-up activities taking place immediately adjacent to MS3 were also responsible for recorded exceedances.

In an effort to reduce the number of recorded exceedances, Collins and Sons have increased the frequency of access road dust suppression wet downs and water cart frequencies. They have also checked, repaired and replaced where necessary all dust suppression sprinkler heads and extended line lengths to expand the wetted area. Dust migration from the nearby Spring Farm urban re-development is beyond the control of Collins and Sons.

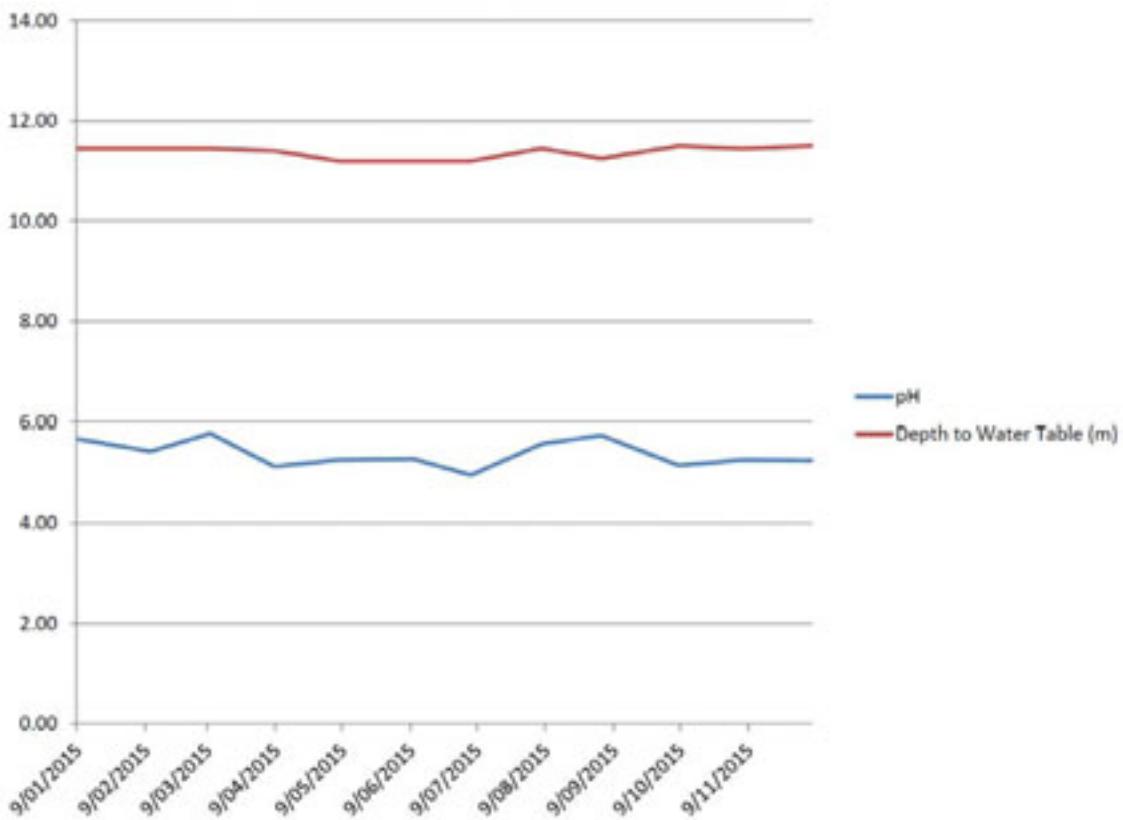
Figure 12: Results of 2015 Groundwater Monitoring (pH and Depth)

A slight downtrend in groundwater conductivity (EC) values was noted over the 2015 monitoring period. However, no obvious trends or fluctuations in groundwater depth or pH were noted. Groundwater fluctuated between 10.80m and 11.50m depth.

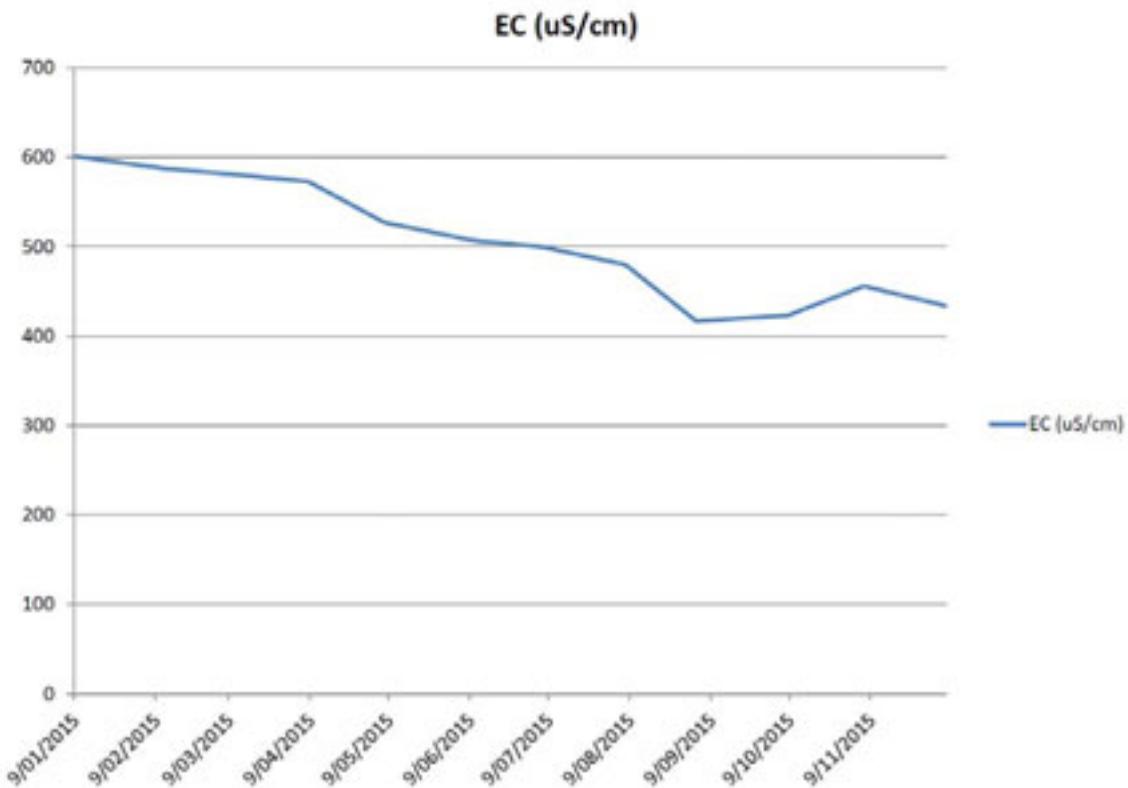
Figure 13: Results of 2015 Groundwater Monitoring (EC)

The reason for the moderate fluctuation in electrical conductivity is uncertain but is likely to be associated with prevailing rainfall conditions.

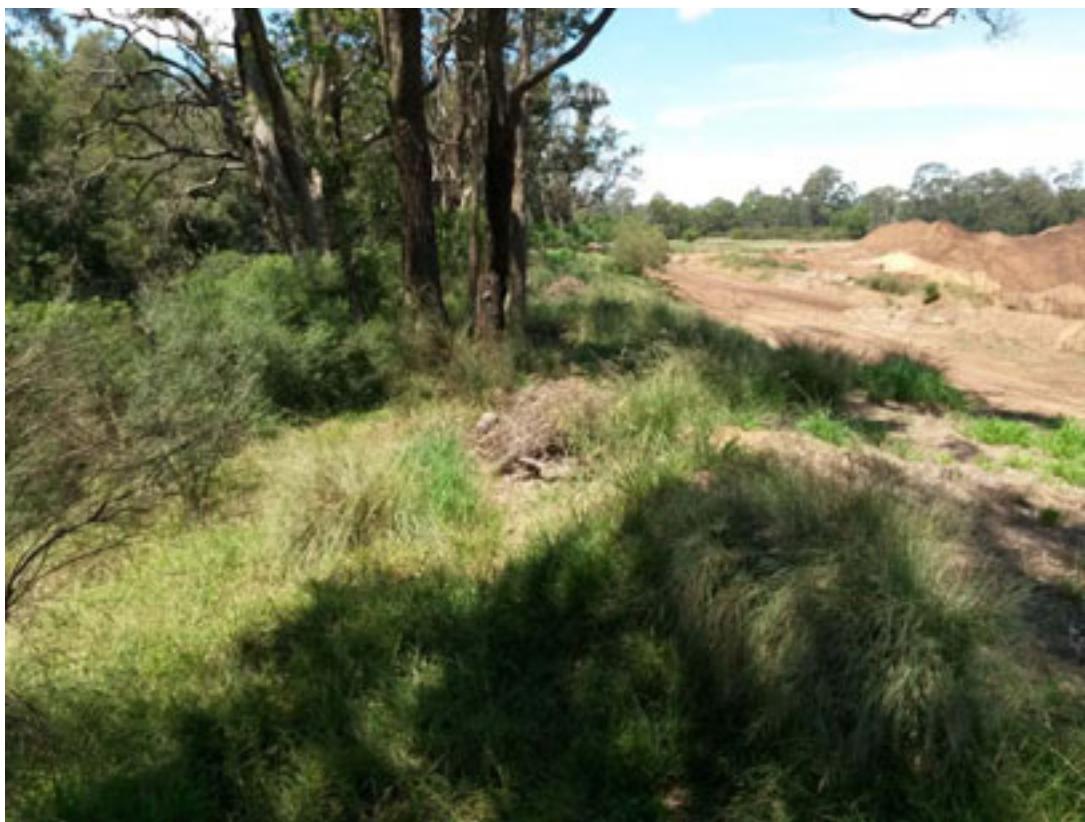
Figure 16: Looking south along the western bank of the anabranch (Lot 22)

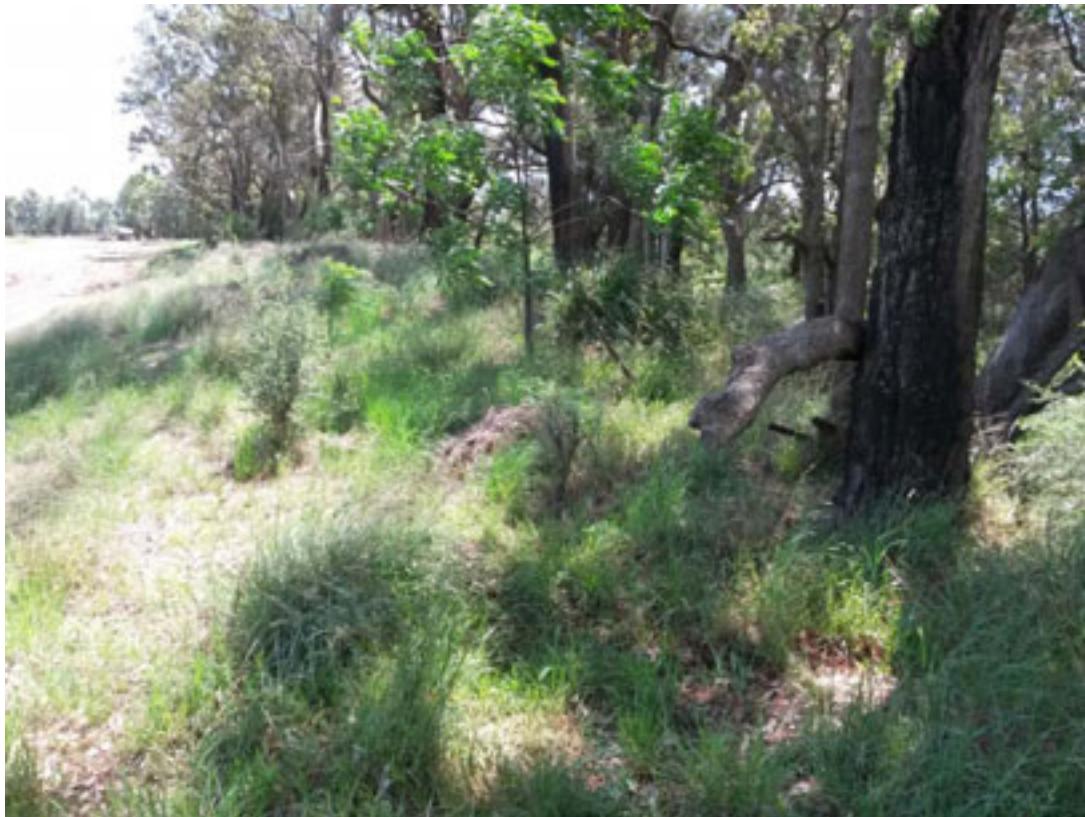
Figure 3: Looking north along the western bank of the anabranch (Lot 22)

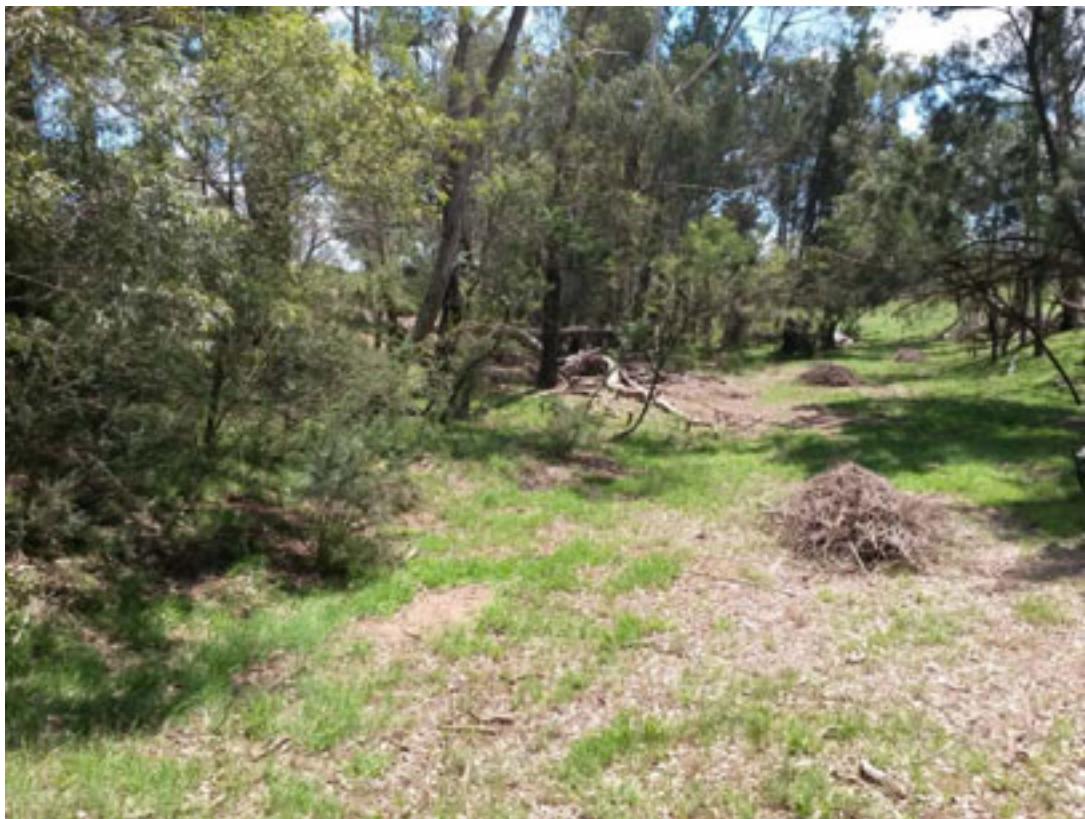
Figure 4: Looking north along the eastern bank of the anabranch (Lot 32)

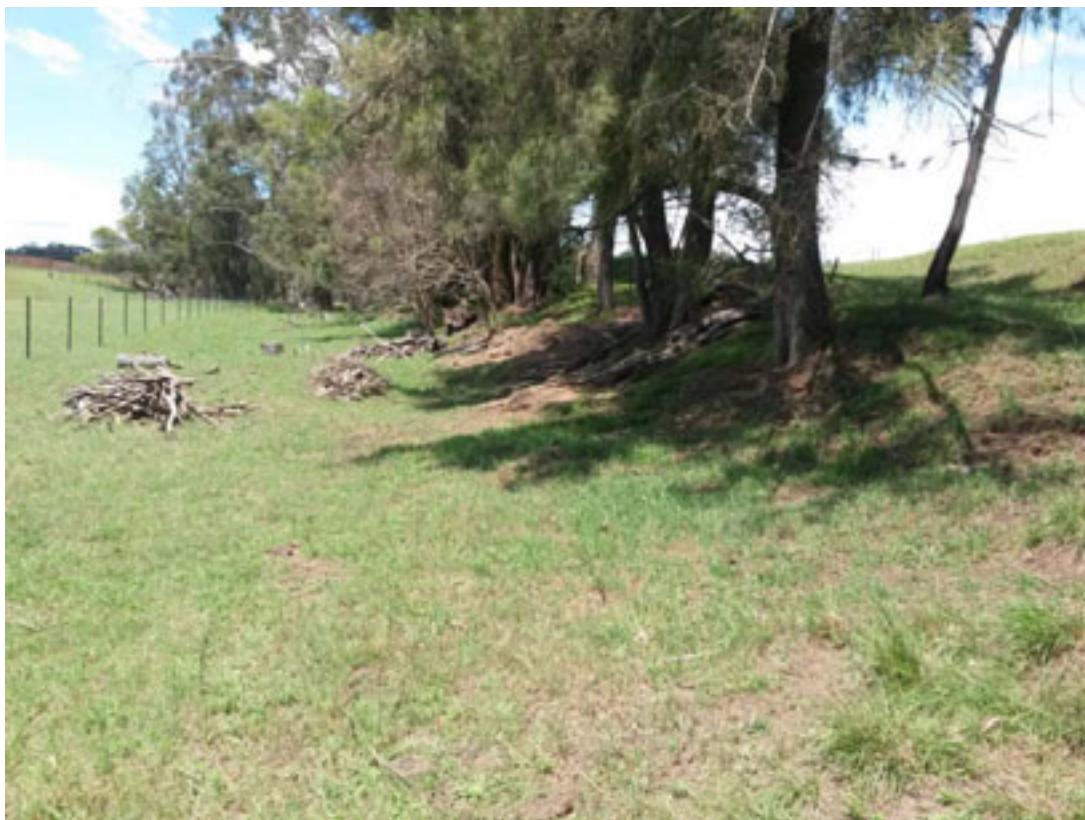
Figure 5: Looking south along the eastern bank of the anabranch (Lot 32)

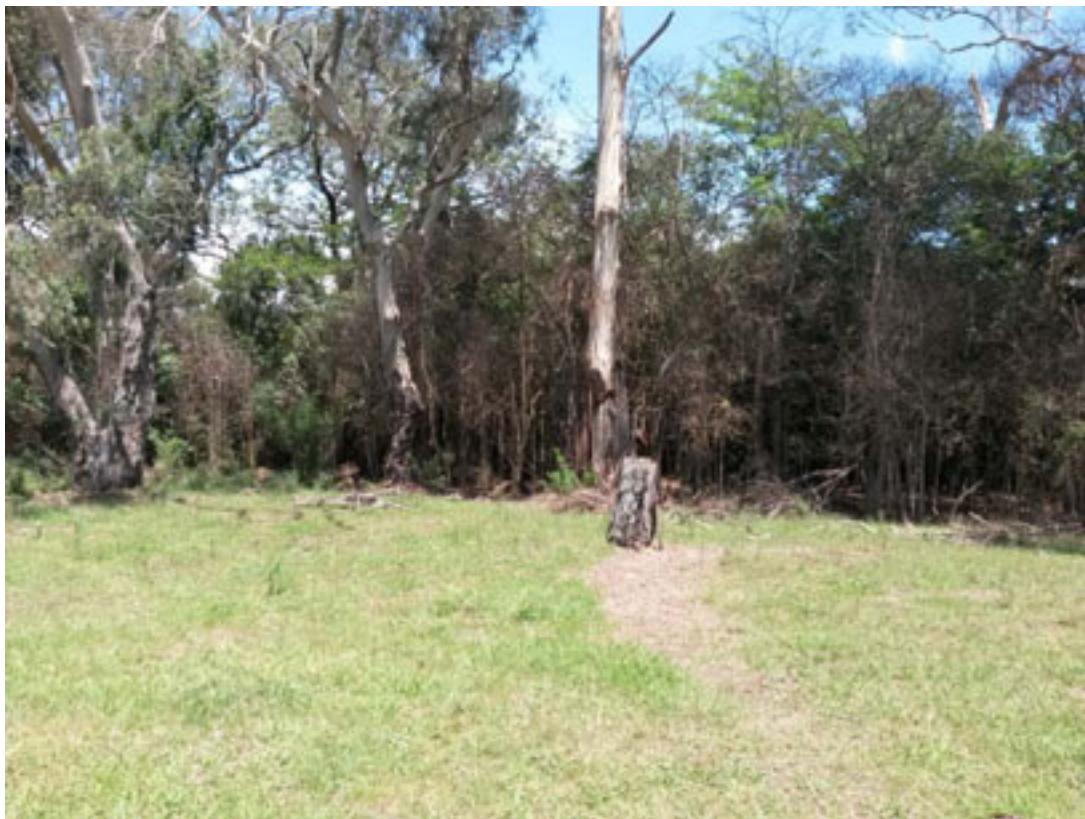
Figure 20: Recently poisoned Broad Leaf Privet (*Ligustrum lucidum*) adjacent to the Nepean River

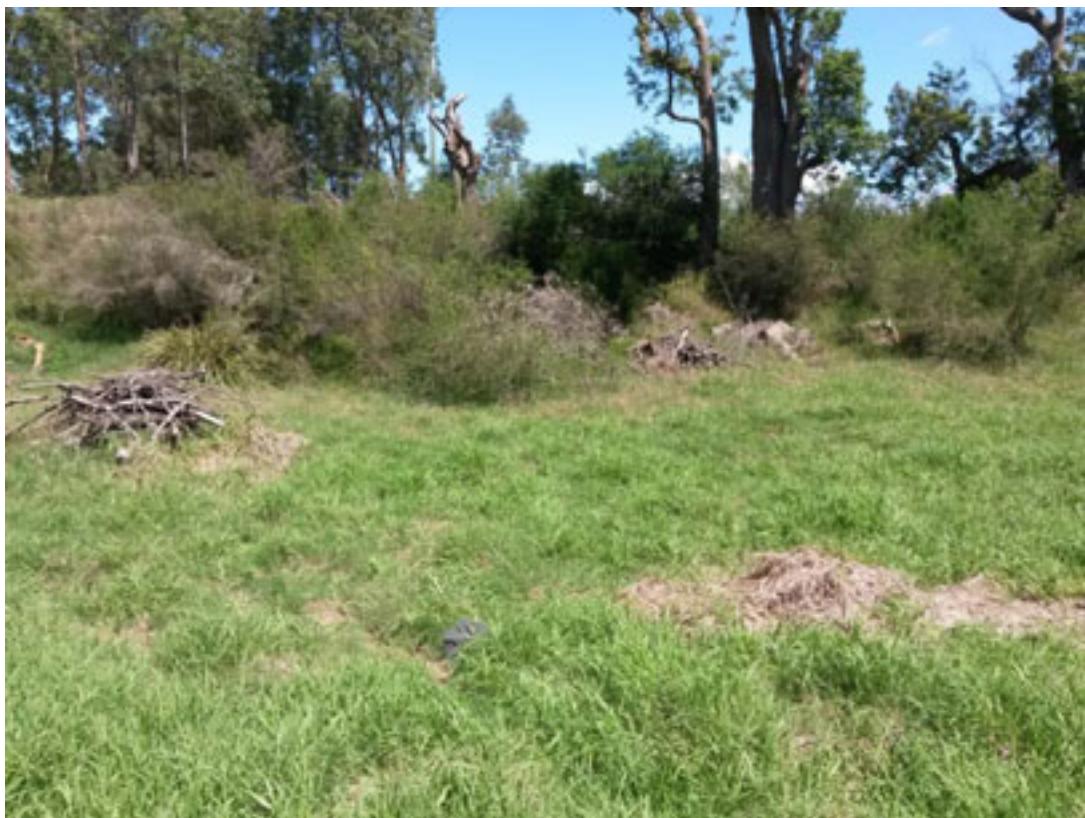
Figure 21: Woody weeds are removed and left in small piles where they serve as potential fauna habitat

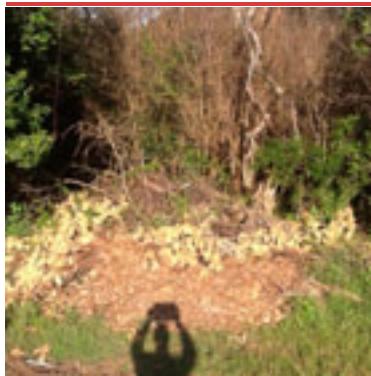
DUMPING

A large amount of green waste and rubbish has been dumped on site in this area. Some of the vegetative matter in this waste is viable and will make for more work! We subject putting a lock on the gates, or alternatively talking to the farmer next door to advise him this is an environmental site and to remove the pictured green waste.

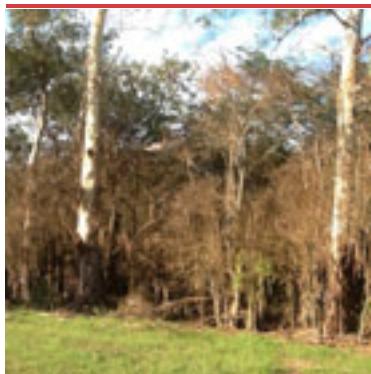
DEAD WOODY WEEDS

Some woody weeds are beginning to come up in the areas previously treated along the river bank. We will endeavour to control these weeds before they reach seeding maturity.

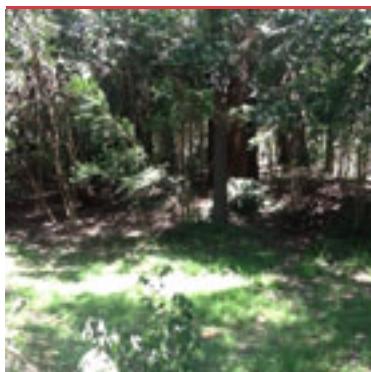
ZONE 1A

Weed control area after primary works were completed. The majority of the larger Privet sp. were frilled and injected with glyphosate bi-active. Some individuals were left to provide some shade in areas where the weeds were a monoculture.

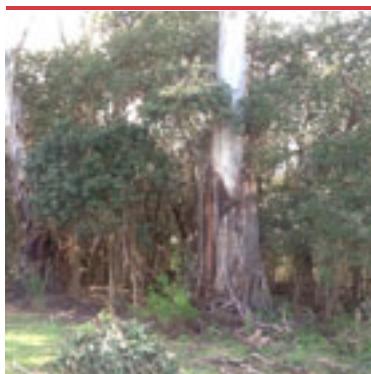
WOODY WEED INFESTATION

Mine extension area adjacent to the Nepean River in Zone 1A after primary works. Some larger specimens of Privet sp. have been left to provide shade in the aid of future weed control and re-vegetation works.

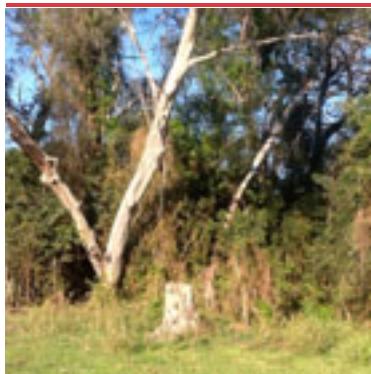
INVASIVE VINE SPECIES

Balloon vine is abundant in this area.

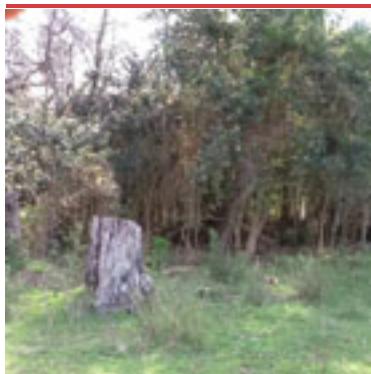
INVASIVE VINE SPECIES

Invasive vines were scraped and painted with Glyphosate Bi-Active.

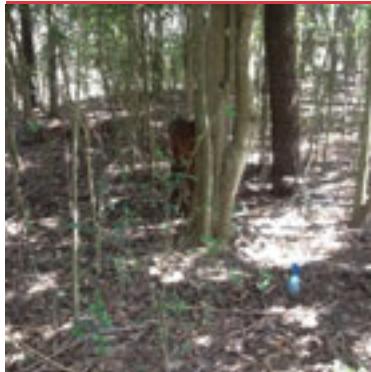
JUVENILE PRIVET SP.

Pictured is the density of juvenile Privet sp. in this area.

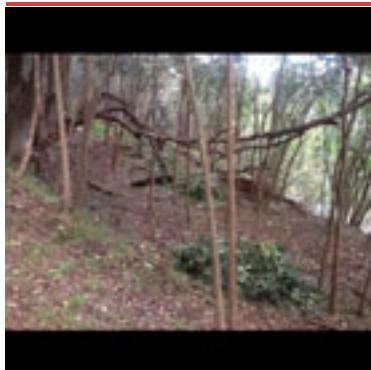
ZONE 1A

Privet sp. Was targeted in this area as shown in the picture. The pile in the foreground is as mentioned previously a 'Habitat' pile to consolidate the biomass. Larger Privet sp. we're frilled and injected with Glyphosate Bi-Active, juvenile Privet sp. we're cut and painted with Glyphosate Bi-Active, while seedlings were hand pulled. Some of the largest trees have been left to provide shade as a monoculture of Privet existed in this area. Providing temporary shade in these areas will not only make it easier to control the seedlings emerging but also assist in the re-vegetation works.

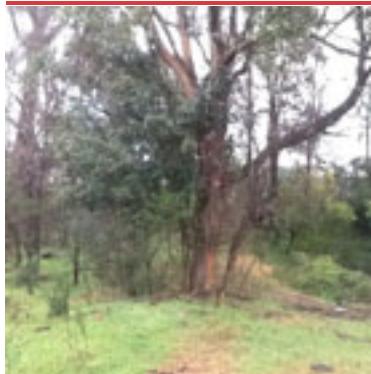
PRIMARY WEED CONTROL WORKS IN THE ANABRANCH ZONE

A large amount of invasive woody weed species including; Privet sp., Gleditsia sp., & Elms were targeted in this area.

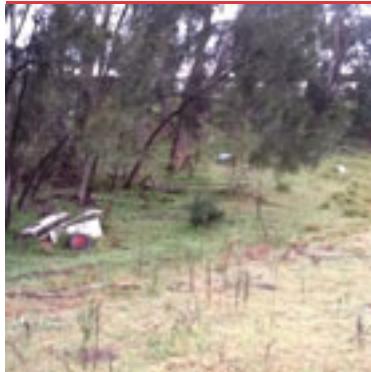
ISSUE 3

Rubbish found scattered through the site was stockpiled for collection in appropriate areas.

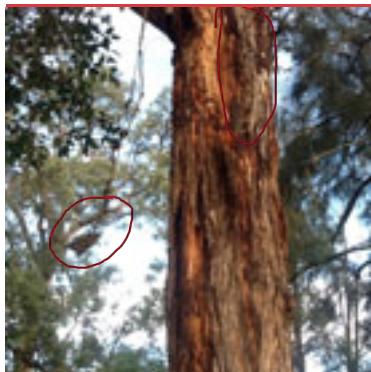
MADEIRA VINE

Madeira vine was located climbing up some remnant trees in this area. Madeira vine will be targeted in spring. The method used for this invasive vine sp. is scraping of the main stems to expose the cambium layer, then a dose of 'Vigilant gel' is applied to the open scar. The large clusters of viable tubers are circled in red and approximately 30cm in length.

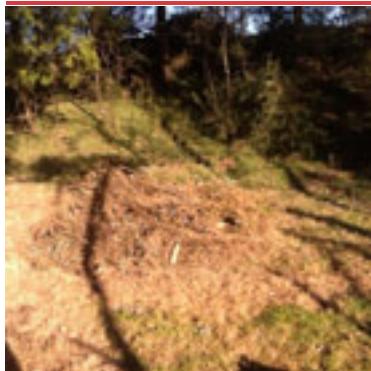
ISSUE 5

All excess biomass created during weed control in this area have been placed into burn piles in appropriate areas. All burn piles are within the recommended RFS Guidelines.

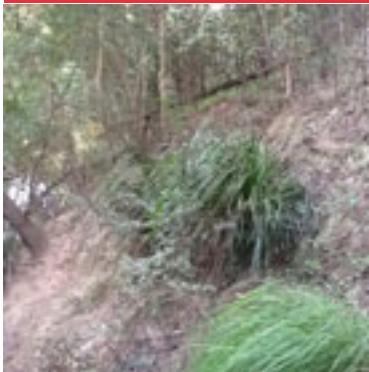
RIPARIAN BUFFER ZONE 1A

Woody weed infestation along the riparian corridor zone 1a. The major weeds in this area were Privet sp., Gleditsia sp., & Japanese honeysuckle.

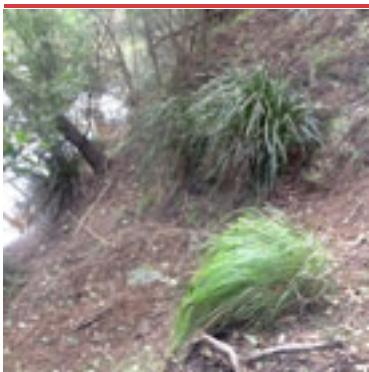
RIPARIAN BUFFER ZONE 1A

Woody weed infestation along the riparian corridor zone 1a. The major weeds in this area were Privet sp., Gleditsia sp., & Japanese honeysuckle. All woody weeds and invasive vines were treated in this area. Excess biomass created in cutting and painting woody weeds was chopped down into habitat piles above the mean flood level.

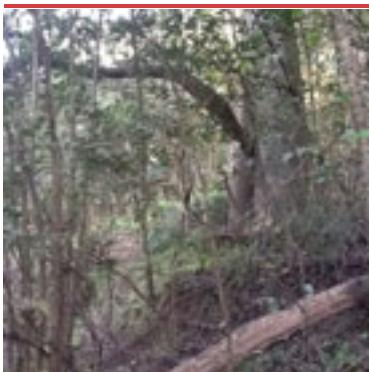
RIPARIAN BUFFER ZONE 1A

Woody weed infestation along the riparian corridor zone 1a. The major weeds in this area were Privet sp., Gleditsia sp., & Japanese honeysuckle.

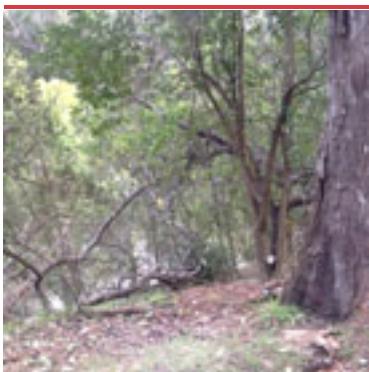
RIPARIAN BUFFER ZONE 1A

Woody weed infestation along the riparian corridor zone 1a. The major weeds in this area were Privet sp., Gleditsia sp., & Japanese honeysuckle. All woody weeds and invasive vines were treated in this area. Excess biomass created in cutting and painting woody weeds was chopped down into habitat piles above the mean flood level.

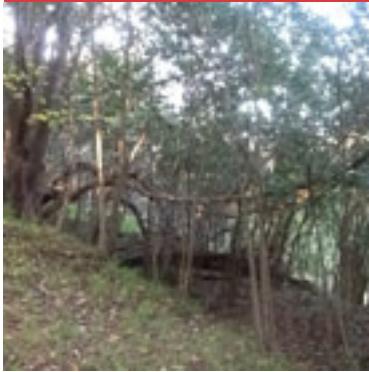
RIPARIAN BUFFER ZONE 1A

Woody weed infestation along the riparian corridor zone 1a. The major weeds in this area were Privet sp., Gleditsia sp., & Japanese honeysuckle.

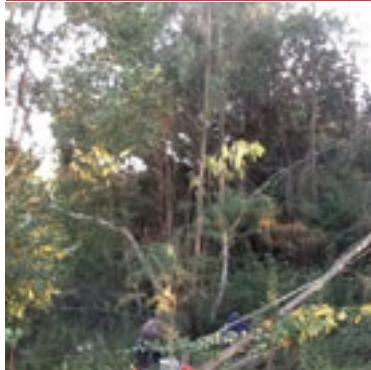
WEED INFESTATION PRIOR TO WORKS COMMENCING

A large amount of Privet so. is present in this zone. Japanese honeysuckle (*Lonicera japonica*) and Balloon vine (*Cardiospermum grandiflora*) are also very dense in this zone.

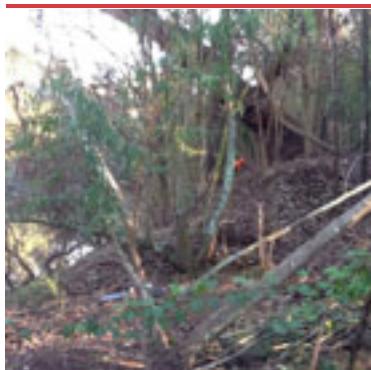
WEED INFESTATION AFTER PRIMARY WORKS

All woody weeds and invasive vine species were treated in this area.

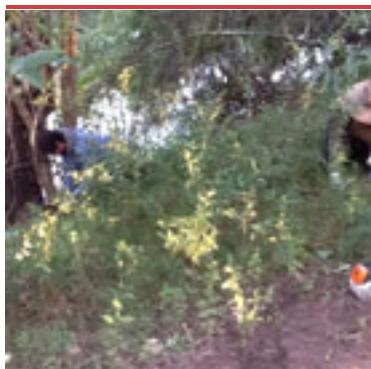
UNDERSTORY WEED INFESTATION

A large amount of juvenile weeds will be controlled in this area to reduce the rapid growth after the mature weeds treated loose their leaves.

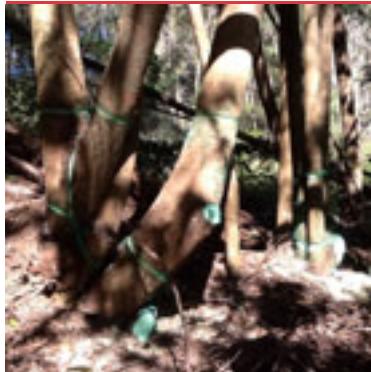
LARGE ELM TREES

Larger species of weeds in this area were frilled and injected with Glyphosate bi-active.

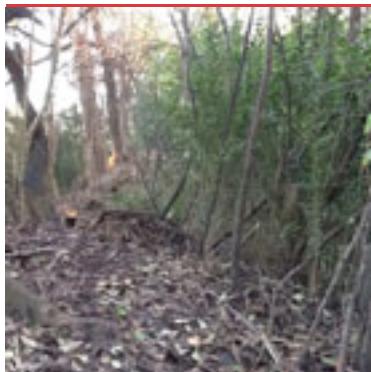
INITIAL PRIMARY TARGET AREA

A 15m section parallel to the Nepean River has been targeted as a priority in Zone 1a. The left side of the photo has been treated and the right side is yet to be treated.

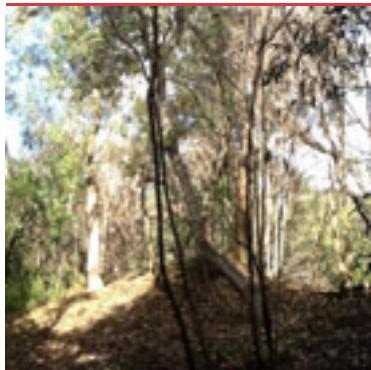
REMNANT VEGETATION AREAS

Areas directly adjacent to the works along the rivers edge that contain significant remnant vegetation were also worked around. This area pictured has several mature Banksia integrifolia and other small mid story natives such as Hymenanthera dentata.

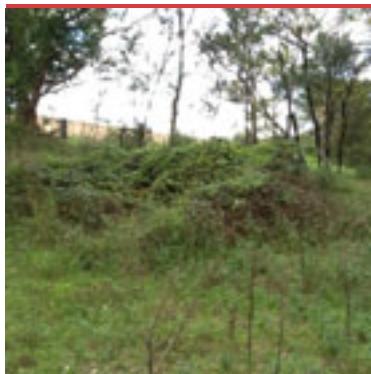
INVASIVE VINES

Blackberry and Balloon vine will be sprayed in spring in this area. Hand treatment will be done surrounding natives to minimise off target kills.
