## **2016 ANNUAL ENVIRONMENTAL MANAGEMENT REPORT**

### **SPRING FARM SAND AND SOIL EXTRACTION AND PROCESSING OPERATION (DA 75/256)**

**MACARTHUR ROAD, SPRING FARM**

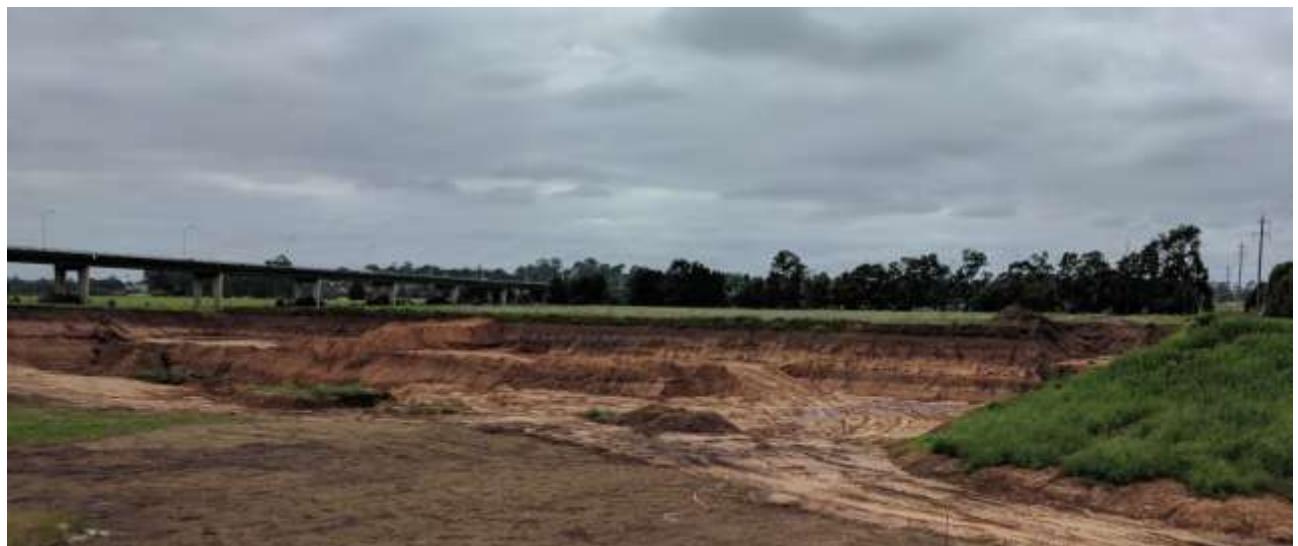
**Figure 2:** Active extraction area on Lot 32 (DP 635271)

Up to 5,000 tonnes of sand and soil are held at any one time in up to five stockpiles. These are segregated by material type, allowing the company to satisfy market demands for specific blended products. Current operations produce around 250,000 – 300,000 tonnes of sand and soil products annually. Thirteen people are directly employed at the quarry including plant operators, supervisors and clerical staff. In addition, drivers are employed to deliver and distribute material to customers.

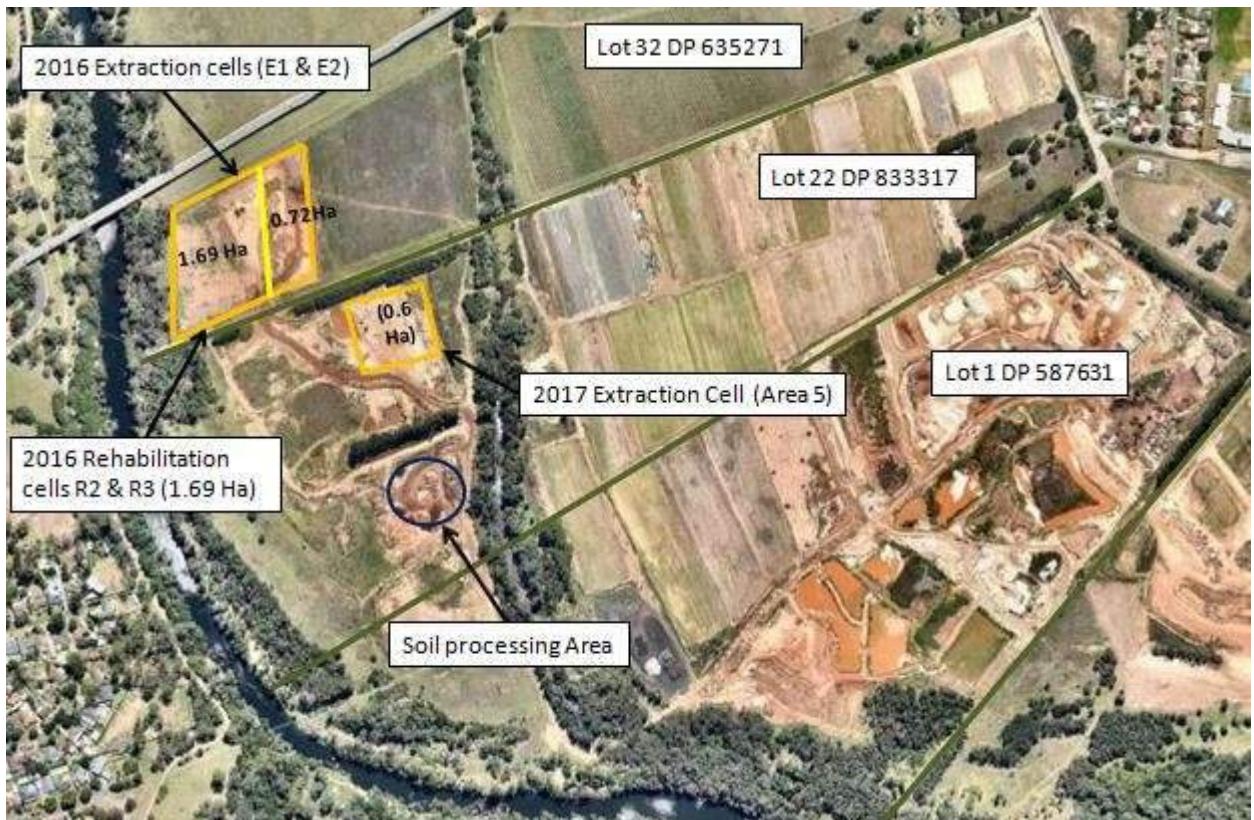
**Figure 3:** 2016 Extraction and Rehabilitation Cells

1. Recommence extraction from Area 5 of Lot 22 (DP 833317);
2. Continue extraction on Lot 32 (DP 635271) proceeding north as illustrated in Figure 4 into E3 and E4 after exhaustion of E1 and E2. It is estimated that total extraction and production figures for the 2017 reporting year will be similar to that of 2016 (Table 1).

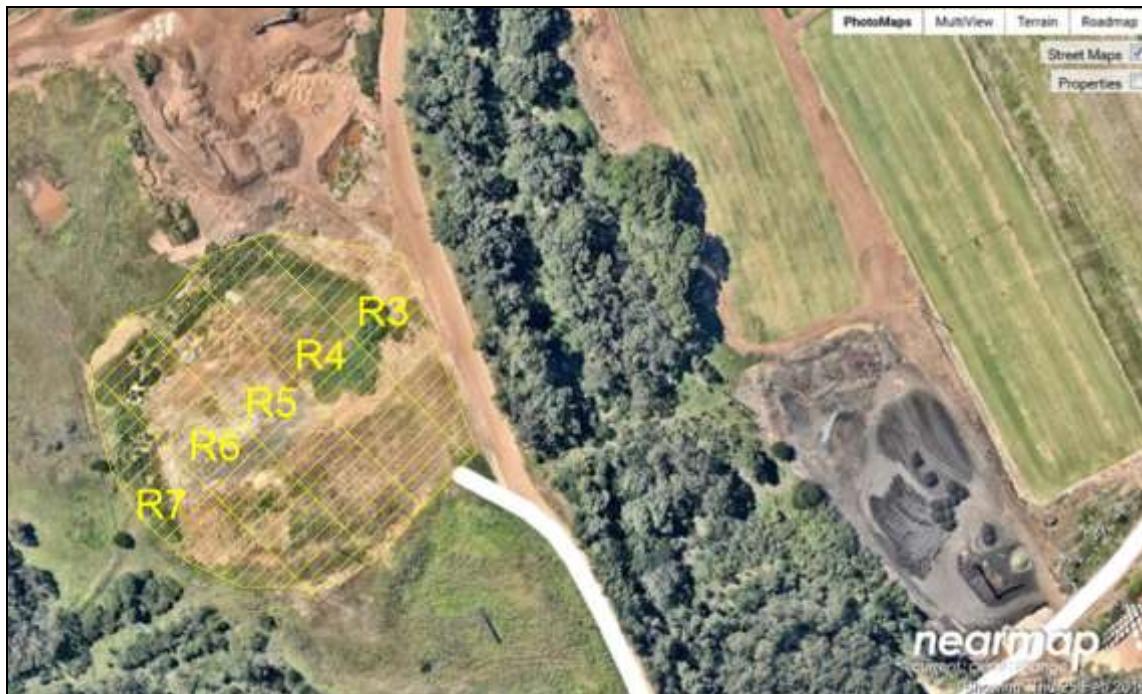
**Figure 5:** 2016 Aerial photo of the site denoting rehabilitation cells.

With the exception of minor trimming, final levels (RL66 as confirmed by Keatley Surveyors) were largely achieved within Rehabilitation Cells R3 to R6 denoted on Figure 5 (Lot 1 DP 587631 and Lot 22 DP 83317). At the time of inspection revegetation in the form of pasture grass was establishing well over approximately half the area.

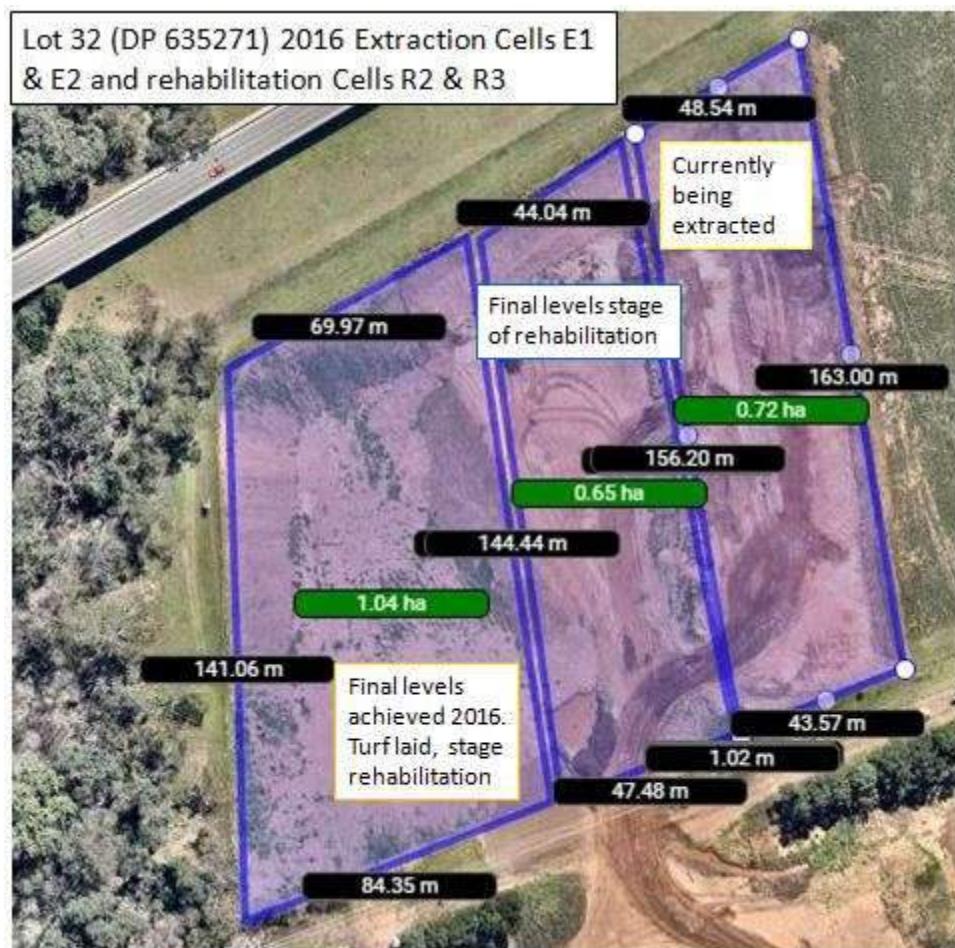
**Figure 6:** Final levels and staged rehabilitation of E1 and E2 on Lot 32 (DP 635271)

Achieving final level within the remaining 0.65 Ha northern section of cells E1 and E2 commenced in December 2016 and will continue into 2017 heading north with concurrent extraction and rehabilitation on Lot 32.

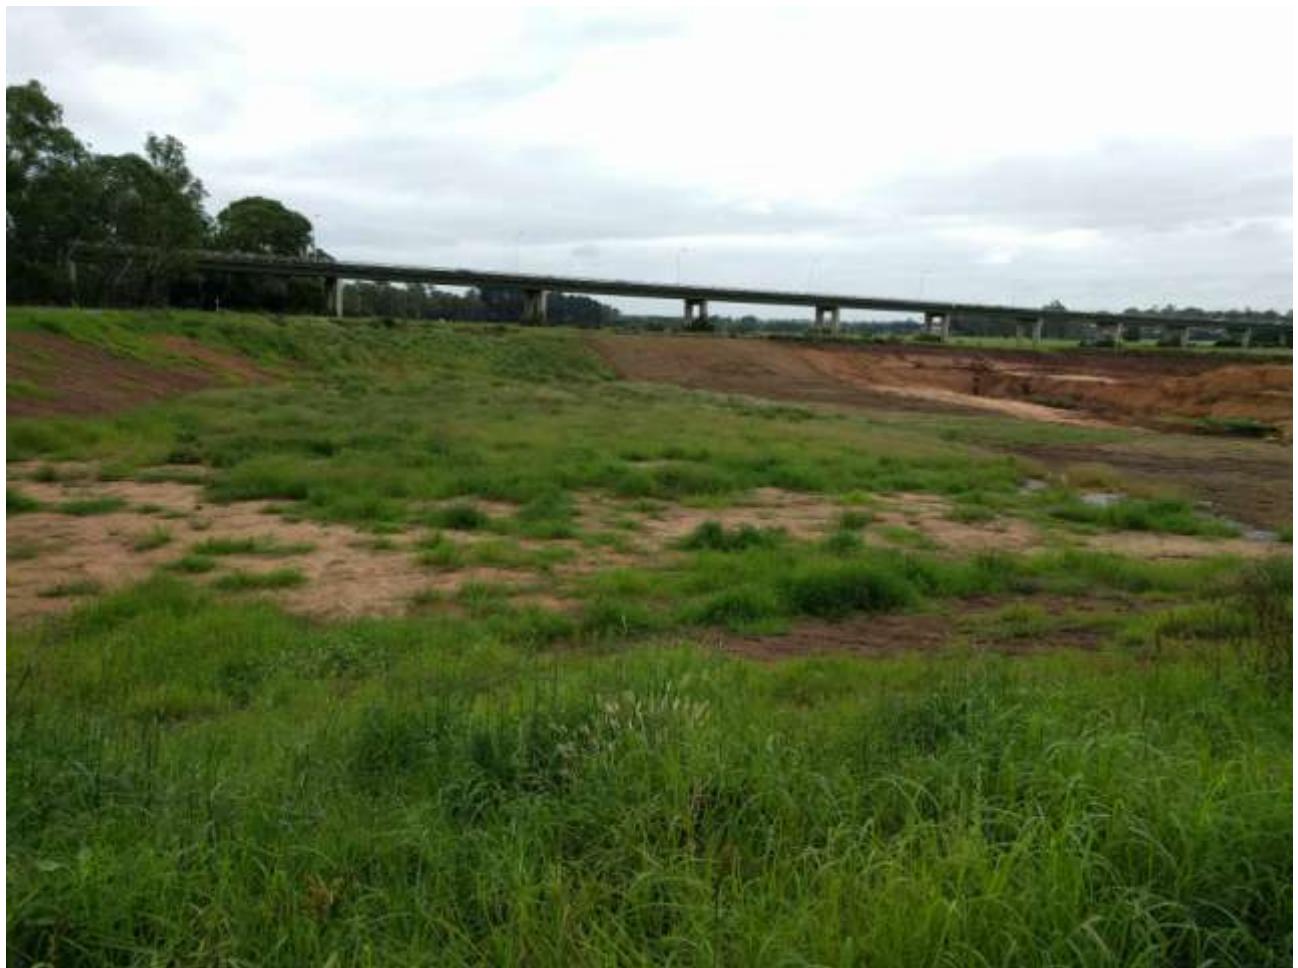
**Figure 7:** Rehabilitation of E1 and E2 on Lot 32 (DP 635271)

Rehabilitation was conducted within 10,385m<sup>2</sup> on Lot 32 (E2 and E1) with turf being laid, turf mulch and hand seeding. (Figure 7) Interim rehabilitation was conducted on Lot 22 (DP 83317) Area 5 with hand seeding 7000m<sup>2</sup> due to delayed commencement of extraction in the area.

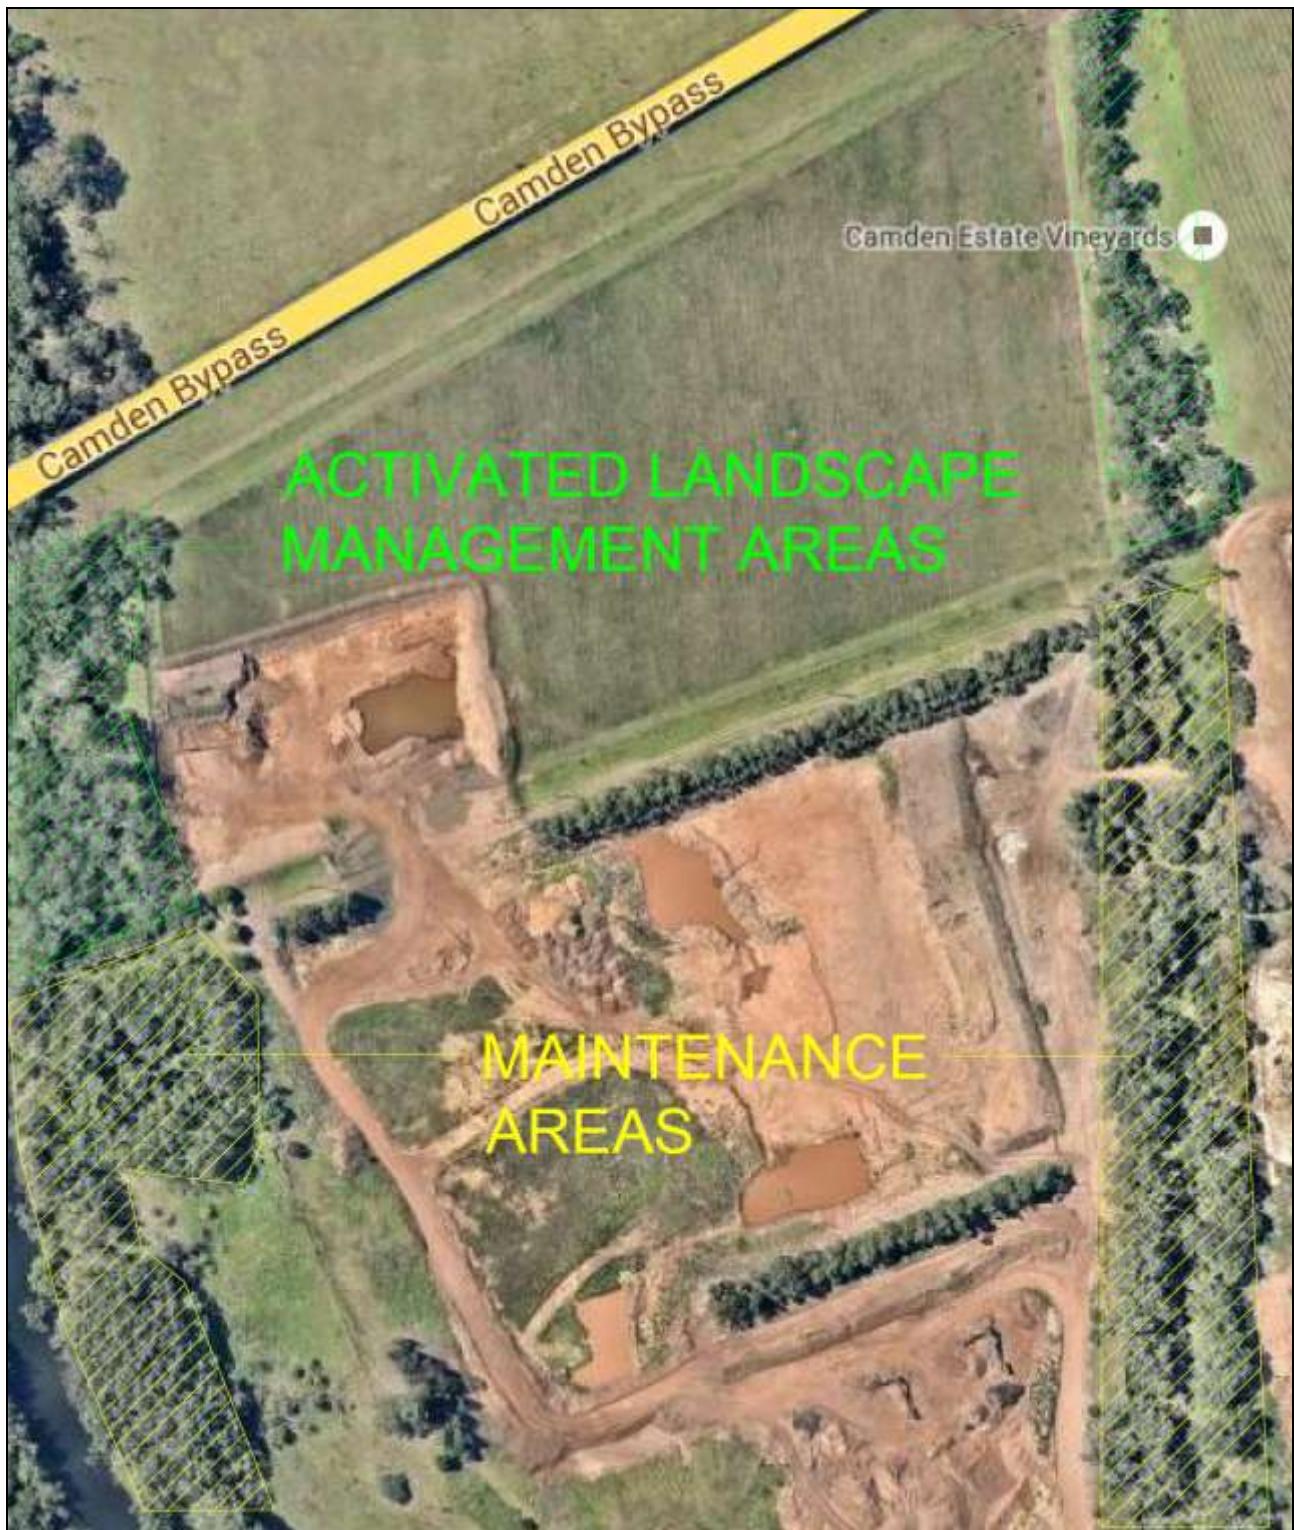
**Figure 8:** Completed active rehabilitation and maintenance areas during the 2016 AEMR period

The two areas for primary active rehabilitation were commissioned during the 2015 reporting period (Figure 4, R1, Lot 32 (DP 635271)) and were completed during the 2016 reporting period (denoted as 'Activated Landscape Management Areas' on Figure 8). These areas consisted of the Nepean River Bank and an associated Anabranch both on Lot 32 (DP 635271). On-going maintenance of all other rehabilitated areas continued throughout 2016. 17,000m<sup>2</sup> of primary rehabilitation was completed on Lot 32 (DP 635271) along the Nepean River Bank (R1) and 7,500m<sup>2</sup> within the (R1) Dry River Anabranch.

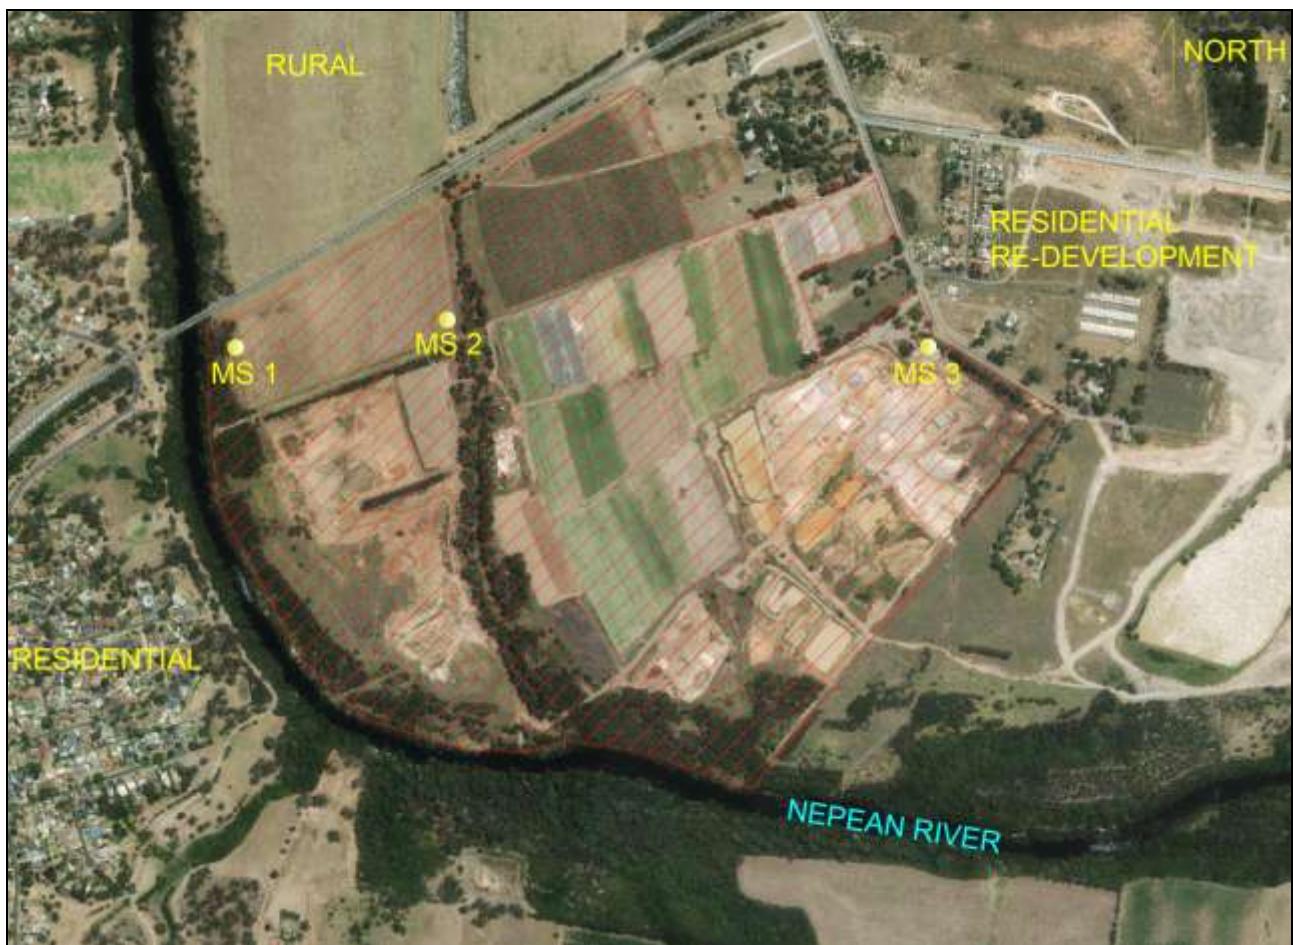
**Figure 9:** Collins Spring Farm Monitoring Sites

As per Item 17 of Schedule 5 of the NSW Department of Planning and Environment *Notice of Modification* (DA 75/256 Mod 3) dated 25 October 2012, there are three monitoring sites across the Collins Spring Farm Quarry; MS1 (*Penman*), MS2 (*Turf Farm*), and MS3 (*Wash Plant*). They can be identified on the western boundary of the site, central to the site and nearest the front gate respectively (Figure 9). Monitoring Stations 1 and 3 consist of a dust deposition sampler. Monitoring Station 2 consists of a dust deposition sampler and groundwater monitoring bore.

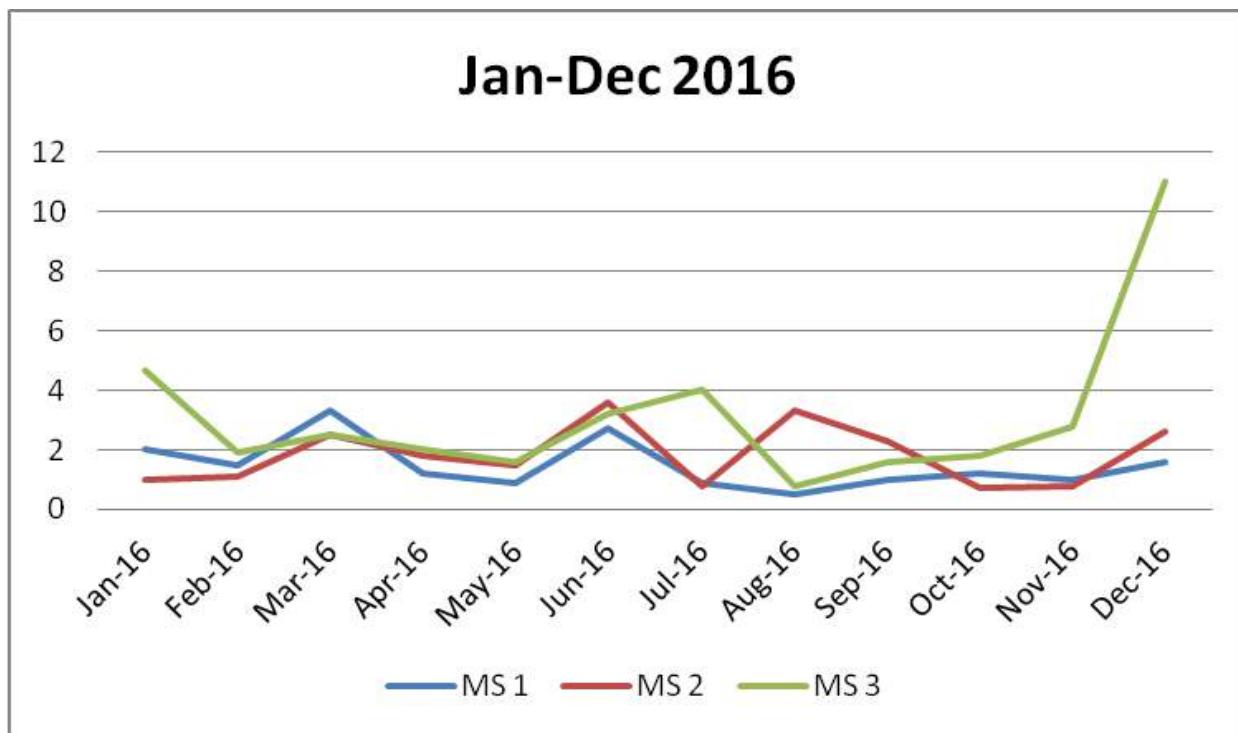
**Figure 10:** Results of 2016 Routine Dust Deposition Monitoring

1. A general increase in exceedances at Stations 1 and 3 (Figure 11). These are attributed to:
    - a. Expansion of the quarry extraction area into Lot 32 and within 10 m of MS1; and
    - b. Earthworks associated with expansion of the nearby Spring Farm urban development site, widening of Springs Road and extreme heat and windy conditions (MS3).
  2. The data also indicates that exceedances occur mostly during summer months in particular during the December January period, during excessive heat and dry windy conditions.

In an effort to reduce the number of recorded exceedances, Collins and Sons have increased the frequency of access road dust suppression wet downs and water cart frequencies. They have also checked, repaired and replaced where necessary all dust suppression sprinkler heads and extended line lengths to expand the wetted area. A new mobile water cart has been purchased and a full time employee will be dedicated to monitor weather conditions, truck movements and speeds and increase mobile wet down of quarry and road areas in 2017. Bund heights are monitored and increased as ongoing site maintenance to capture quarry and extraction pit dust in conjunction with existing controls and the mobile water cart. During excessive dry heat and wind conditions, the plant is shut down, plant and vehicle speed is reduced, product stockpiles are reduced and wet down to form a crust to reduce windblown dust. Dust migration from the nearby Spring Farm urban re-development is beyond the control of Collins and Sons.

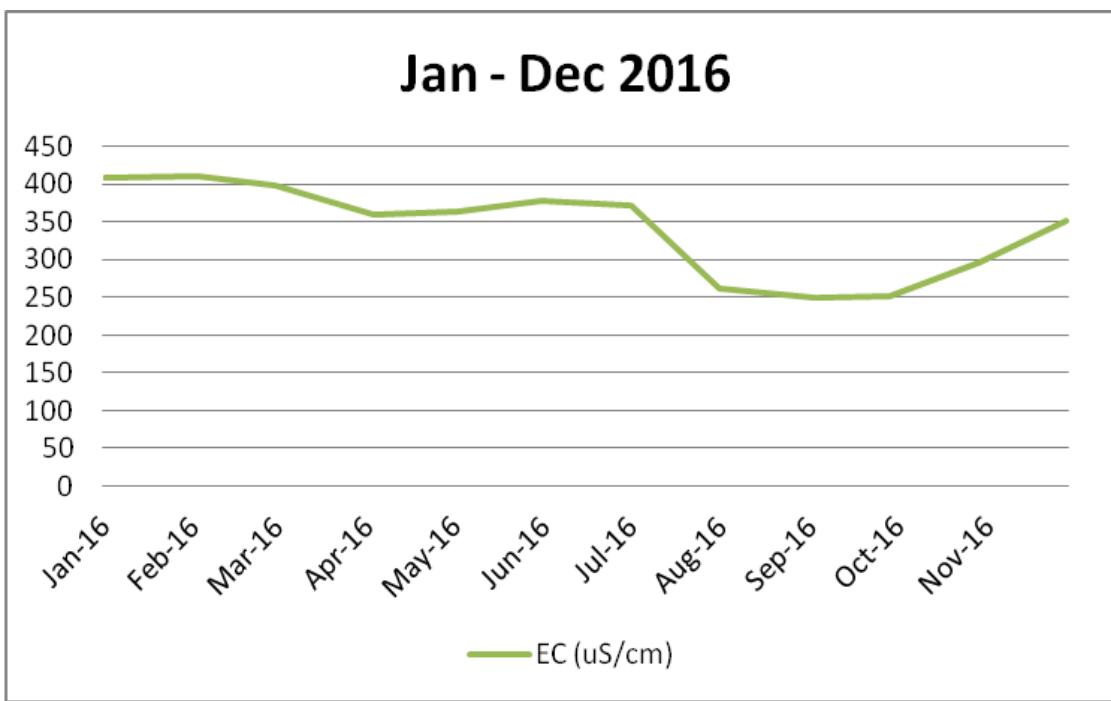
**Figure 13:** Results of 2016 Groundwater Monitoring (EC)

A slight downtrend in groundwater conductivity (EC) values was noted over the 2016 monitoring period. However, no obvious trends or fluctuations in groundwater depth or pH were noted. Groundwater fluctuated between 10.10m and 11.60m depth.

The reason for the moderate downward in electrical conductivity is uncertain but is likely to be associated with prevailing weather and rainfall conditions.

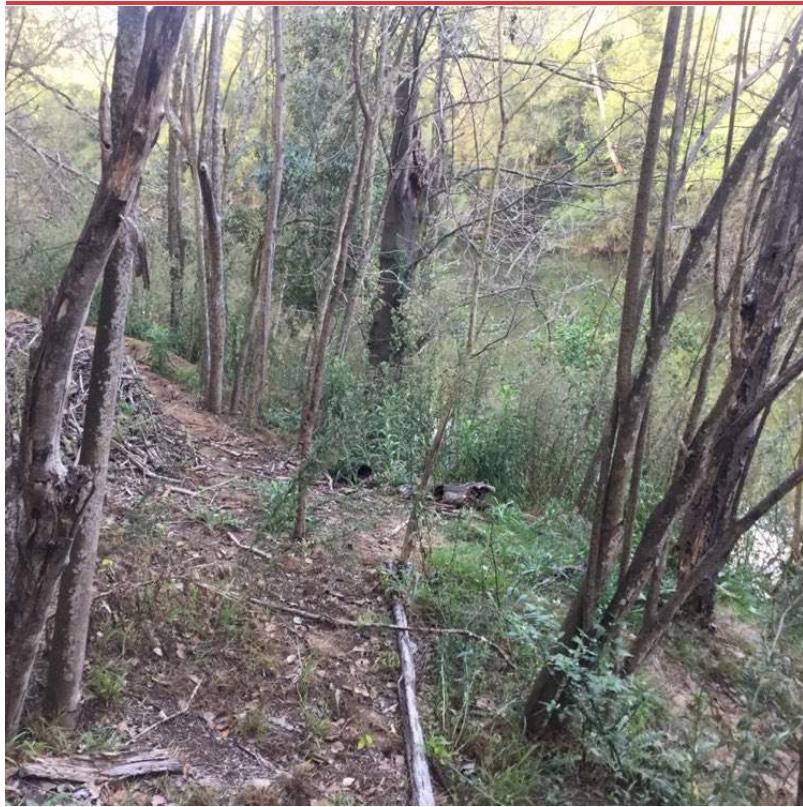
Pictured here is the bank of the riparian zone after primary works had been completed. A large amount of invasive herbaceous weeds have germinated since the large woody weeds treated in this area defoliated.

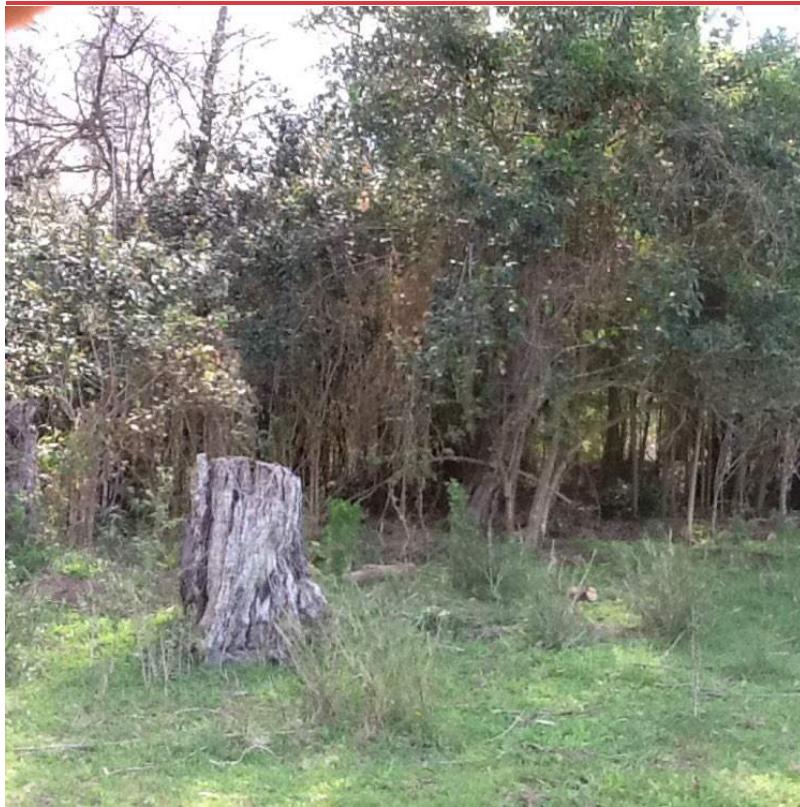
Shown in this picture is a dense infestation of mature Privet sp. several remnant trees are providing shade in this area so all invasive weeds were targeted.

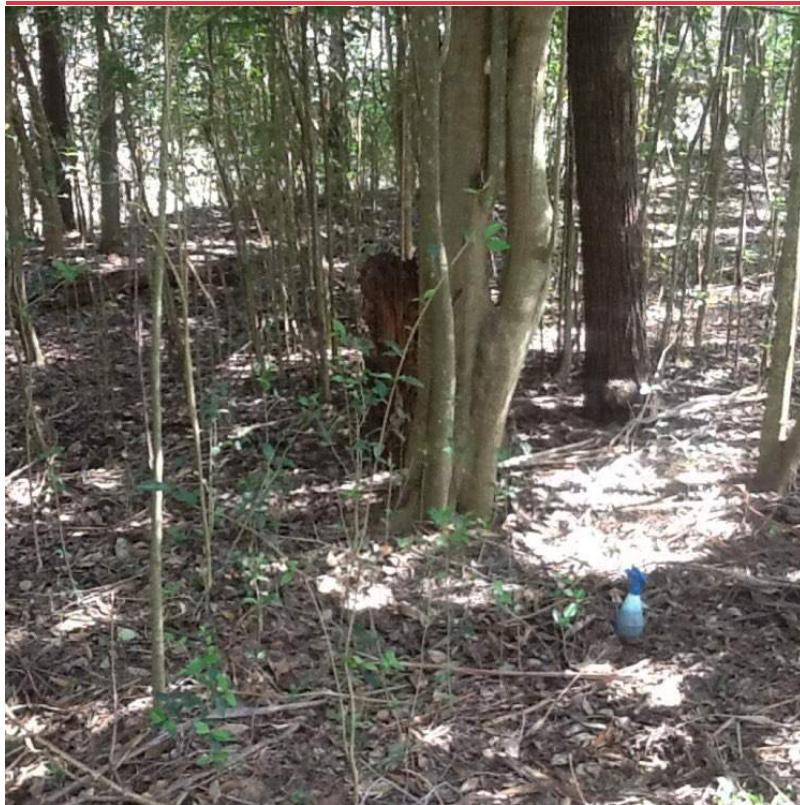
Seen in this picture is the work area from the previous picture. Herbicide was sprayed in this area several months ago and had a successful control on the juvenile Privet sp in this area.

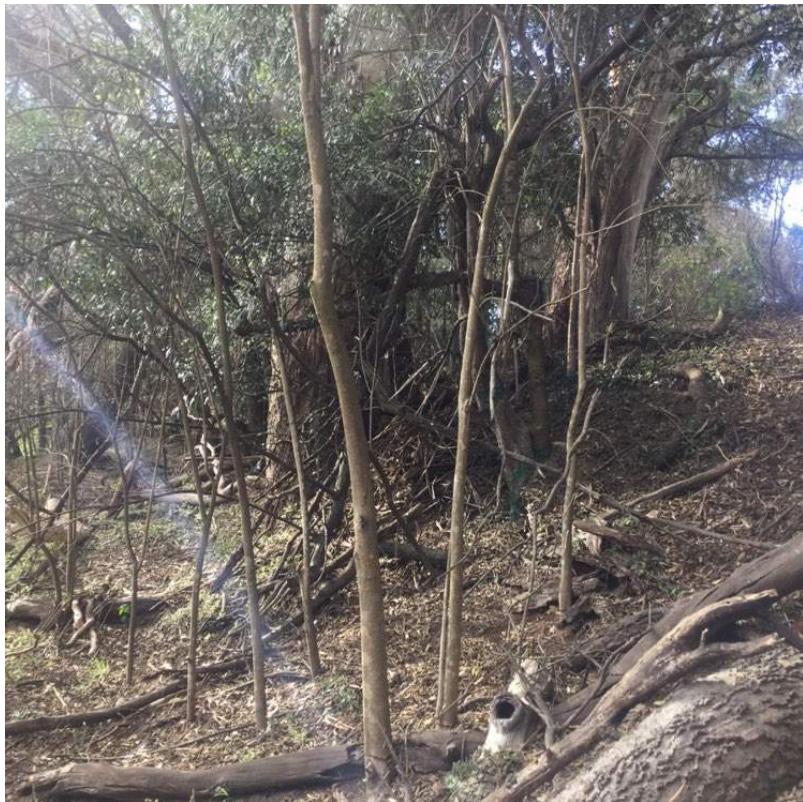
Assigned To After 1

Large *Ligustrum* sp. in this area were frilled and injected with Glyphosate Bi-Active and left standing. Smaller woody weeds were controlled in this area using the cut and paint method, cut stumps were painted with glyphosate Bi-Active. The Biomass created during works were piled to consolidate any viable seed that may be present and make it easier for follow up weed control.

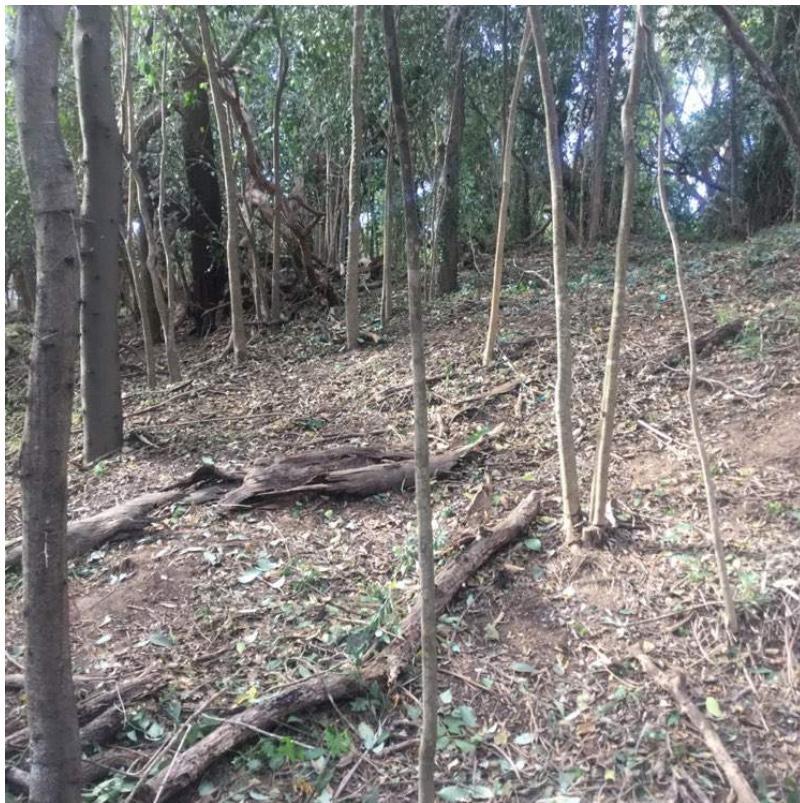
Assigned To After 3

Large *Ligustrum* sp. in this area were frilled and injected with Glyphosate Bi-Active and left standing. Smaller woody weeds were controlled in this area using the cut and paint method, cut stumps were painted with glyphosate Bi-Active. The Biomass created during works were piled to consolidate any viable seed that may be present and make it easier for follow up weed control.

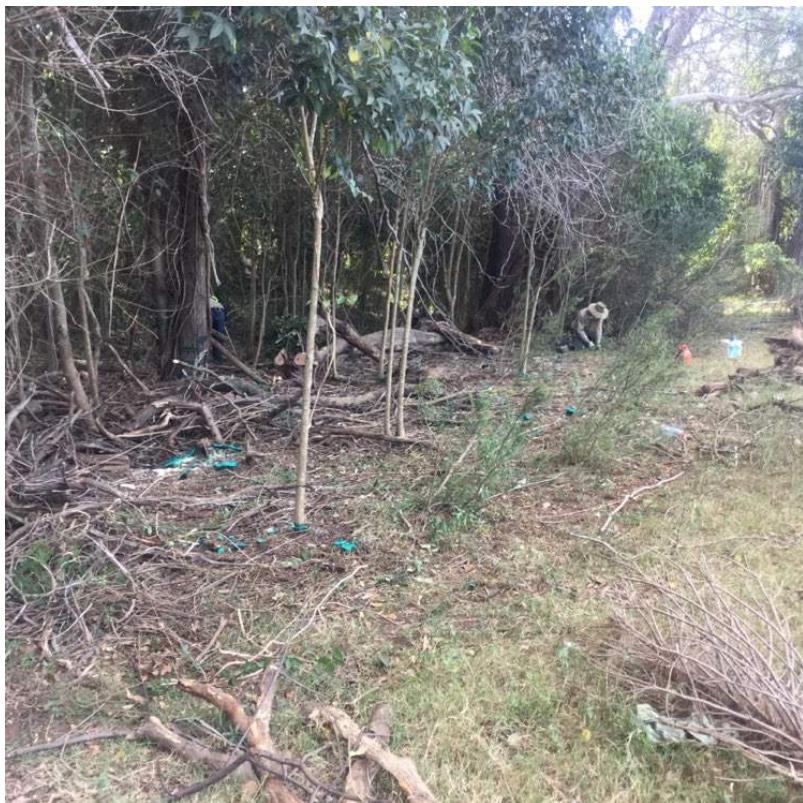
Shown in this picture is a habitat pile that was created with the excess biomass generated during weed control works. This practice ensures easier follow up weed control and reduces hazards on the site.

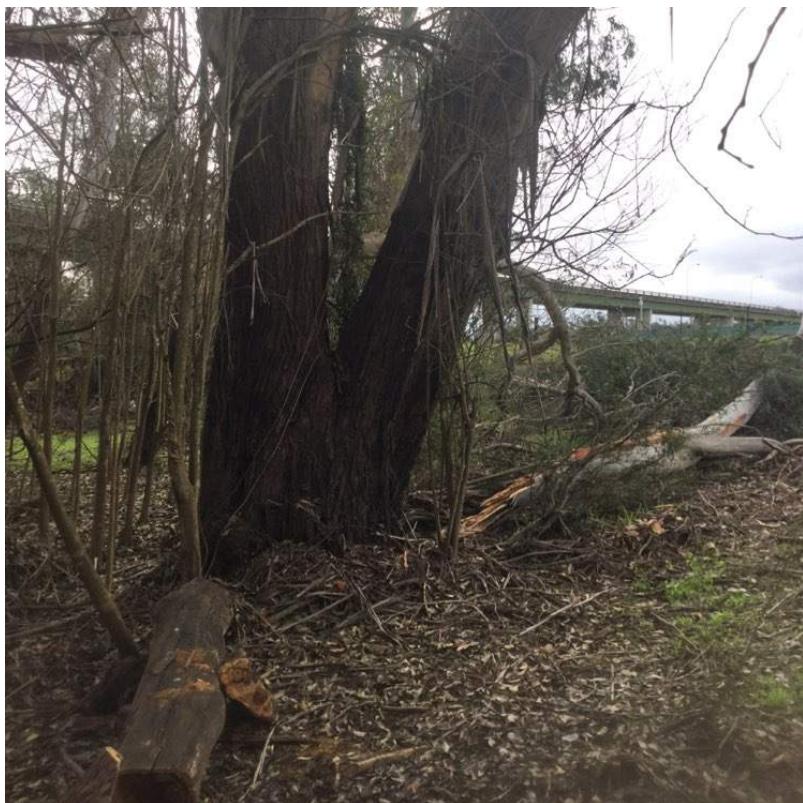
Assigned To After 1

Large Ligustrum sp. in this area were frilled and injected with Glyphosate Bi-Active and left standing. Smaller woody weeds were controlled in this area using the cut and paint method, cut stumps were painted with glyphosate Bi-Active. The Biomass created during works were piled to consolidate any viable seed that may be present and make it easier for follow up weed control.

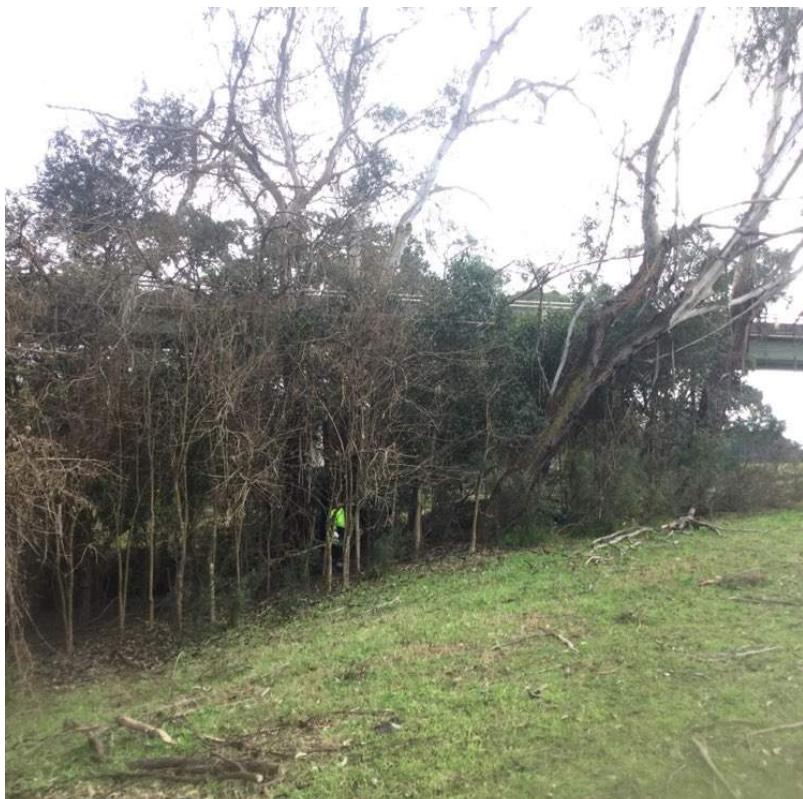
Assigned To After 2

Large Ligustrum sp. in this area were frilled and injected with Glyphosate Bi-Active and left standing. Smaller woody weeds were controlled in this area using the cut and paint method, cut stumps were painted with glyphosate Bi-Active. The Biomass created during works were piled to consolidate any viable seed that may be present and make it easier for follow up weed control.

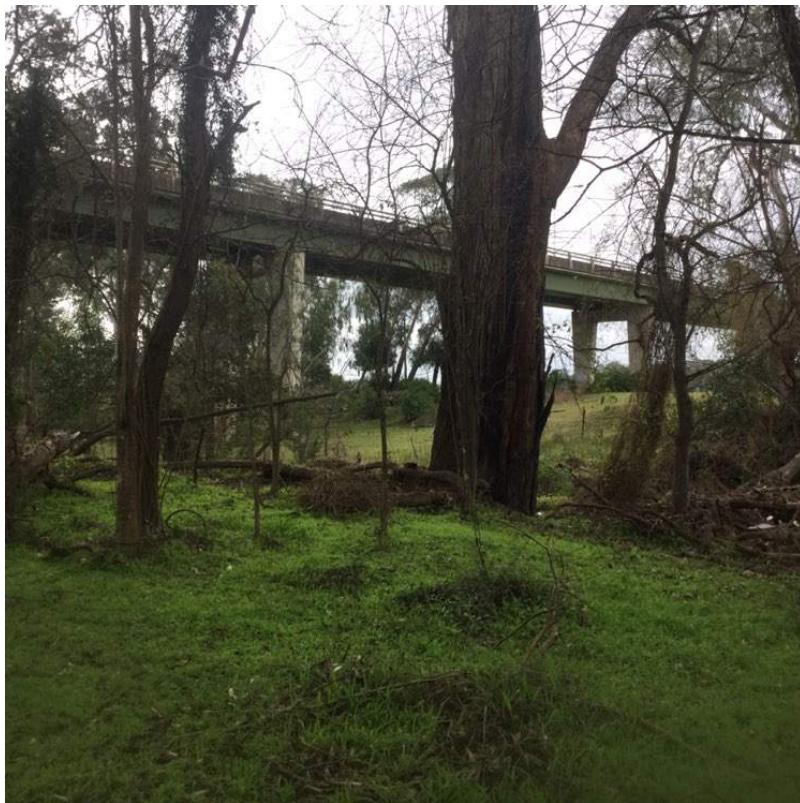
Assigned To After 3

Large Ligustrum sp. in this area were frilled and injected with Glyphosate Bi-Active and left standing. Smaller woody weeds were controlled in this area using the cut and paint method, cut stumps were painted with glyphosate Bi-Active. The Biomass created during works were piled to consolidate any viable seed that may be present and make it easier for follow up weed control.

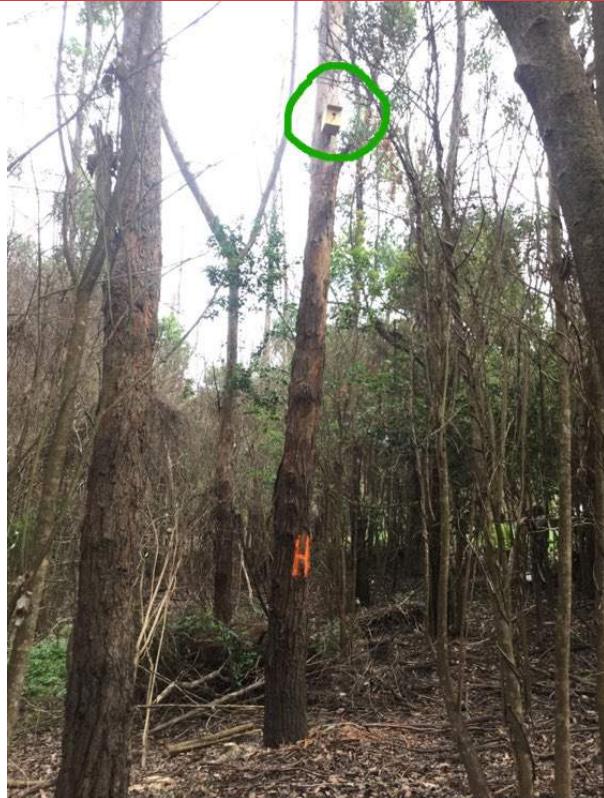
#### Picture Nesting Box 1

Shown in this picture circled in green is a newly installed nesting box. The nesting box was located in an area with an obvious lack in habitat for the targeted species, in this case small finch birds such as Pardalotes. Nesting boxes were located in the most appropriate position for the target species. All trees with nesting boxes fixed to them were labelled with a H for habitat. This practice aids in not only relocation of the nesting box tree, but also maintenance of the boxes.

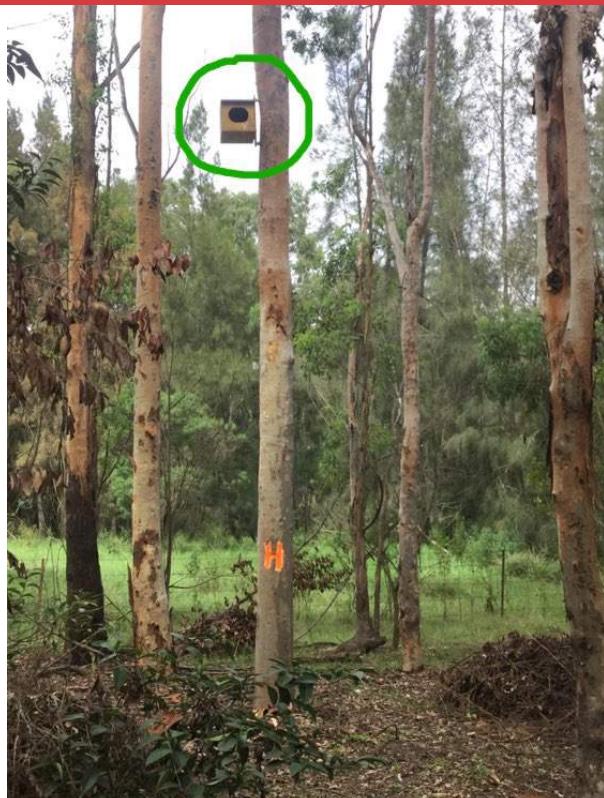
#### Picture Nesting Box 2

Shown in this picture circled in green is a newly installed nesting box. The nesting box was located in an area with an obvious lack in habitat for the targeted species, in this case kookaburra and other large predatory birds. Nesting boxes were located in the most appropriate position for the target species.

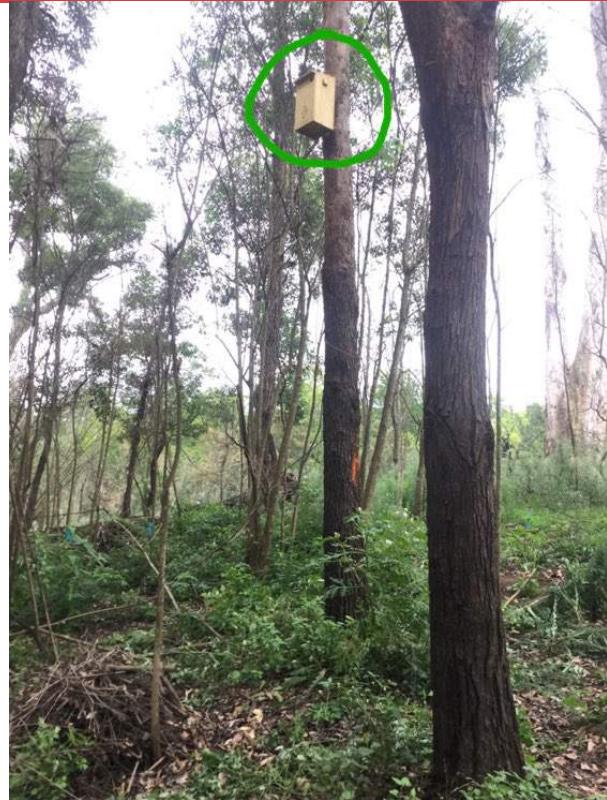
#### Picture Nesting Box 5

Shown in this picture circled in green is a newly installed nesting box. The nesting box was located in an area with an obvious lack in habitat for the targeted species, in this case arboreal marsupials such as sugar gliders. Nesting boxes were located in the most appropriate position for the target species. All trees with nesting boxes fixed to them were labelled with a H for habitat. This practice aids in not only relocation of the nesting box tree, but also maintenance of the boxes. Arboreal marsupial nesting boxes were located in pairs to aid in the colonisation habits of this species. Several near by hollows were also in the locality of these nesting boxes.

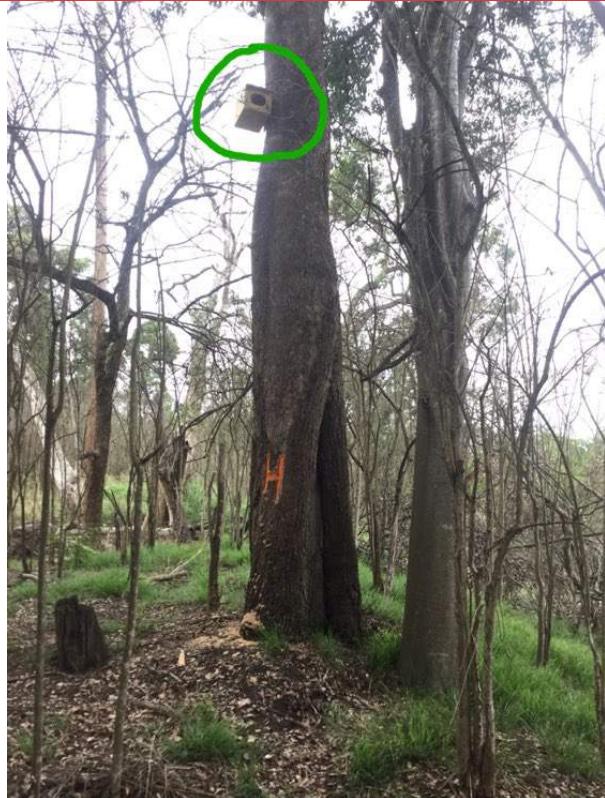
#### Picture Nesting Box 6

Shown in this picture circled in green is a newly installed nesting box. The nesting box was located in an area with an obvious lack in habitat for the targeted species, in this case kookaburra and other large predatory birds. Nesting boxes were located in the most appropriate position for the target species.

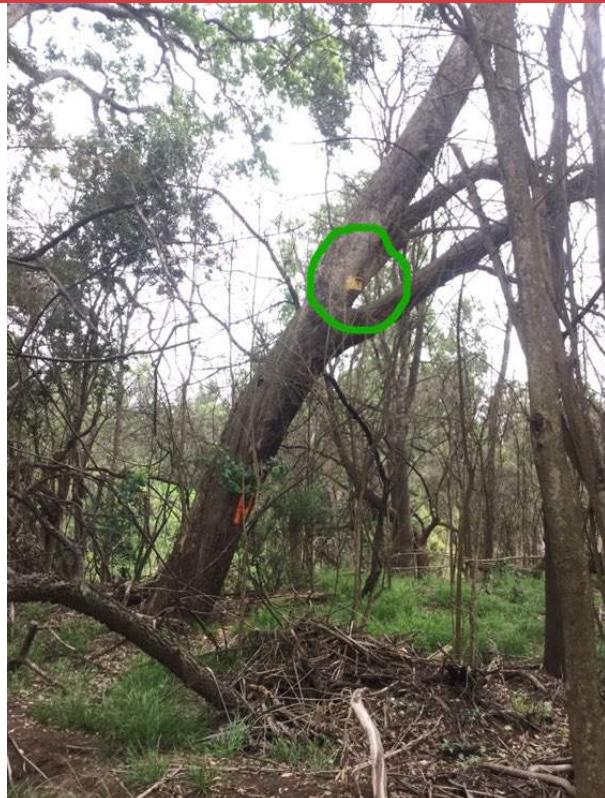
#### Picture Nesting Box 7

Shown in this picture circled in green is a newly installed nesting box. The nesting box was located in an area with an obvious lack in habitat for the targeted species, in this case small finch birds such as Pardalotes. Nesting boxes were located in the most appropriate position for the target species. All trees with nesting boxes fixed to them were labelled with a H for habitat. This practice aids in not only relocation of the nesting box tree, but also maintenance of the boxes.

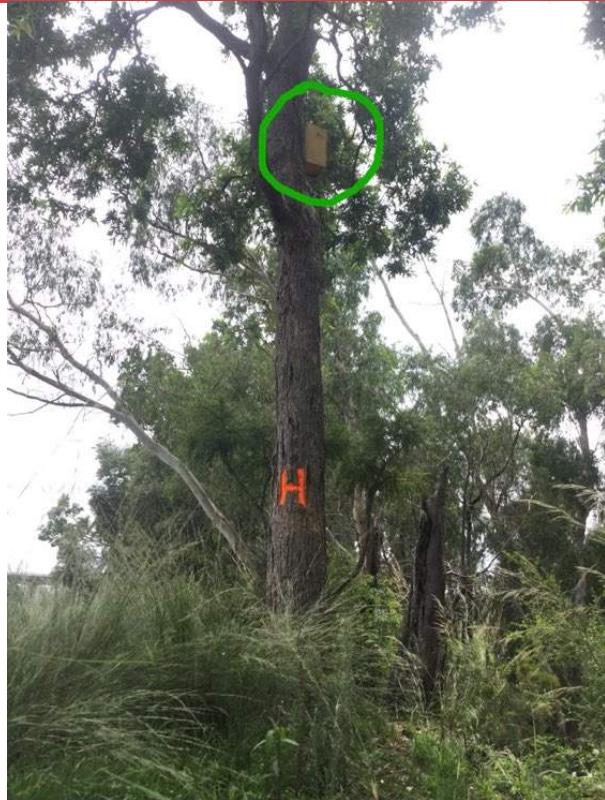
#### Picture Nesting Box 8

Shown in this picture circled in green is a newly installed nesting box. The nesting box was located in an area with an obvious lack in habitat for the targeted species, in this case arboreal marsupials such as sugar gliders. Nesting boxes were located in the most appropriate position for the target species. All trees with nesting boxes fixed to them were labelled with a H for habitat. This practice aids in not only relocation of the nesting box tree, but also maintenance of the boxes. Arboreal marsupial nesting boxes were located in pairs to aid in the colonisation habits of this species. Several near by hollows were also in the locality of these nesting boxes.

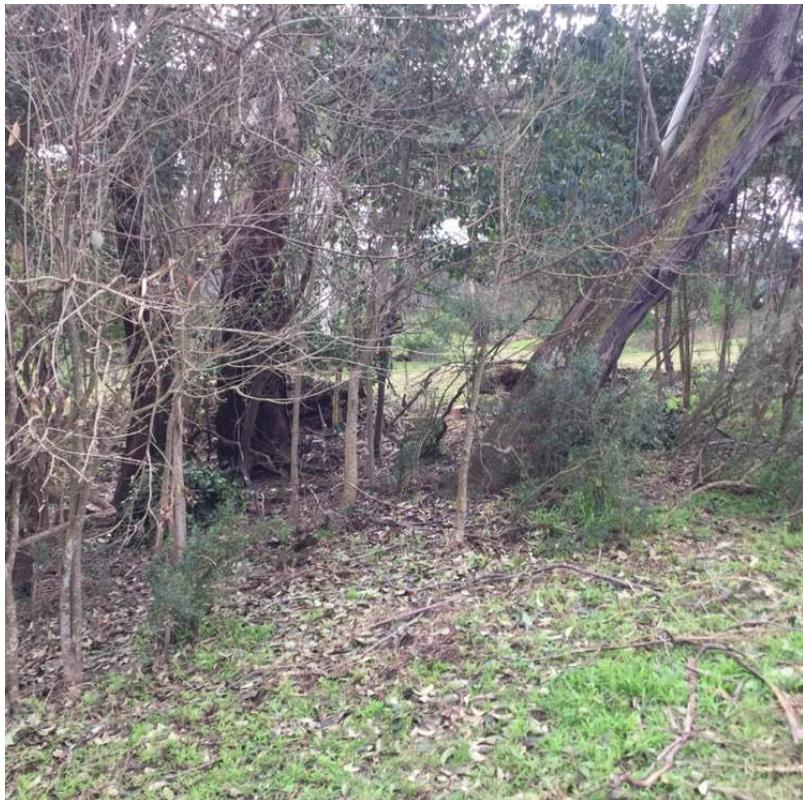
Assigned To After 1

Seen in this picture is the previously mentioned work area after primary weed control was completed. Larger specimens were frilled and injected with glyphosate bi-active. Smaller specimens were cut and painted with glyphosate bi-active. Any excess biomass that was created was chopped into habitat piles to aid in follow up work. Invasive vine species were scraped and painted with glyphosate bi-active.

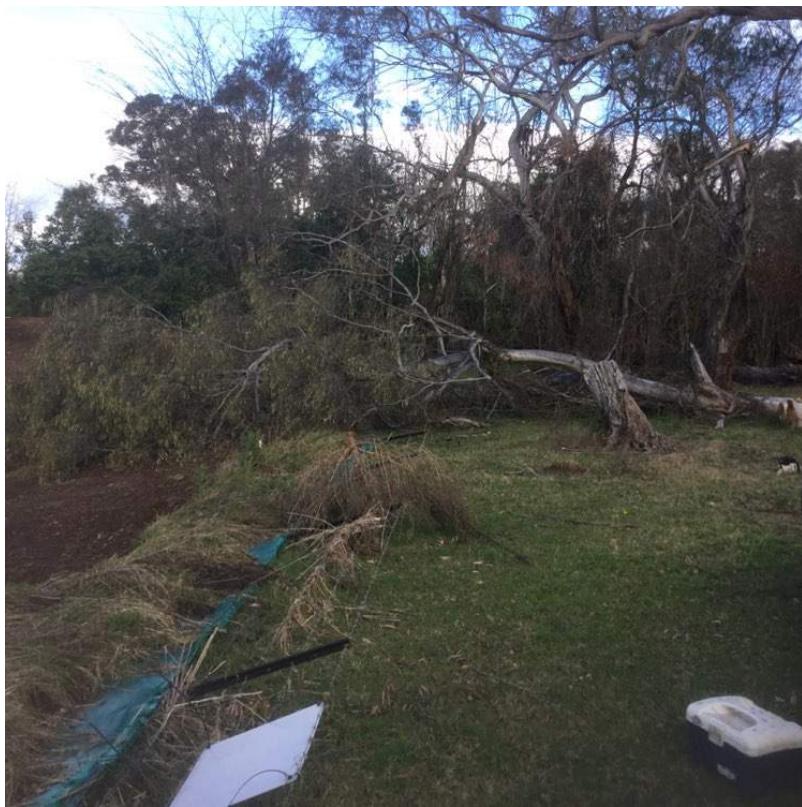
Shown in this picture is the fallen tree that has been removed off the fencing.
