## **2016 ANNUAL ENVIRONMENTAL MANAGEMENT REPORT**

### **SPRING FARM SAND AND SOIL EXTRACTION AND PROCESSING OPERATION (DA 75/256)**

**MACARTHUR ROAD, SPRING FARM**

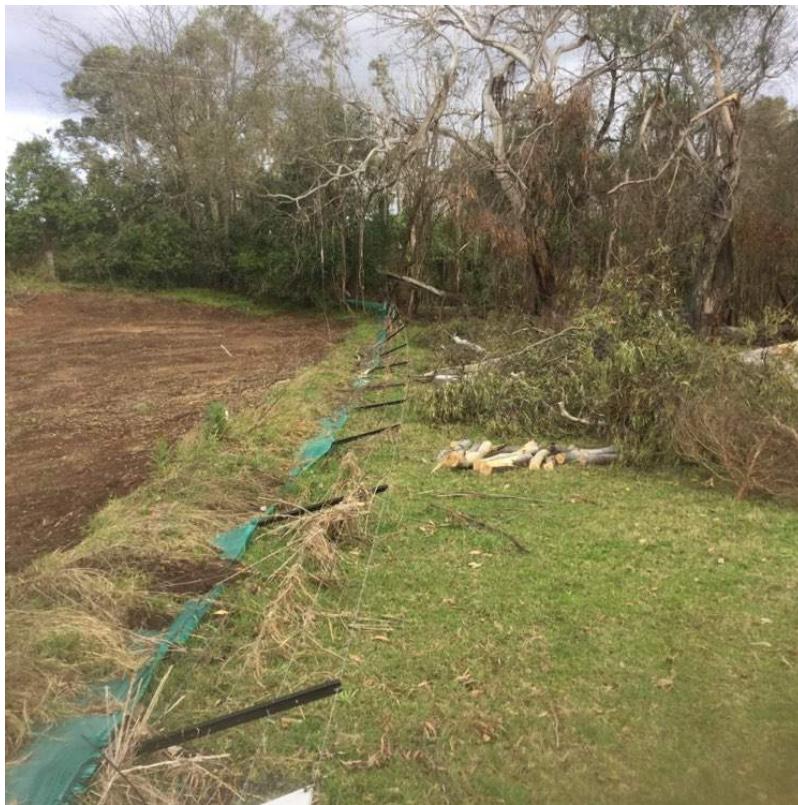
Assigned To Tree Down On Fence  
Before

Shown in this picture is a tree that had fallen and landed on the safety fencing around the mine extraction area in the recent storm.

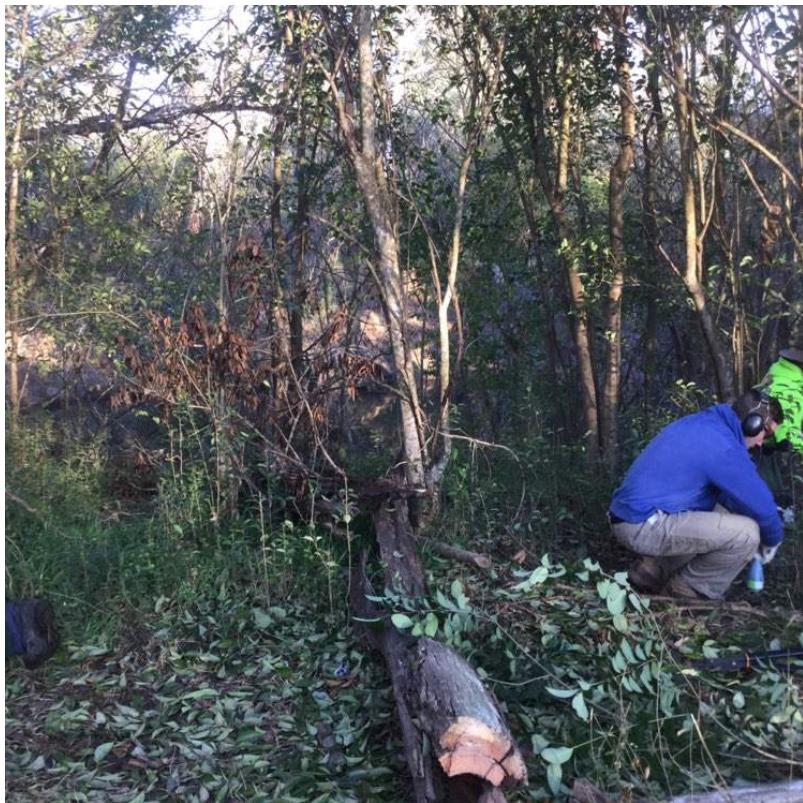
Assigned To Tree Down On Fence  
After

Shown in this picture is the fallen tree that has been removed off the fencing.

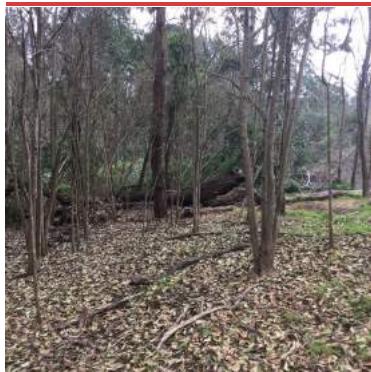
Assigned To Before 1

Shown in this picture is the riparian area in Zone 1A before primary weed control commenced.

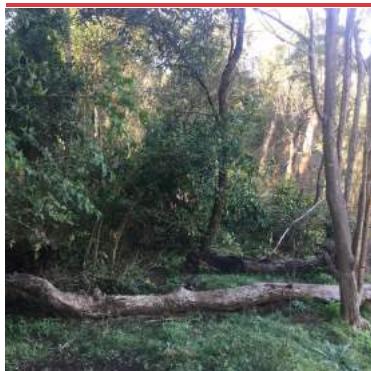
Assigned To After 1

Large Ligustrum sp. in this area were frilled and injected with Glyphosate Bi-Active and left standing. Smaller woody weeds were controlled in this area using the cut and paint method, cut stumps were painted with glyphosate Bi-Active. The Biomass created during works were piled to consolidate any viable seed that may be present and make it easier for follow up weed control.

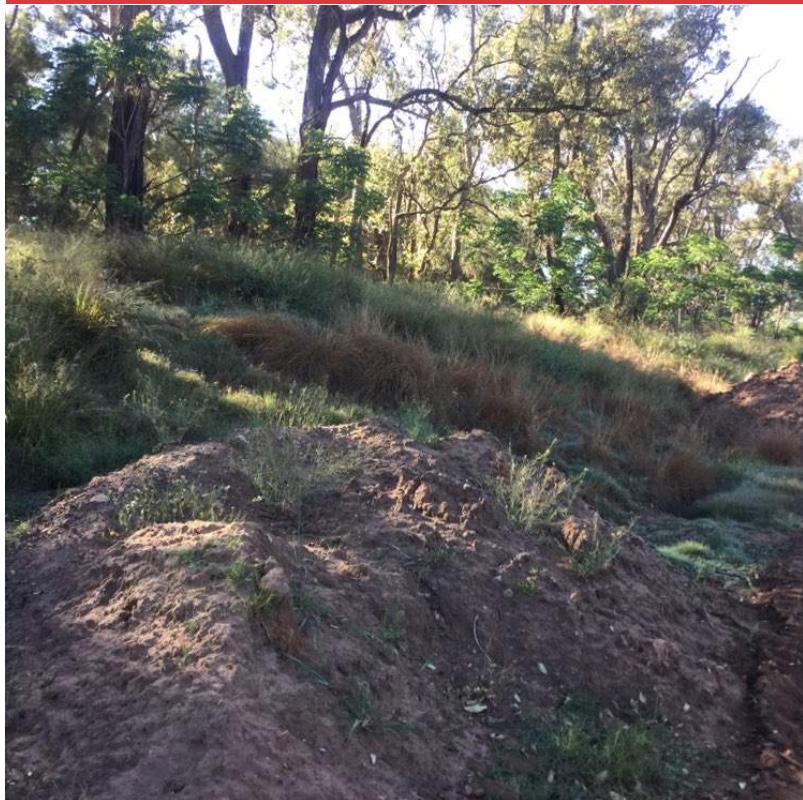
Picture Work In Progress

Bowantz team undertaking weed control on the edge of the anabranch.

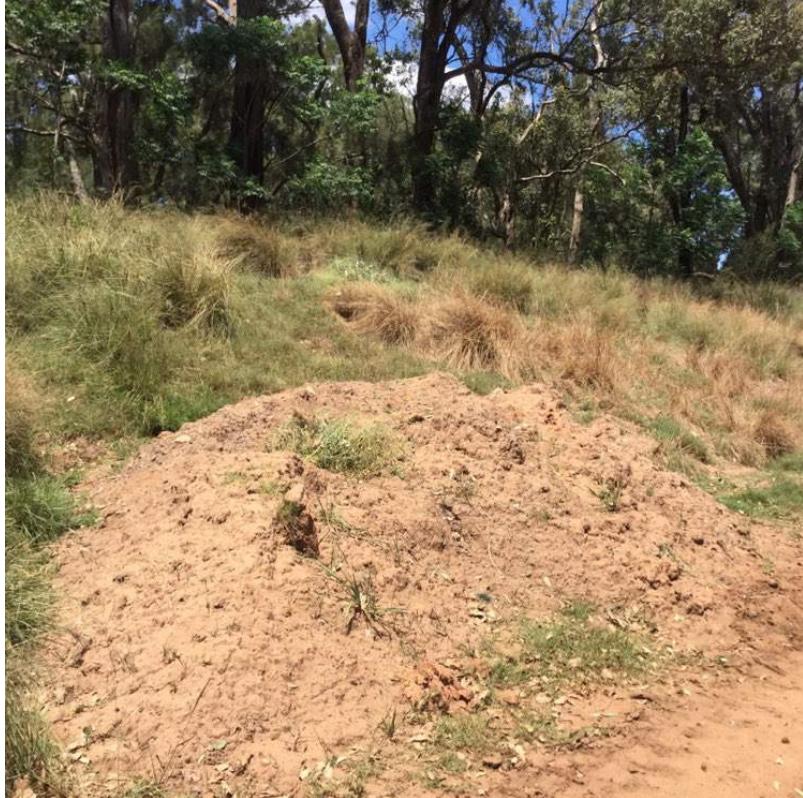
Picture Before 1

Shown in this picture is the upper banks of the anabranch before weed control was undertaken.

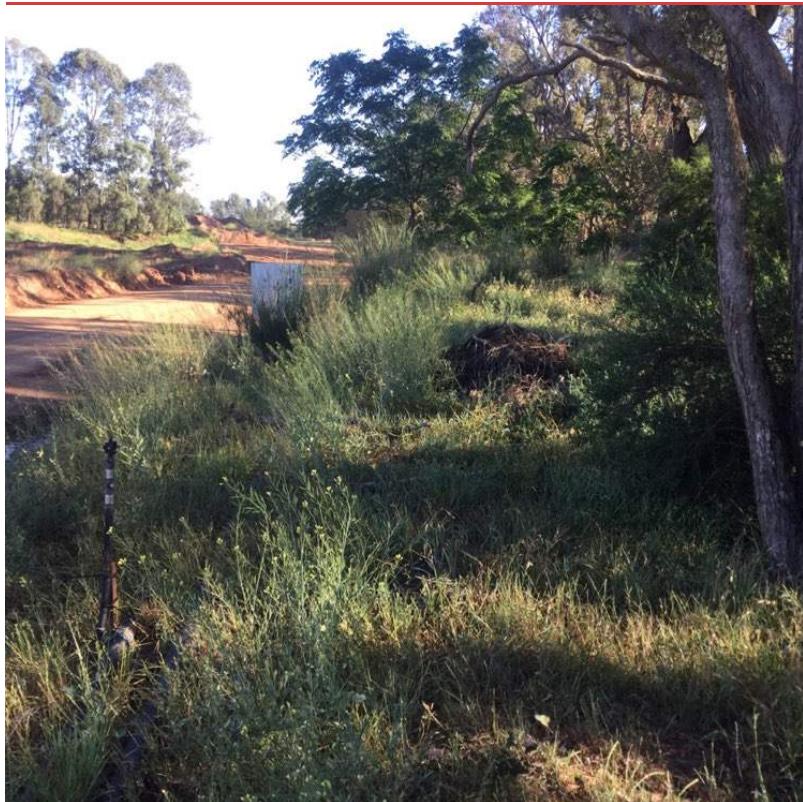
### Picture After 1

Seen in this picture is the upper banks of the anabranch after weed control was completed. Herbaceous fibrous rooted species were hand pulled and woody weeds were cut and painted with glyphosate bi-active. Excess bio-mass generated during weed control was placed into piles to consolidate any viable reproductive parts that may be present.

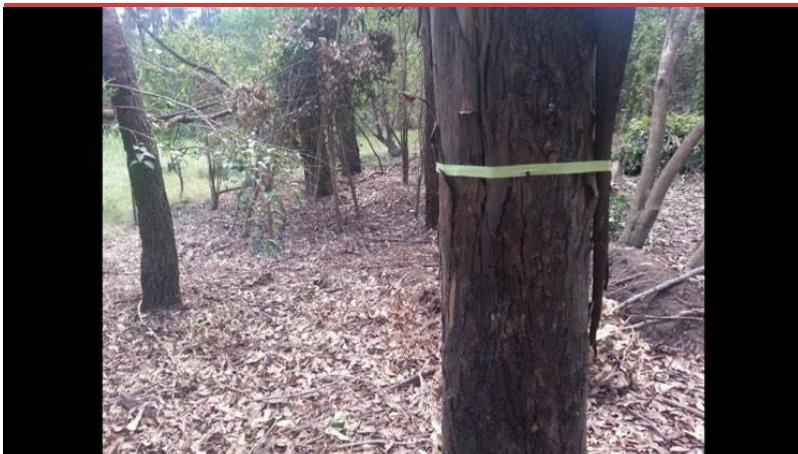
### Picture Before 1

Shown in this picture is a dense infestation of mature Privet sp. several remnant trees are providing shade in this area so all invasive weeds were targeted.

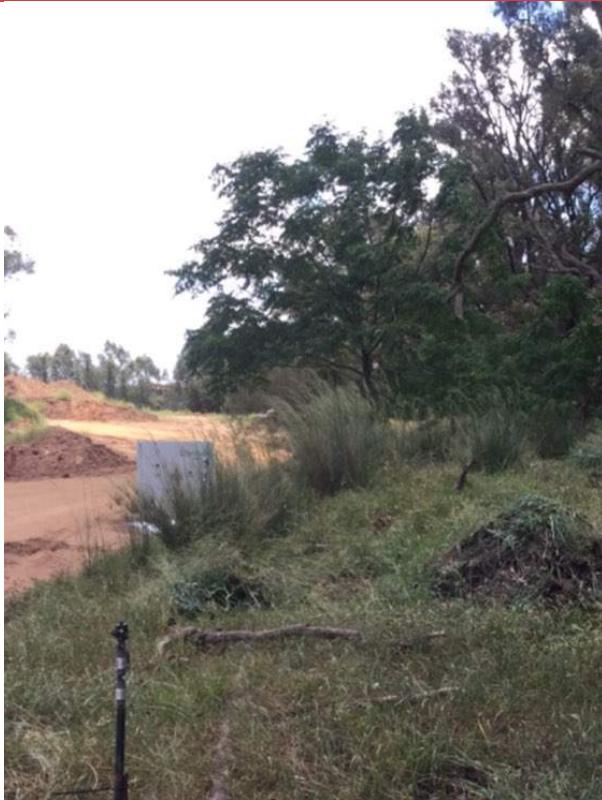
### Picture After 1

Large Ligustrum sp. in this area were frilled and injected with Glyphosate Bi-Active and left standing. Smaller woody weeds were controlled in this area using the cut and paint method, cut stumps were painted with glyphosate Bi-Active. The Biomass created during works were piled to consolidate any viable seed that may be present and make it easier for follow up weed control. Creating these piles with the excess bio-mass generated during weed control works provides ideal habitat for a wide range of native fauna.

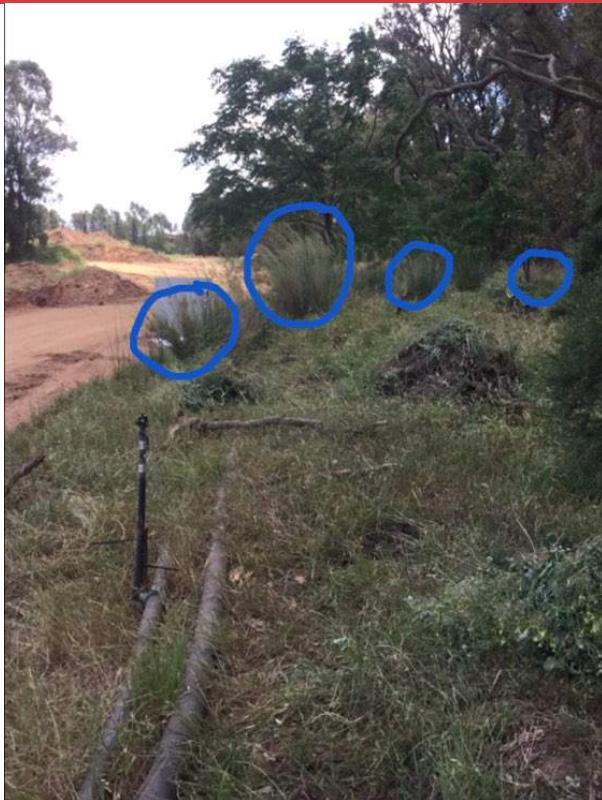
### Picture Before 2

Shown in this picture is the road verge on the western edge of the anabanch before weed control was completed.

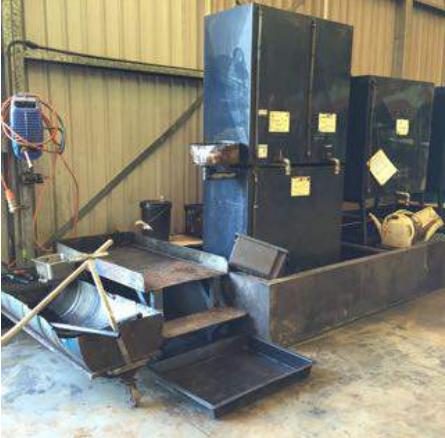
Clean and maintained oil storage area with the workshop areas (area not within scope of this audit).
05

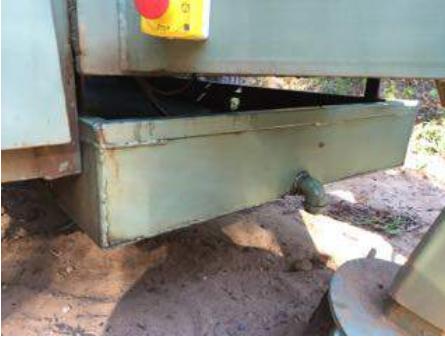
Oil water bund underneath the water pump (located on the bank of the Nepean River). Bund was clean and no evidence of leaks observed (no visible soil contamination). Area was reportedly cleaned post DPE compliance audit. This area is not within scope of this audit.
06

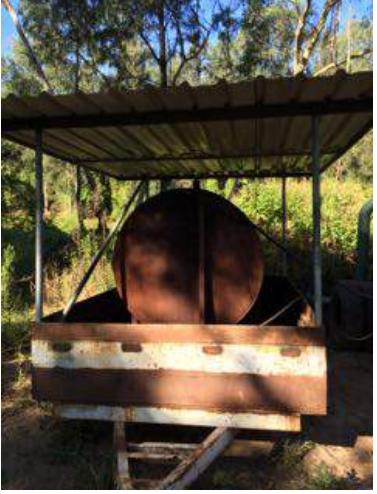
New roofing installed over water pump (located on the bank of the Nepean River).
07

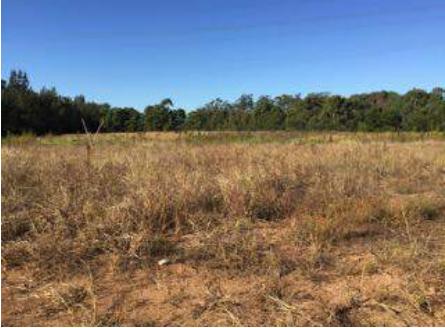
08

Revegetation landform in previous Lot 22 extraction area (Cells R3 – R7)

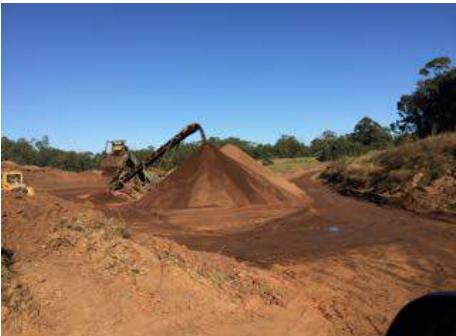
Sand processing within Lot 22 extraction areas.
09

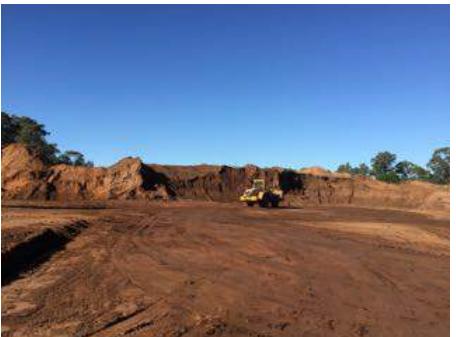
Sand extraction activities within the current Lot 22 extraction area.
10

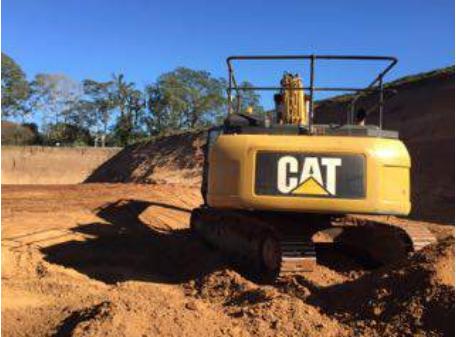
Sand extraction activities within the current Lot 22 extraction area.
11

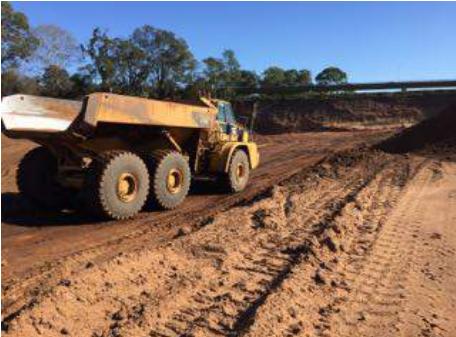
12

Sand extraction activities within the current Lot 22 extraction area.

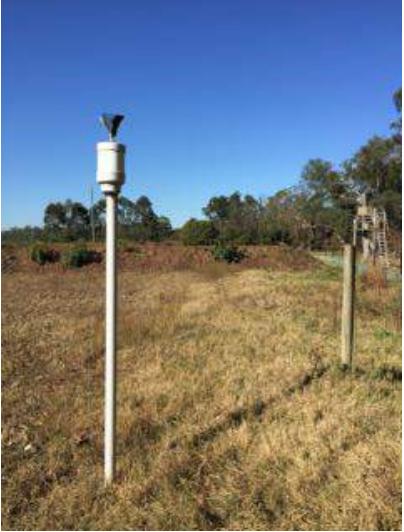
<p>Dust monitoring point adjacent to the sand extraction activities within the current Lot 22 extraction area. Landscape rehabilitation and maintenance also occurring on the bank of the Nepean River (to the back of this photograph).</p>
13

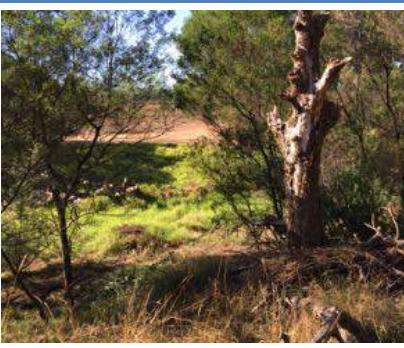
<p>Evidence of ongoing revegetation and land management within the anabranch of the Nepean River.</p>
14

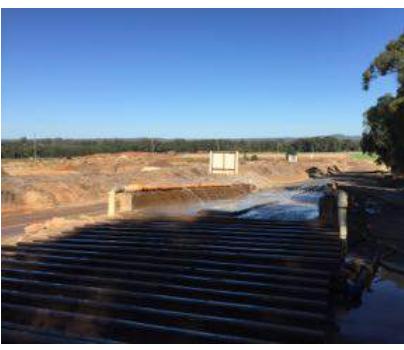
<p>Wheel wash facilities in operation during the audit site inspection.</p>
