LANDSCAPE MANAGEMENT PLAN (Including Quarry Closure, Rehabilitation and Post Extraction Land-use)

EXISTING SAND AND SOIL EXTRACTION OPERATIONS

**Lot 32 DP 635271 and Lot 22 DP 833317
Macarthur Road, Spring Farm**

Job Reference 75/256/4

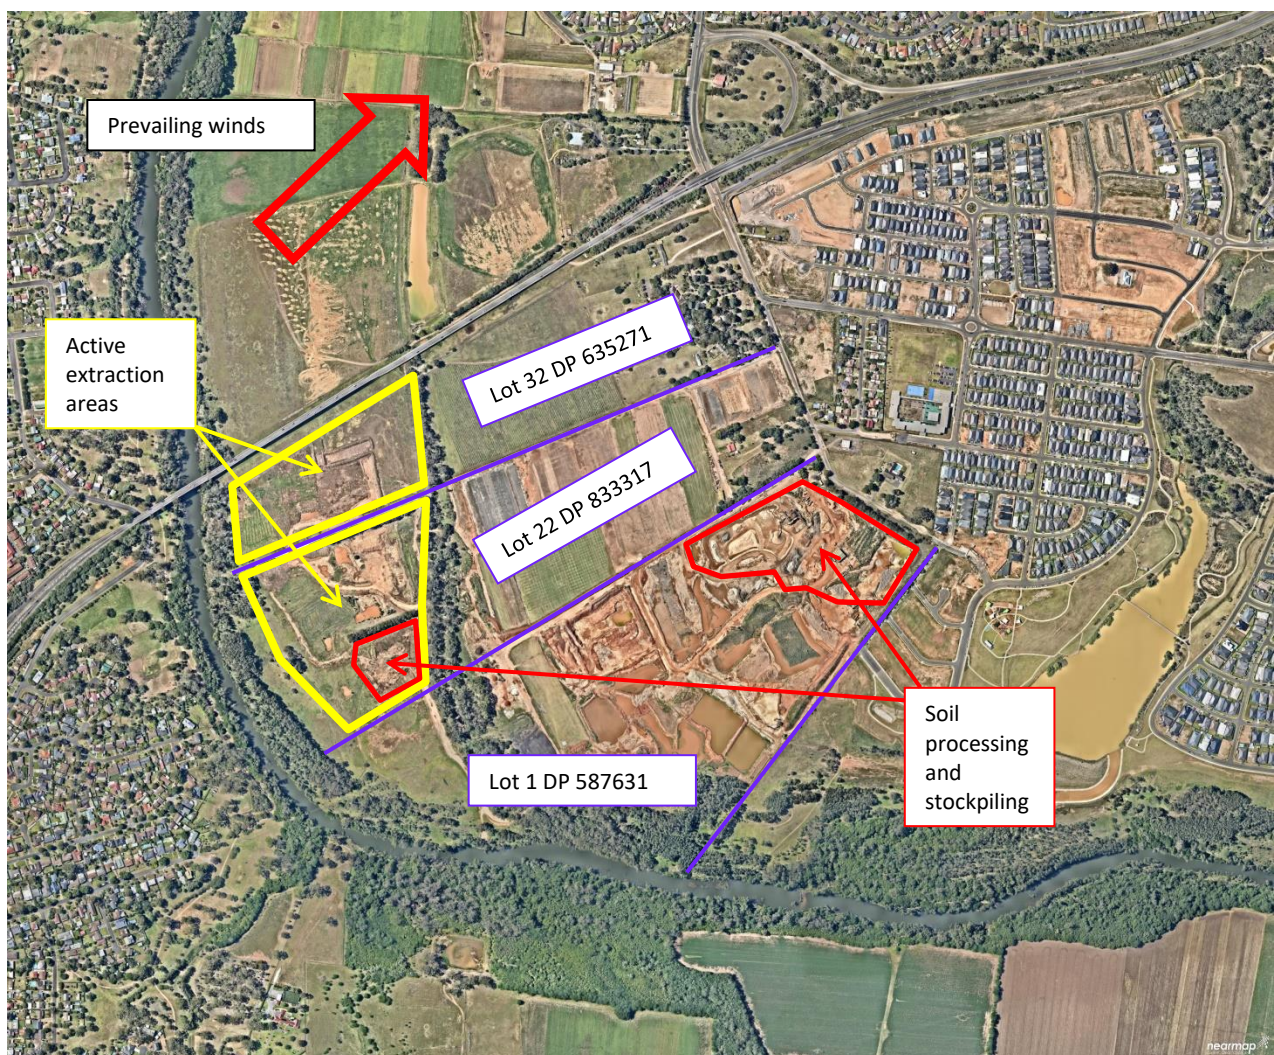
Figure 1. Plan of stockpiling, extraction and processing locations (December 2018)

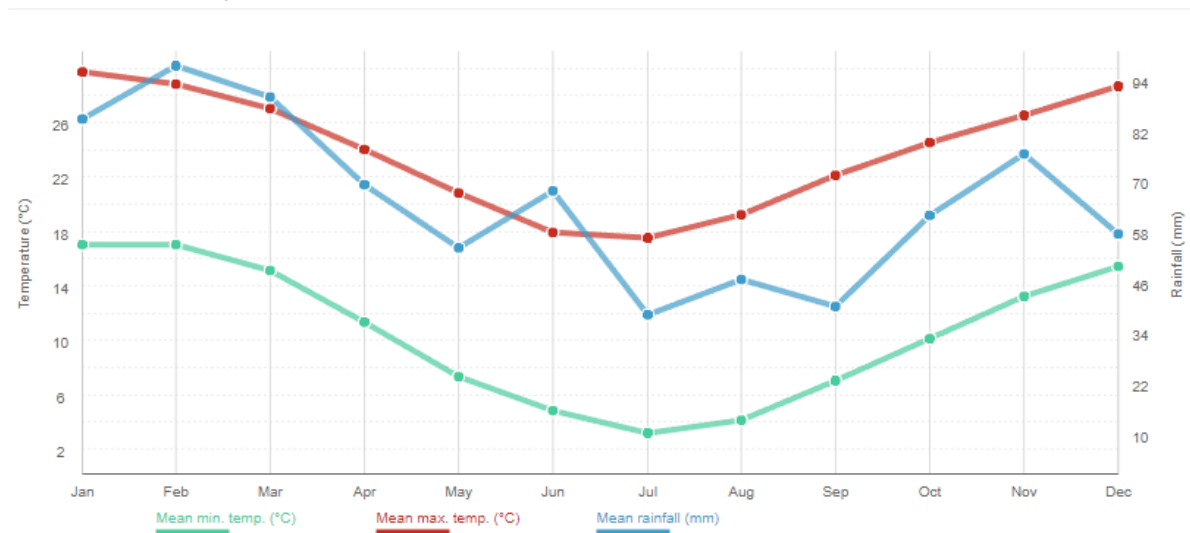
Mean rainfall and temperature

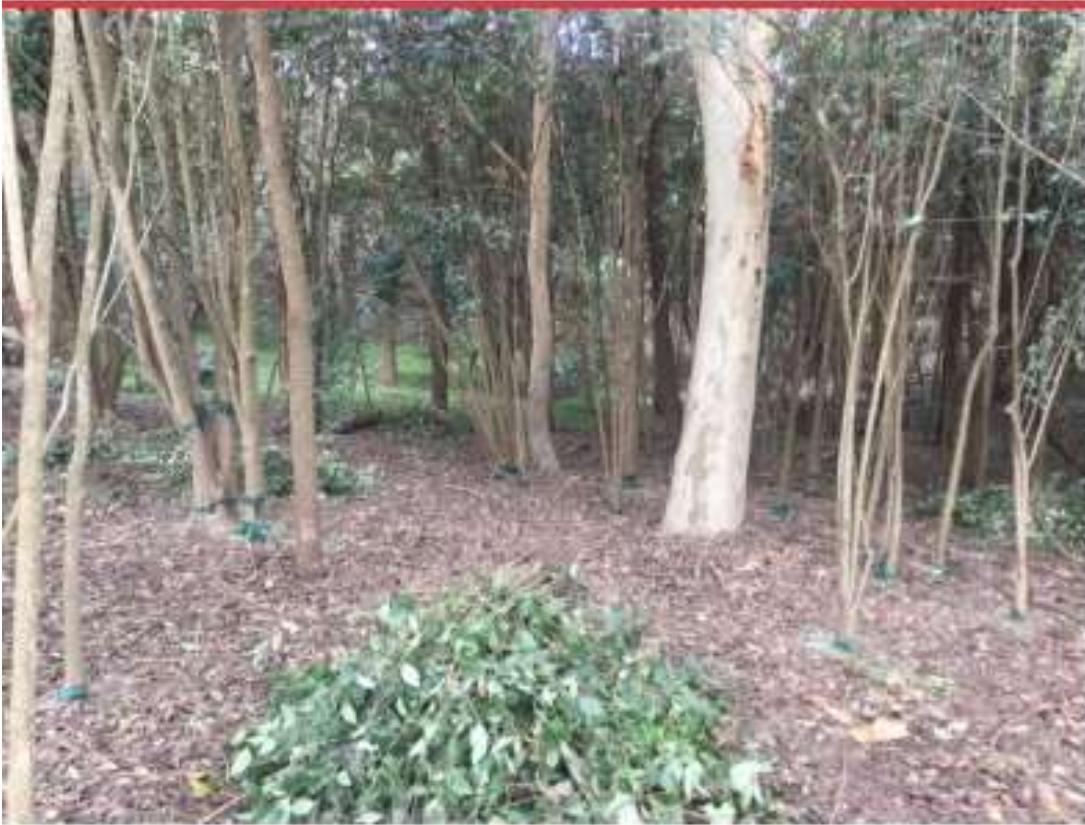
Image 5 Zone 1b) Primary weed control privet eradication September 2017

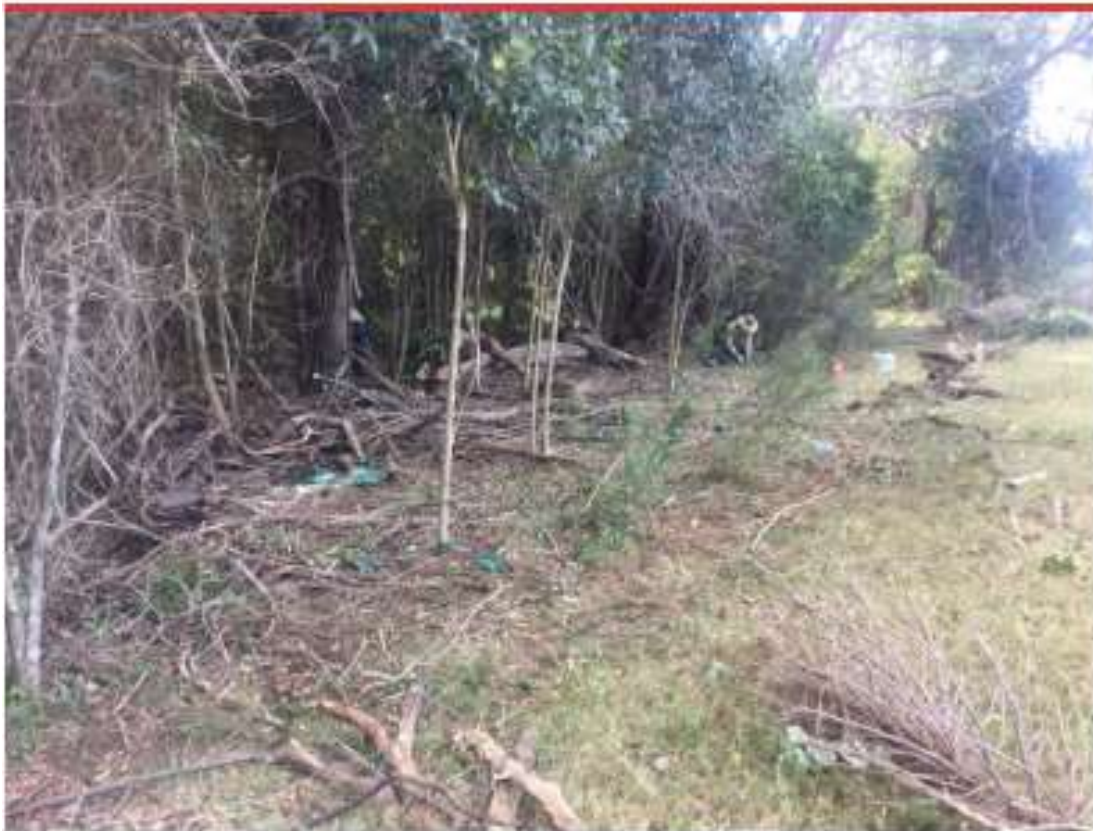
Image 6 Zone 1b) Primary weed control privet eradication October 2017

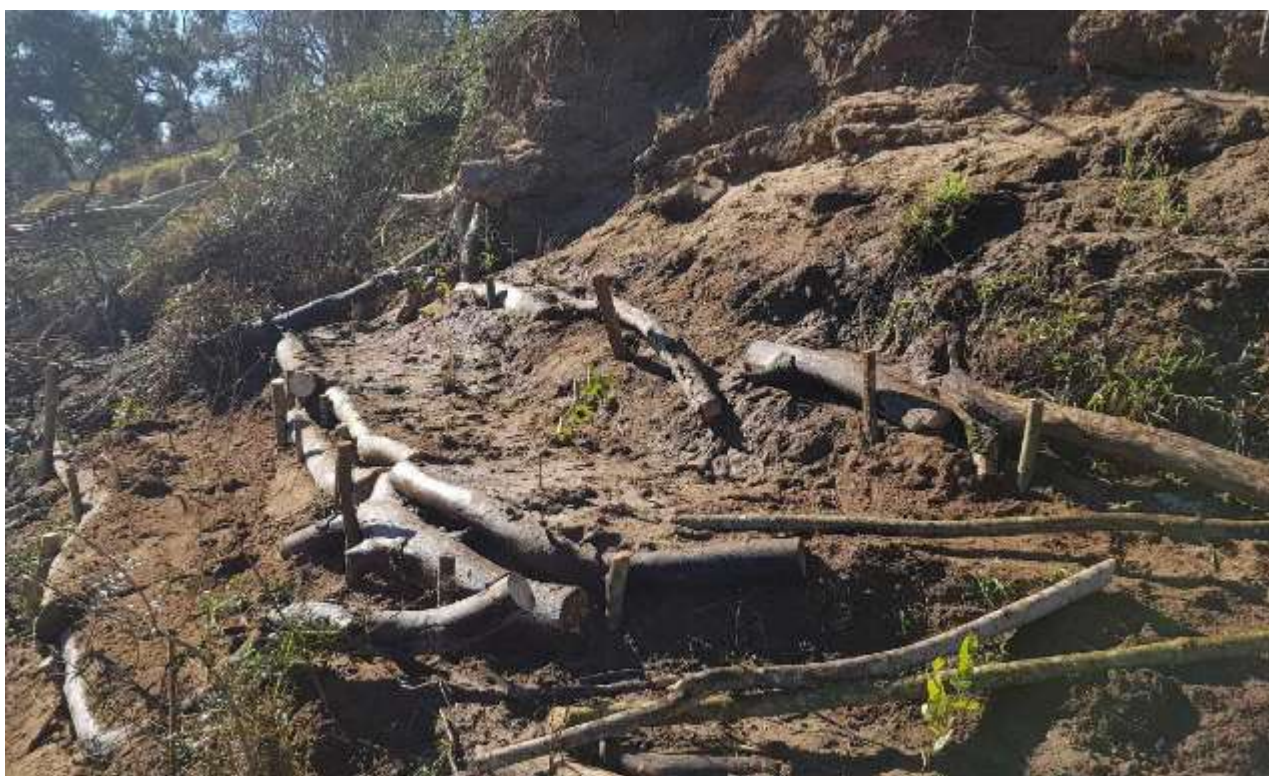
Image 13 Revegetation and erosion control using privet logs salvaged from woody weed control, Core Riparian Zone Nepean River, July 2018

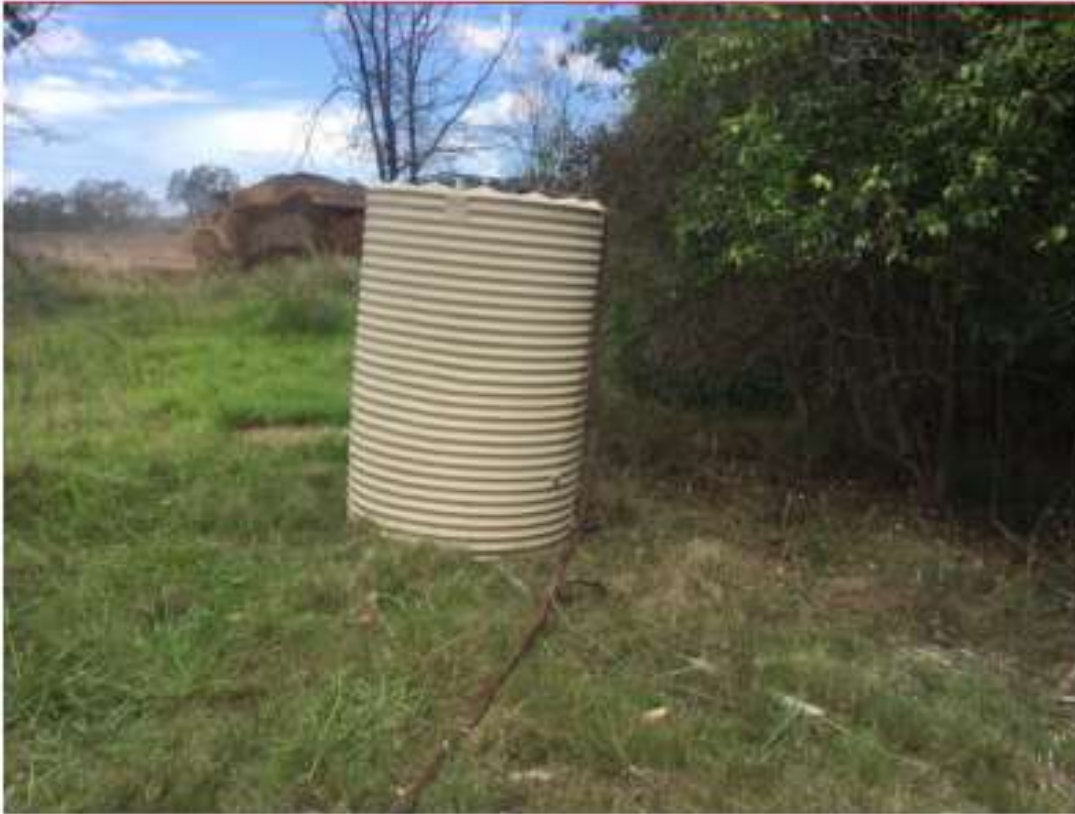
Image 18 Installation of water tanks and irrigation lines for watering of establishing plants Past Revegetation Zone, CRV Nepean River, January 2018

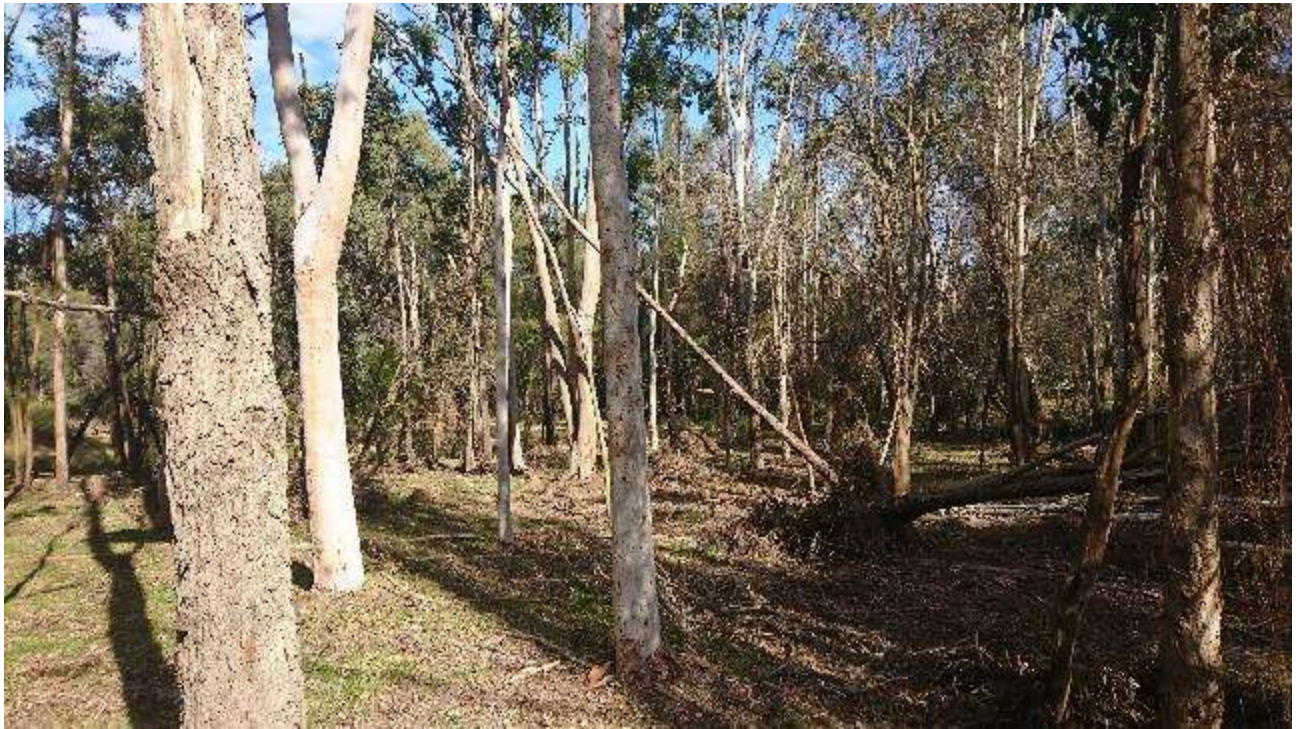
Plot 1 – Zone 5 after weed control but prior to revegetation planting

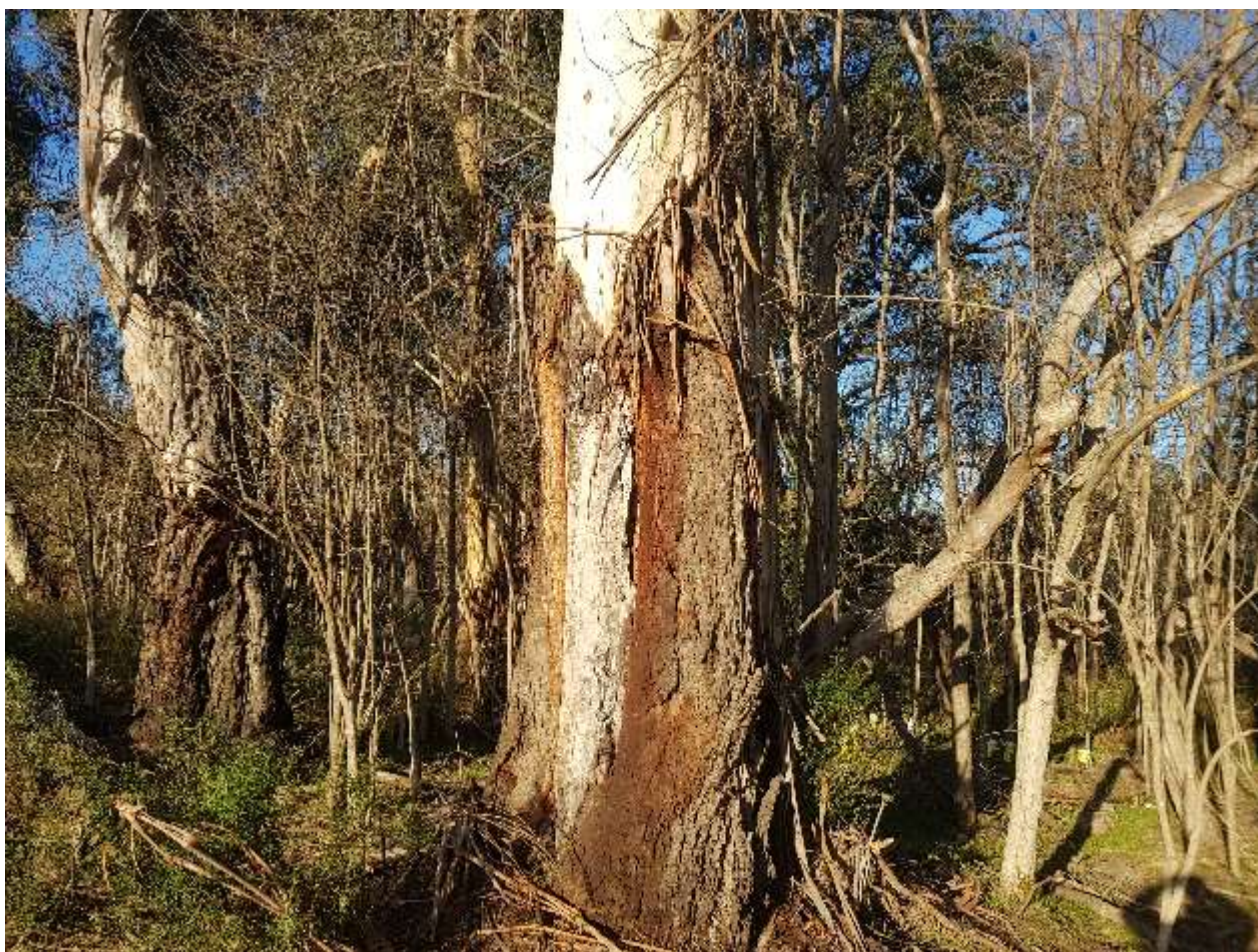
Plot 2 – Zone 1a) after weed control and currently revegetated with forestry tubes.

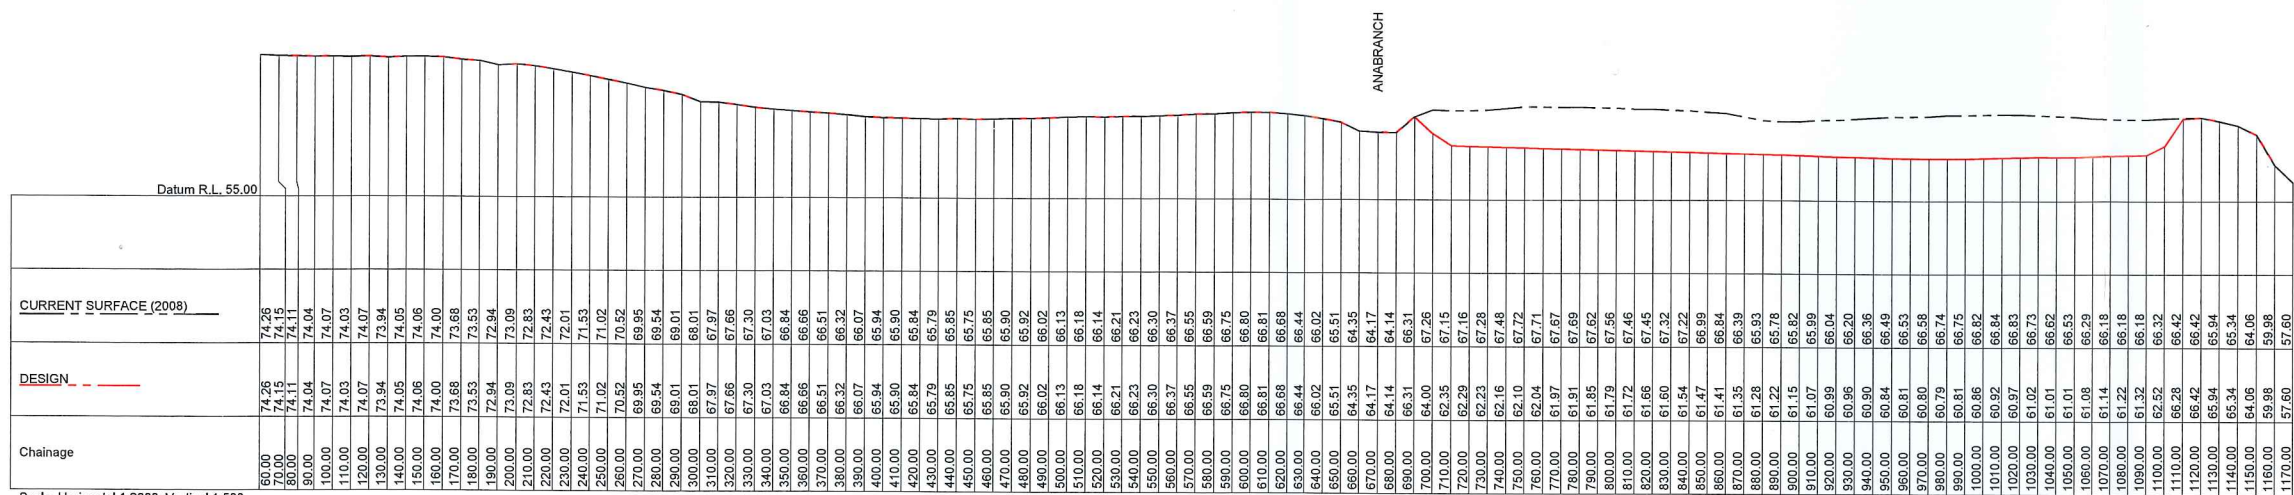
FINAL LANDFORM DESIGN

1. ORIGINAL SURFACE DATA EXTRACTED FROM ORTHOPHOTO MAPPING(1983), FIELD SURVEY(2005) & LIDAR(2008)
2. CURRENT SURFACE DATA EXTRACTED FROM LIDAR (2008)
3. DESIGN SURFACE DATA EXTRACTED FROM JOHNSTONE ENVIRONMENTAL TECHNOLOGY Pty. Ltd., Plan No. JET0328 Drawings 1-16 Issue 4 Dated 11/04/2001 & SMEC URBAN Plan No. 77310.01.P04-P07 Dated 13/10/2011

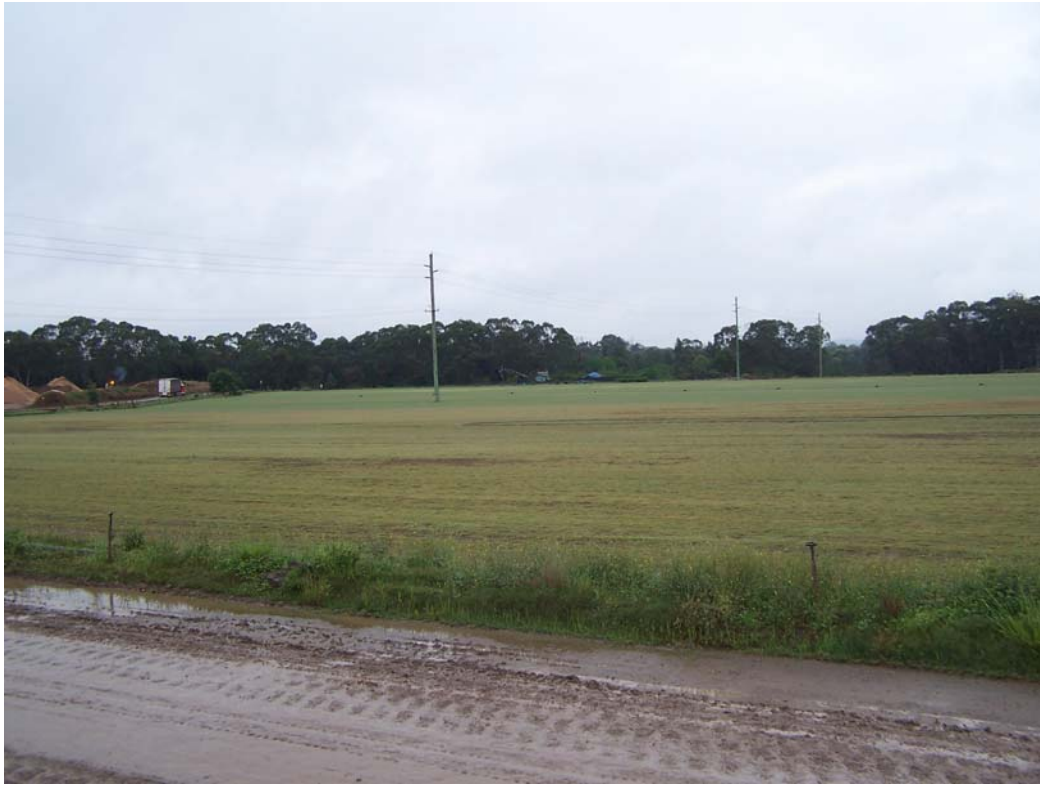
Plate 1 View of the re-constructed agricultural landform – currently utilised for turf farming

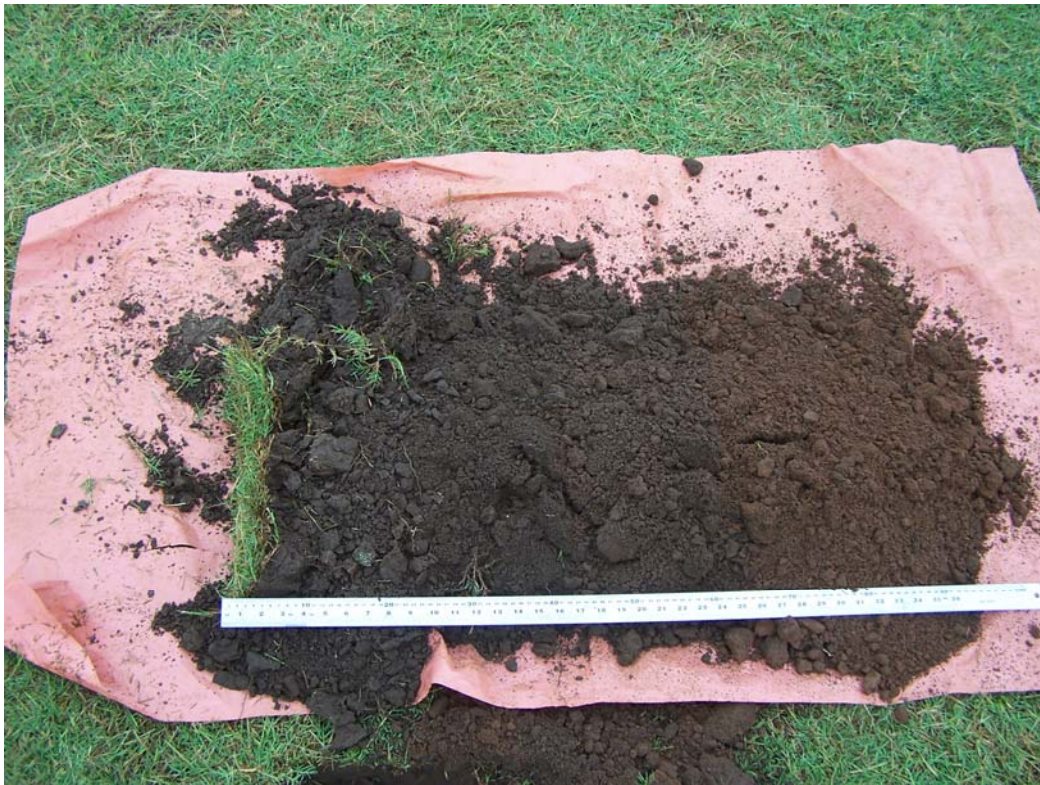
Plate 2 View of the re-constructed soil profile. Note: Scale is 1 metre in length.
