## **2019 ANNUAL ENVIRONMENTAL MANAGEMENT REPORT**

### **SPRING FARM SAND AND SOIL EXTRACTION AND PROCESSING OPERATION (DA 75/256)**

**MACARTHUR ROAD, SPRING FARM**

**25<sup>th</sup> March 2020**

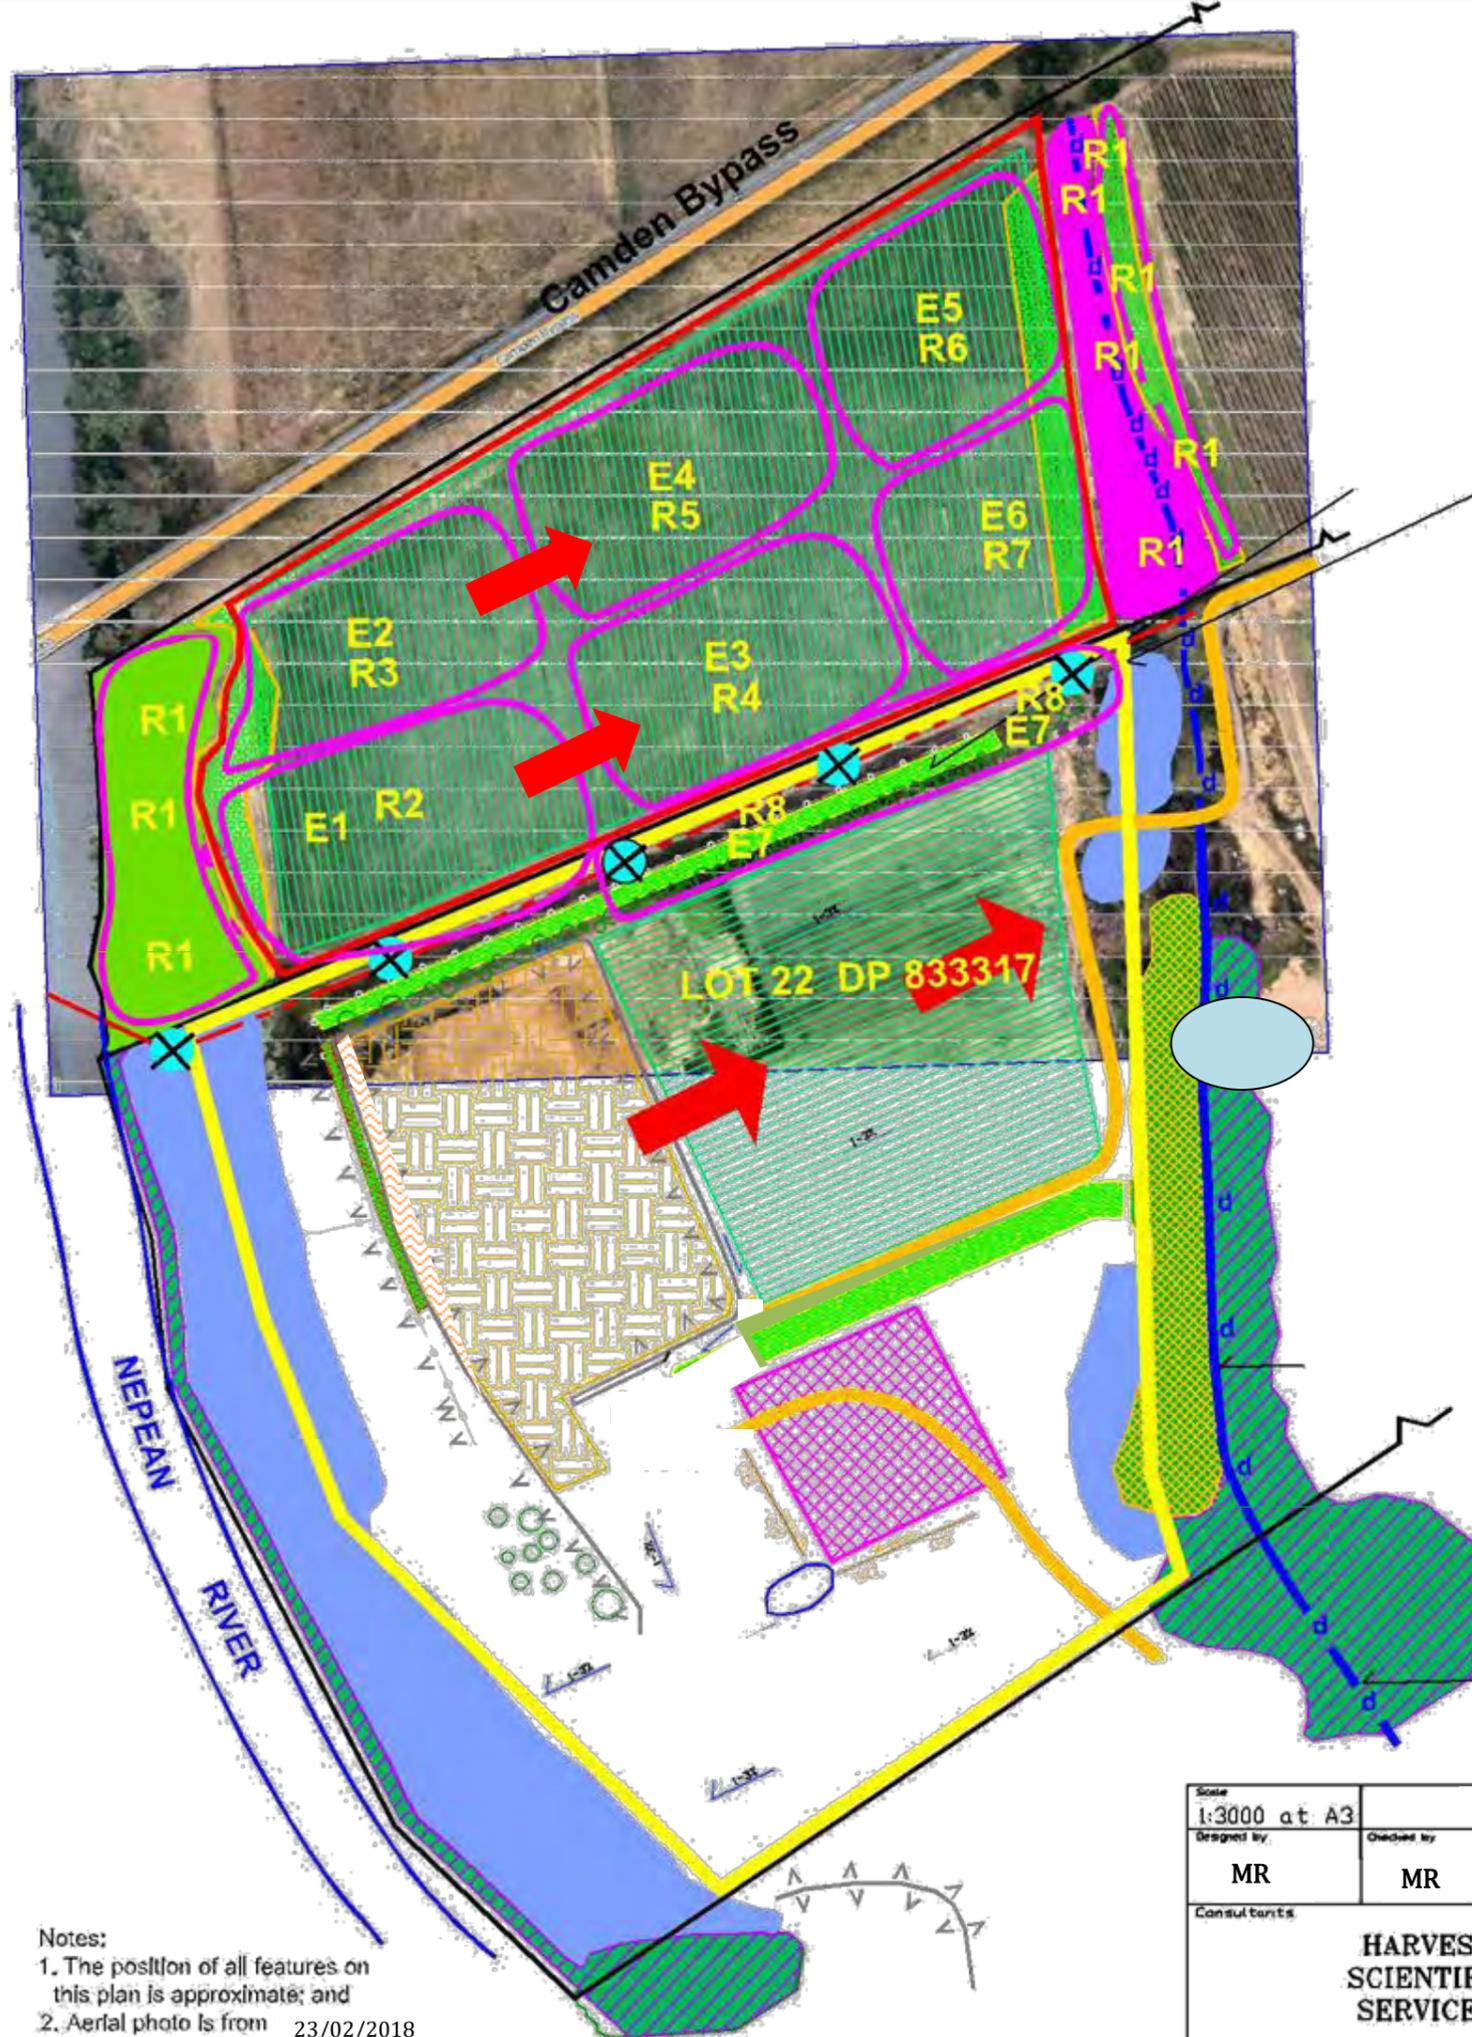
**FIGURE 2**  
**EXTRACTION & REHABILITATION CELLS**

E = Extraction Cell  
R = Rehabilitation Cell

General direction of extraction and rehabilitation

- The open area cell E3 (Figure 2) on Lot 32 (DP 635271) measured approximately 0.2Ha with 1.8 Ha within E1 and E2 cells undergoing concurrent rehabilitation
- Lot 22 (DP 833317) had an active extraction area measuring approximately 1.4Ha (Figure 2); and
- Approximately 64,672 tonnes of raw material had been extracted from the lands (see Figure 3)
- The 2019 total site combined extraction and open area was 3.20Ha (1.80Ha of open area on Lot 22 and 1.4Ha extraction area on Lot 32) complying with the 5.0Ha limit approved by Camden Council.

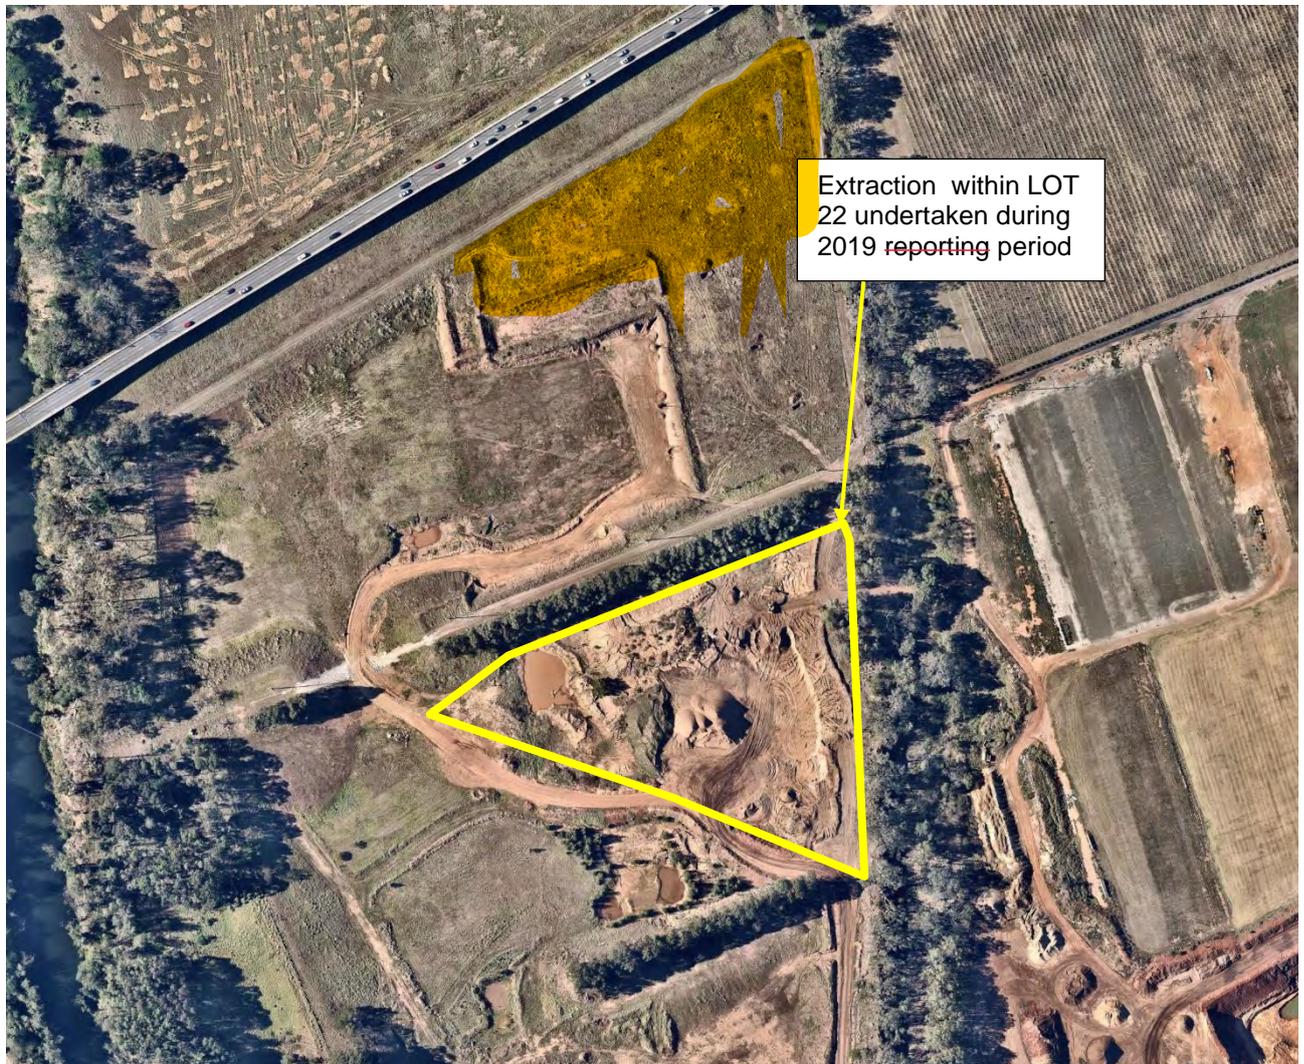
**Figure 3:** Extraction undertaken in 2019 within LOT 22 (NearMap™ November, 2019)

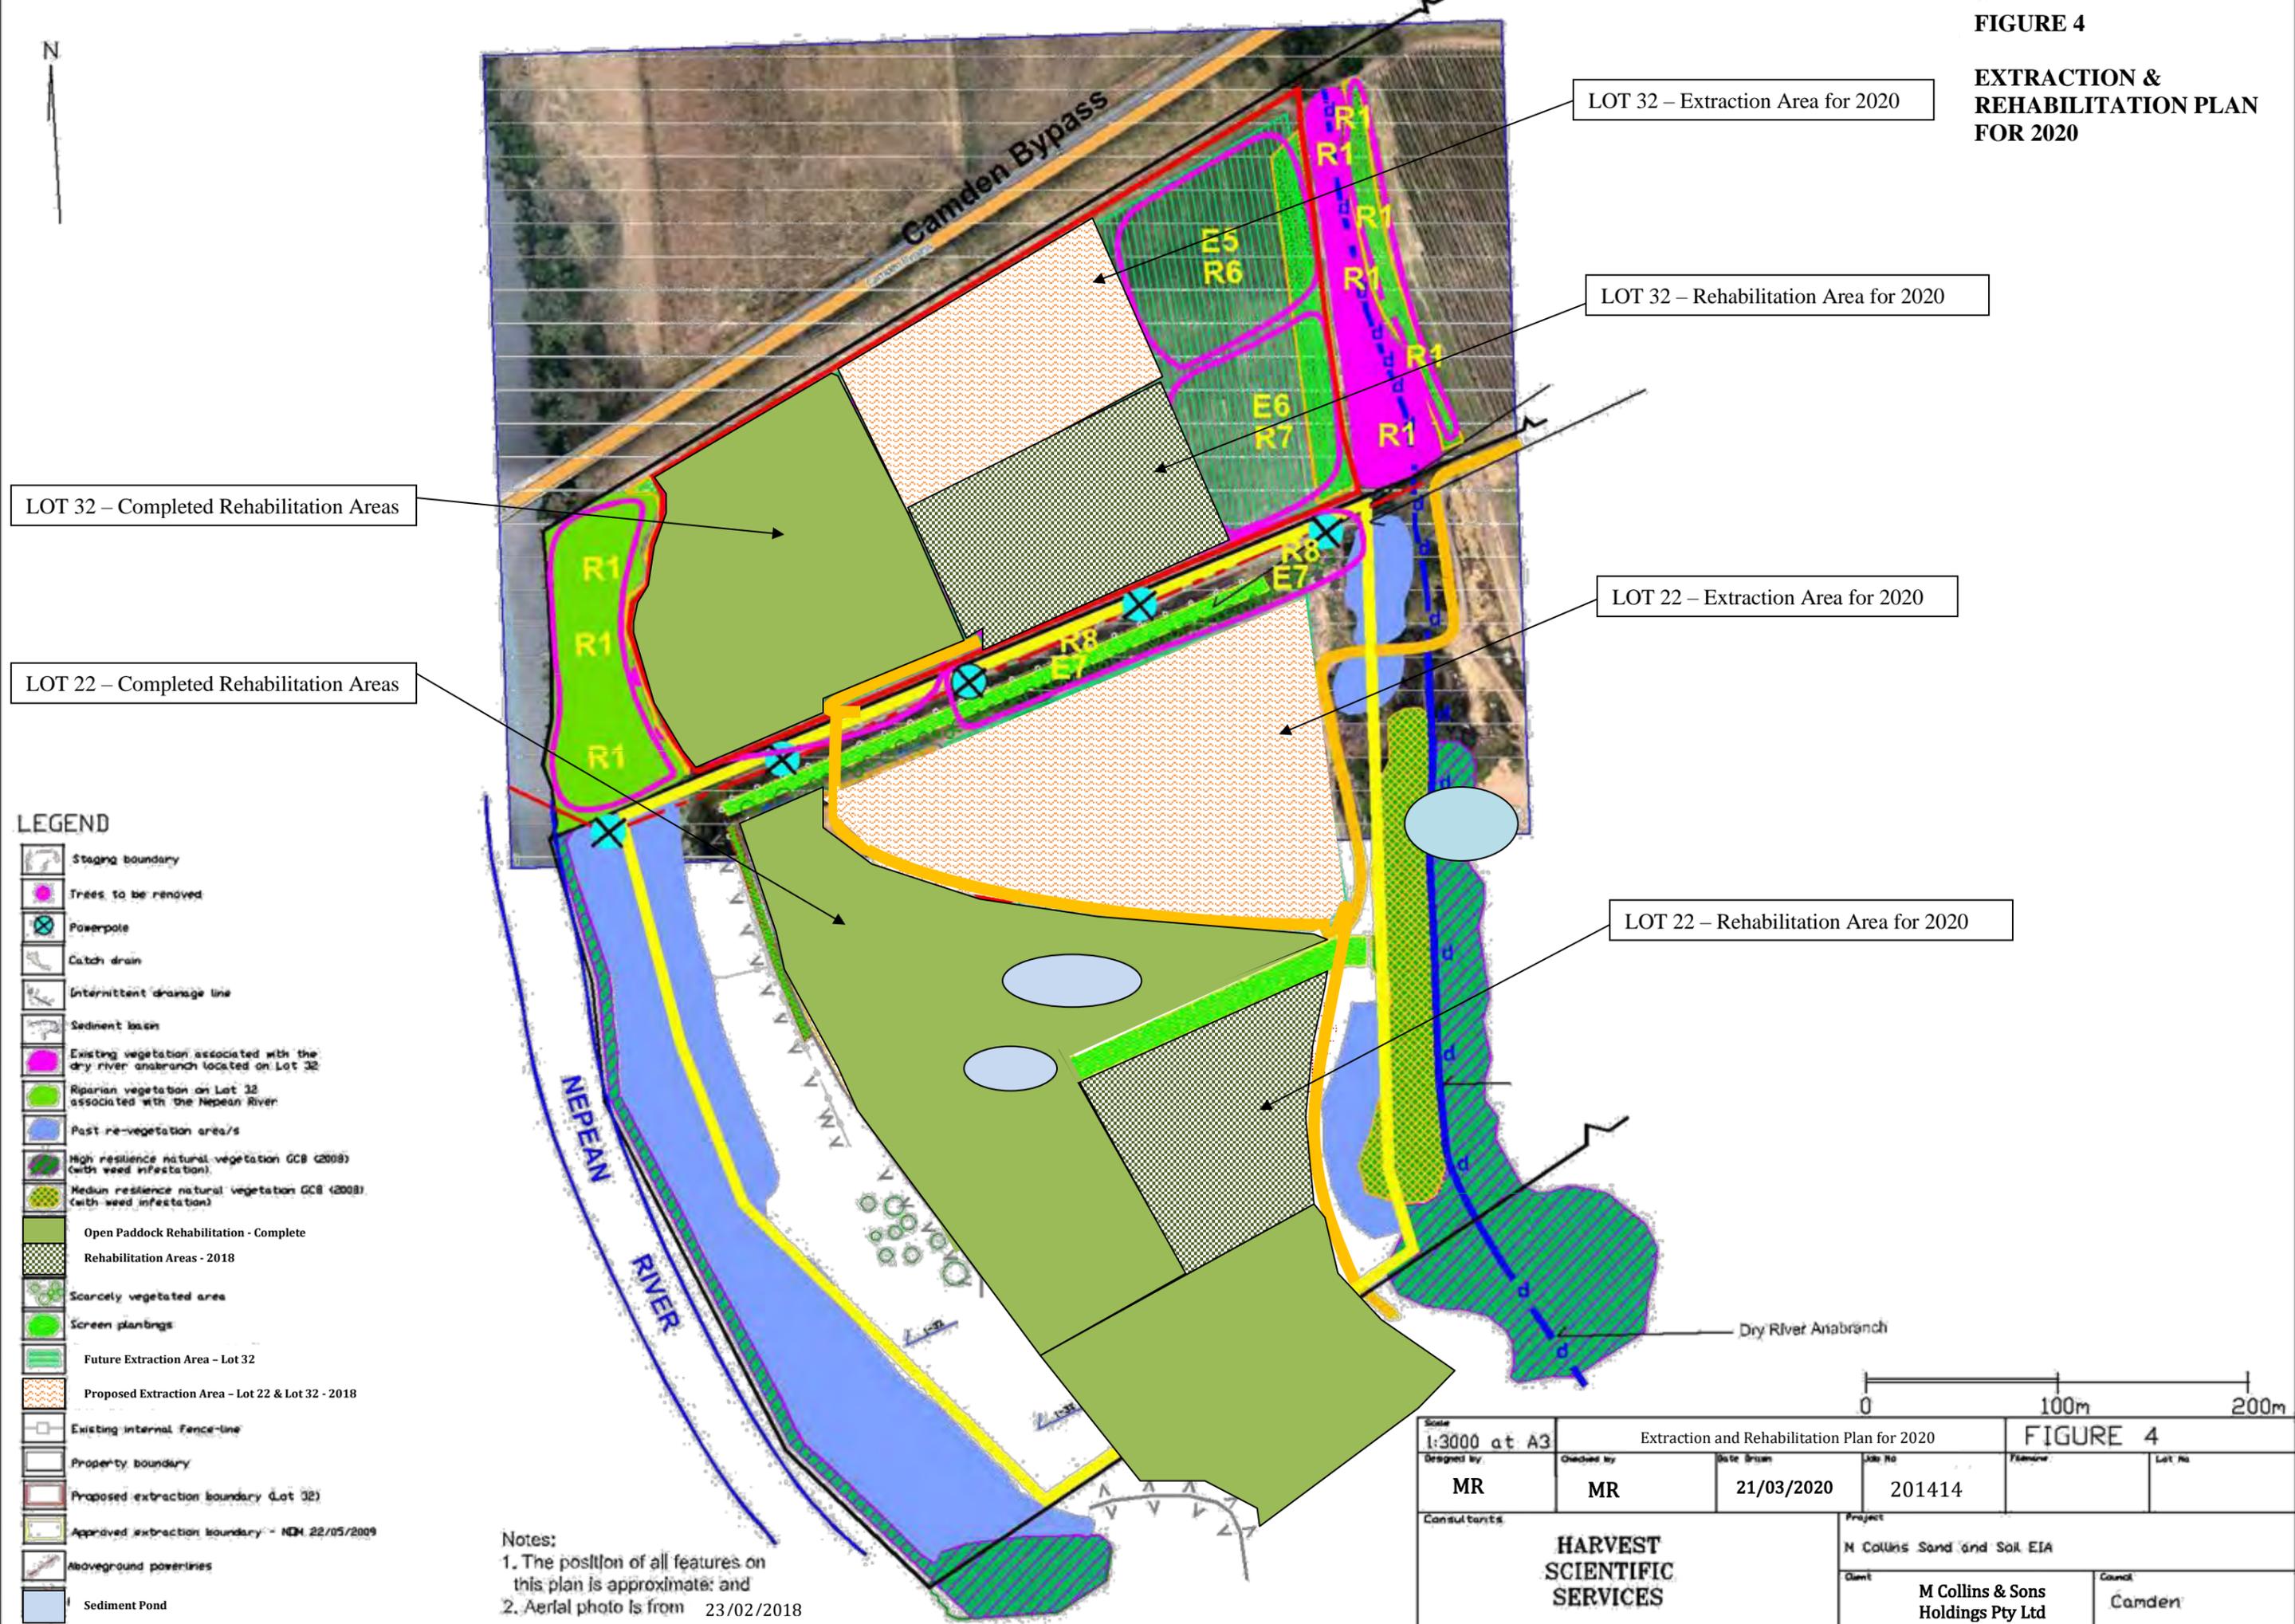
**EXTRACTION & REHABILITATION PLAN FOR 2020**

LOT 32 – Completed Rehabilitation Areas

LOT 22 – Completed Rehabilitation Areas

- Continue extraction from the current extraction of Lot 22 (DP 833317) illustrated in Figure 4; and
- Re-commence extraction on Lot 32 (DP 635271) proceeding north as illustrated in Figure 4 into E4 after exhaustion of E3.

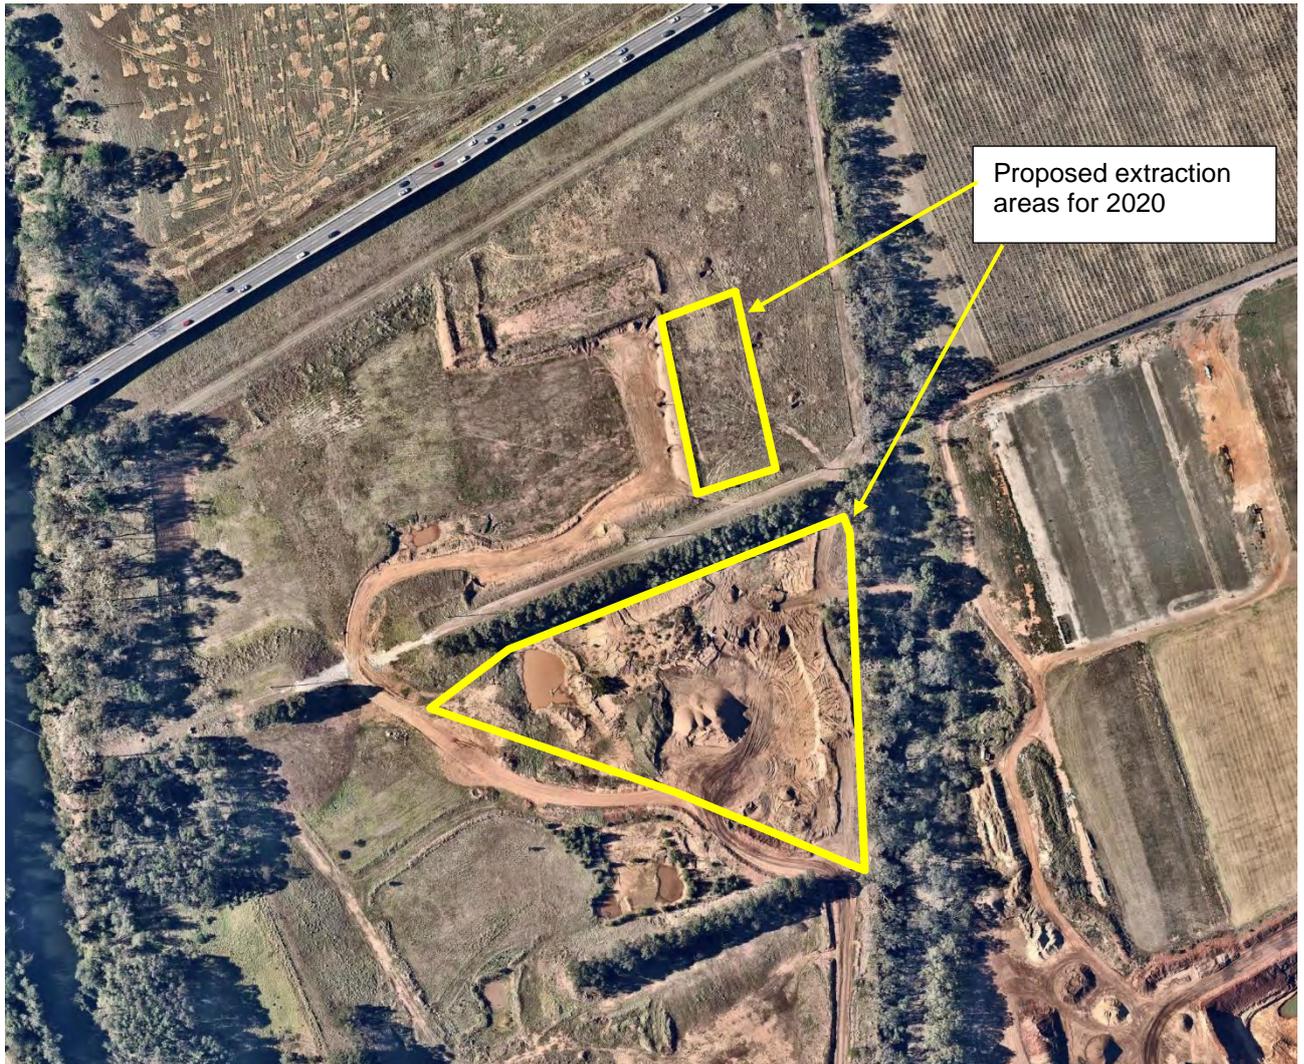
**Figure 5:** Proposed extraction areas for 2020 (NearMap™ November, 2019)

It is estimated that total extraction and production figures for the 2020 reporting year will be similar to that of 2019. The proposed areas of production during the 2020 AEMR are illustrated in Figure 5.

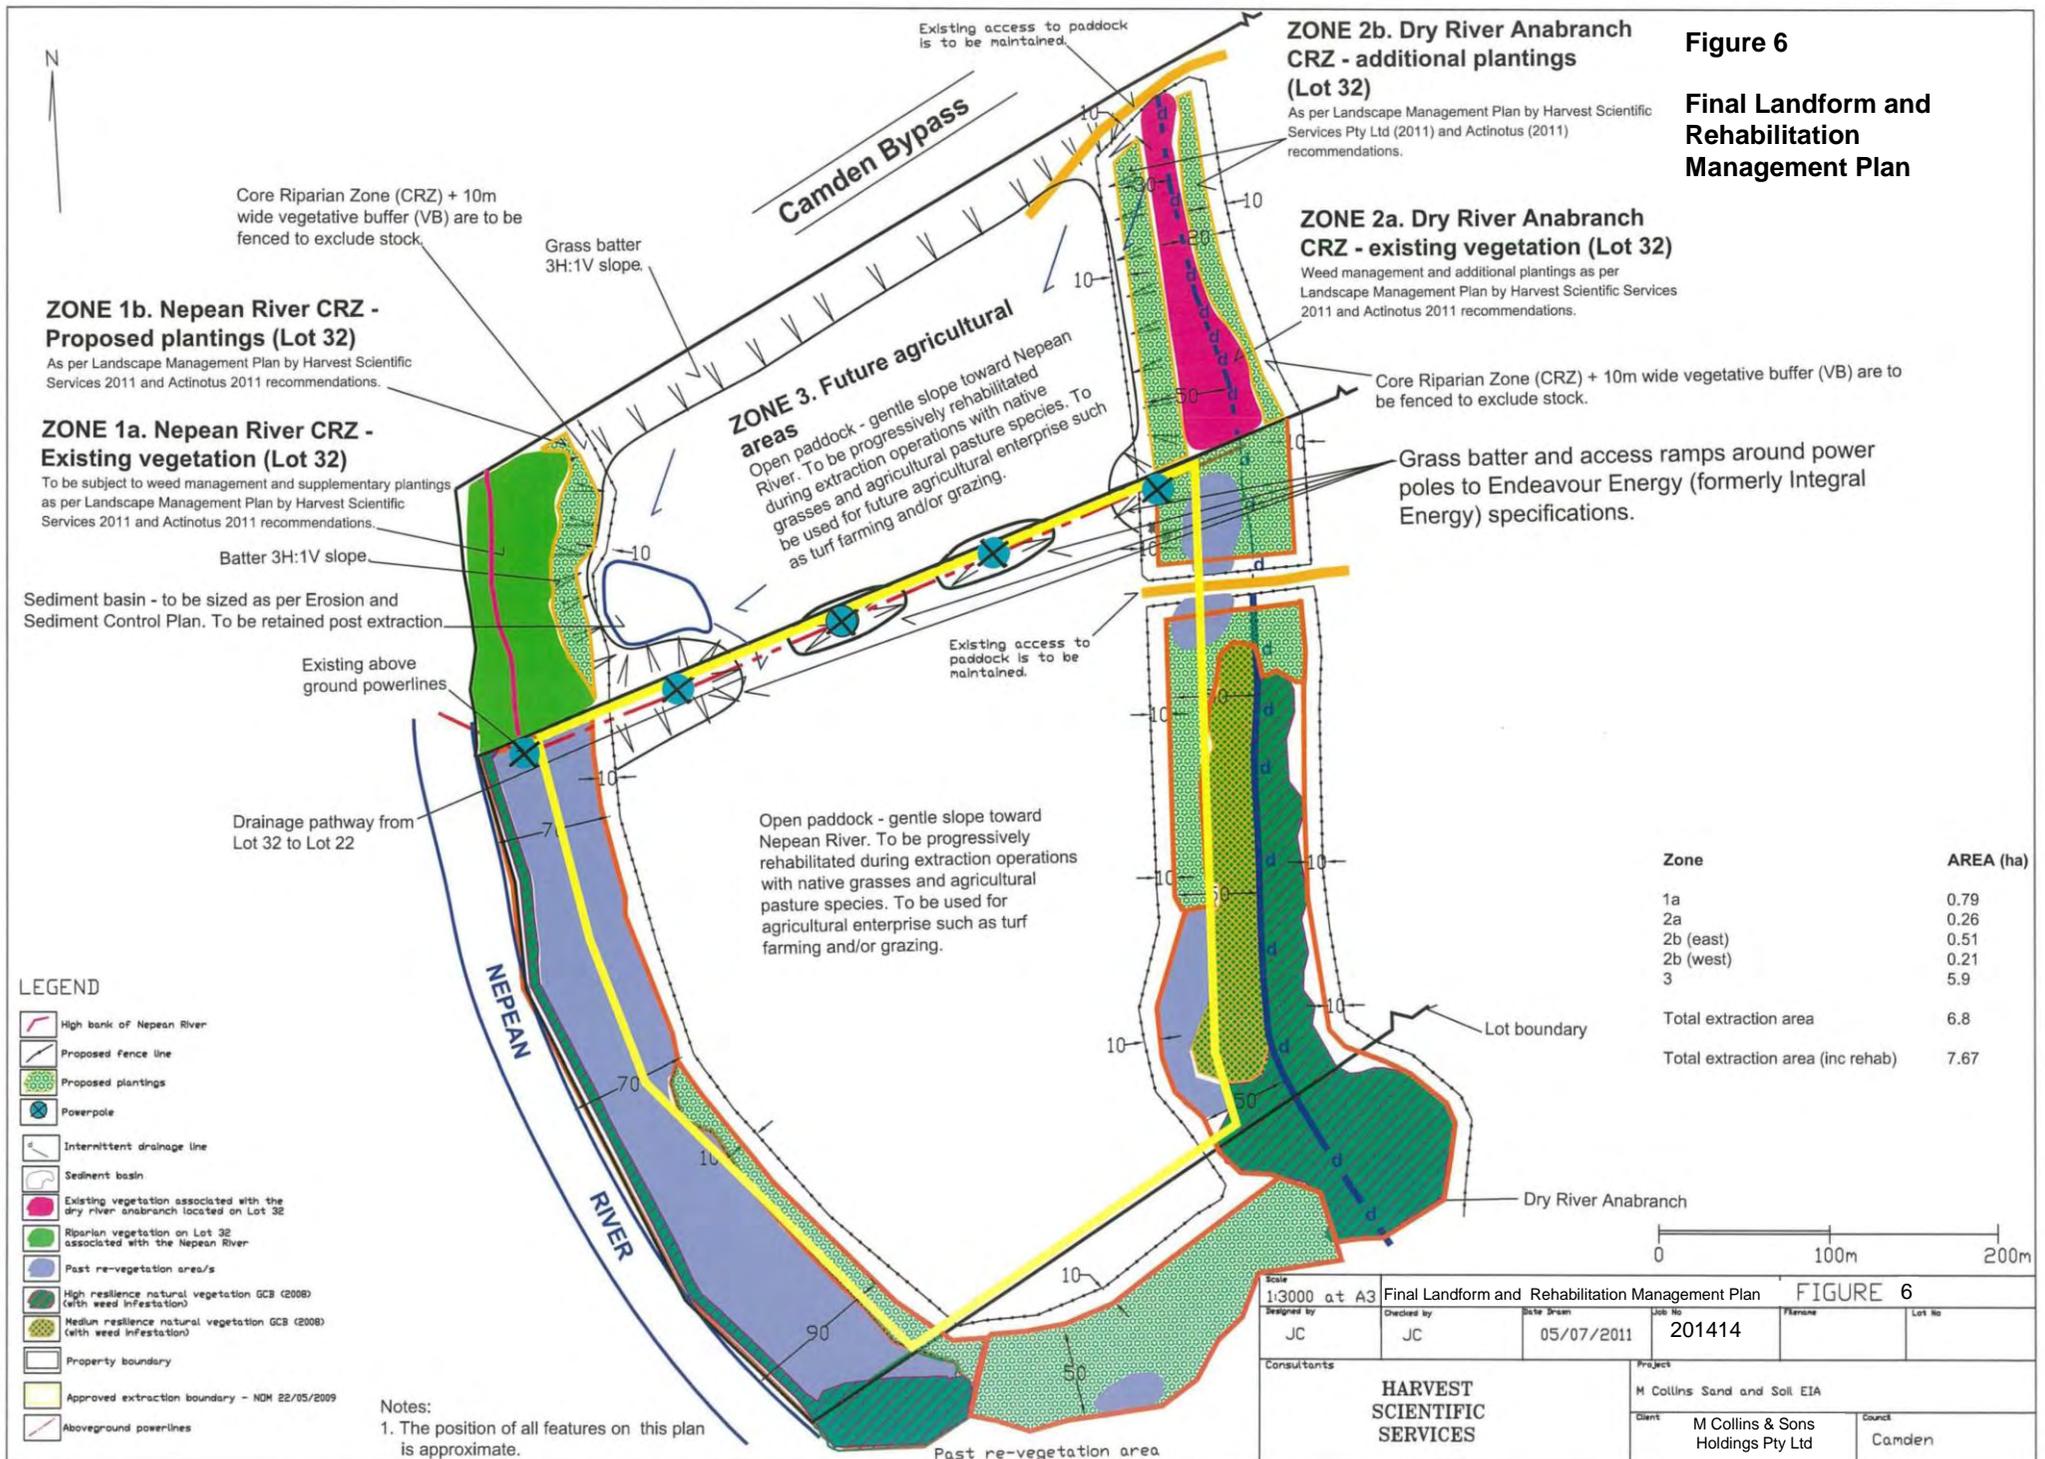
Figure 6

**Final Landform and Rehabilitation Management Plan**

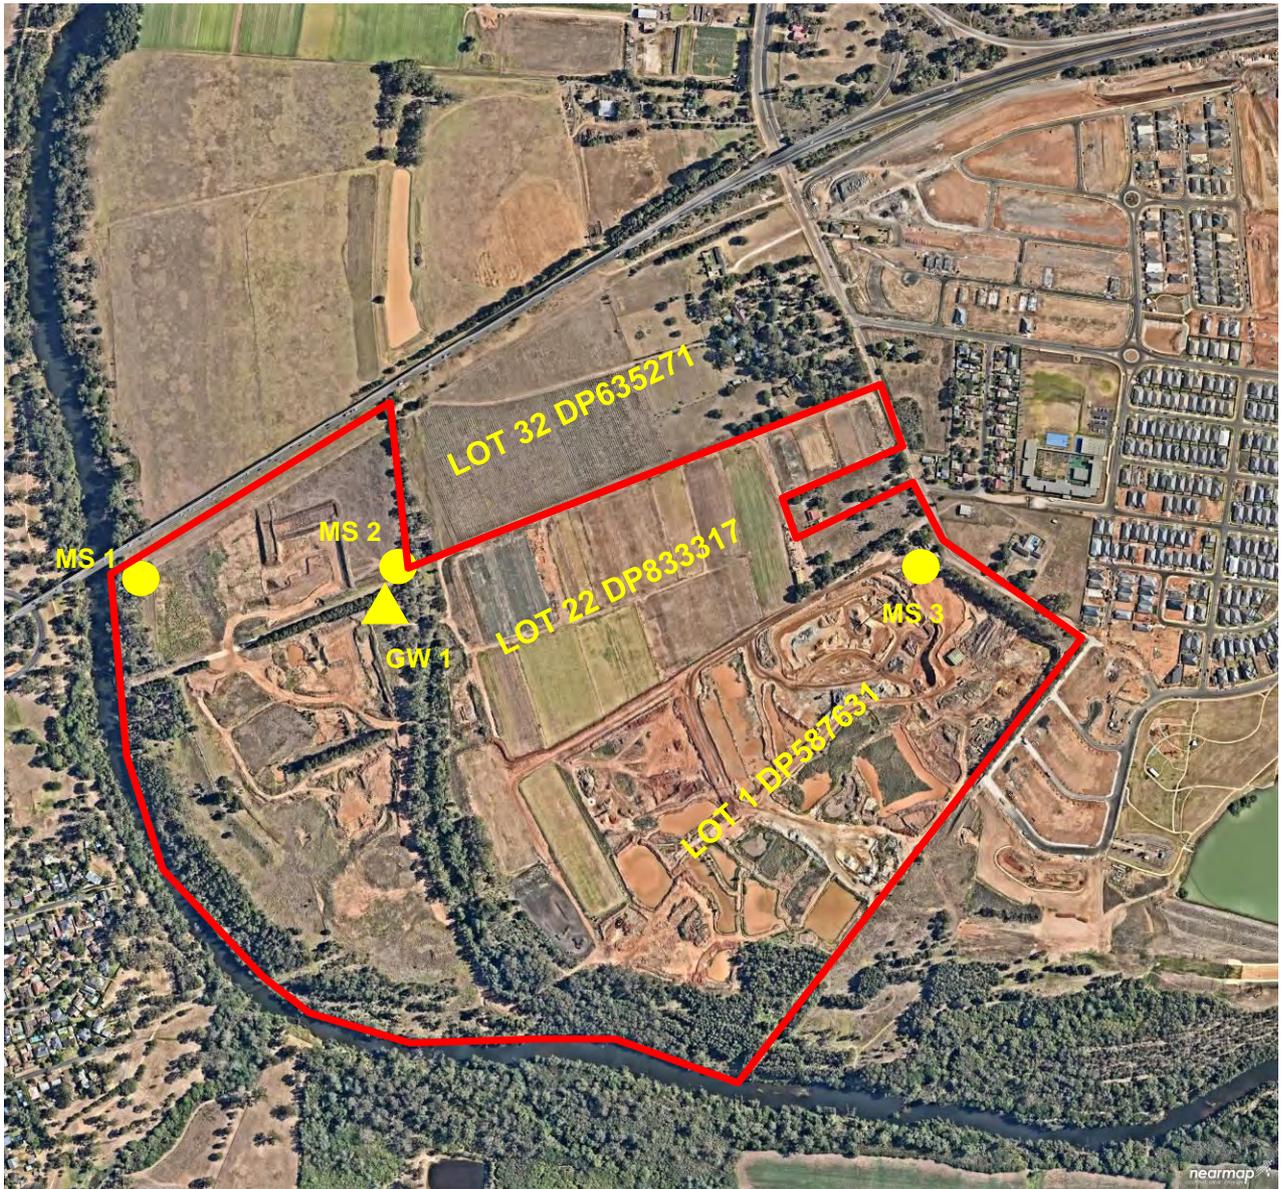
As per Item 17 of Schedule 5 of the NSW Department of Planning and Environment *Notice of Modification* (DA 75/256 Mod 4) dated 2 August 2018, there are three monitoring sites across the Collins Spring Farm Quarry; MS1 (*Penman*), MS2 (*Turf Farm*), and MS3 (*Wash Plant*). They can be identified on the western boundary of the site, central to the site and nearest the front gate respectively (Figure 7). Monitoring Stations 1 and 3 consist of a dust deposition sampler. Monitoring Station 2 consists of a dust deposition sampler and groundwater monitoring bore.

Figure 7: Collins Spring Farm Monitoring Sites

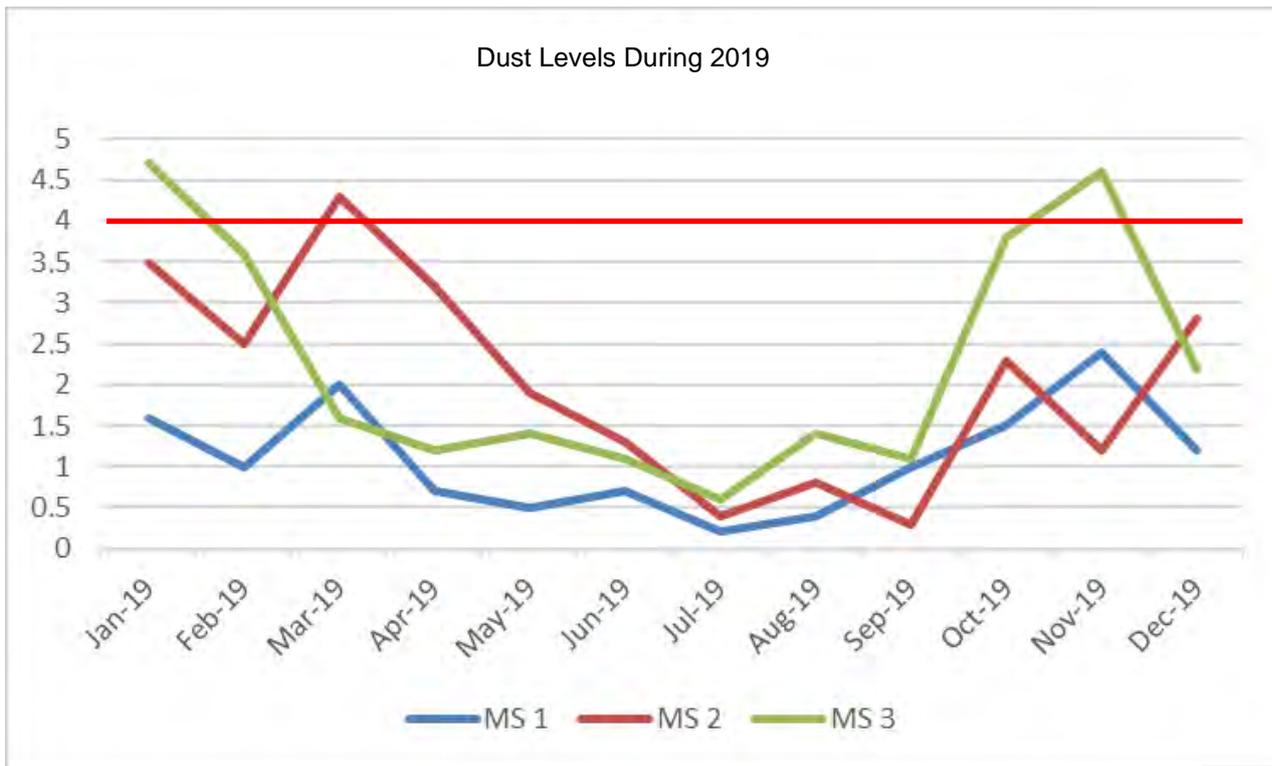
The data suggests that exceedances occur mostly during summer months in particular during the during excessive heat and dry windy conditions as depicted in Figure 8.

**Figure 8:** Results of 2019 routine dust deposition monitoring at stations MS1, MS2 and MS3. LHS scale represents Total Insoluble Material (TIM). EPM target illustrated by red line.

In an effort to reduce the number of recorded dust exceedances and to counter the extreme dry, hot conditions prevalent Collins instigated the following dust suppression methods during the 2019 year;

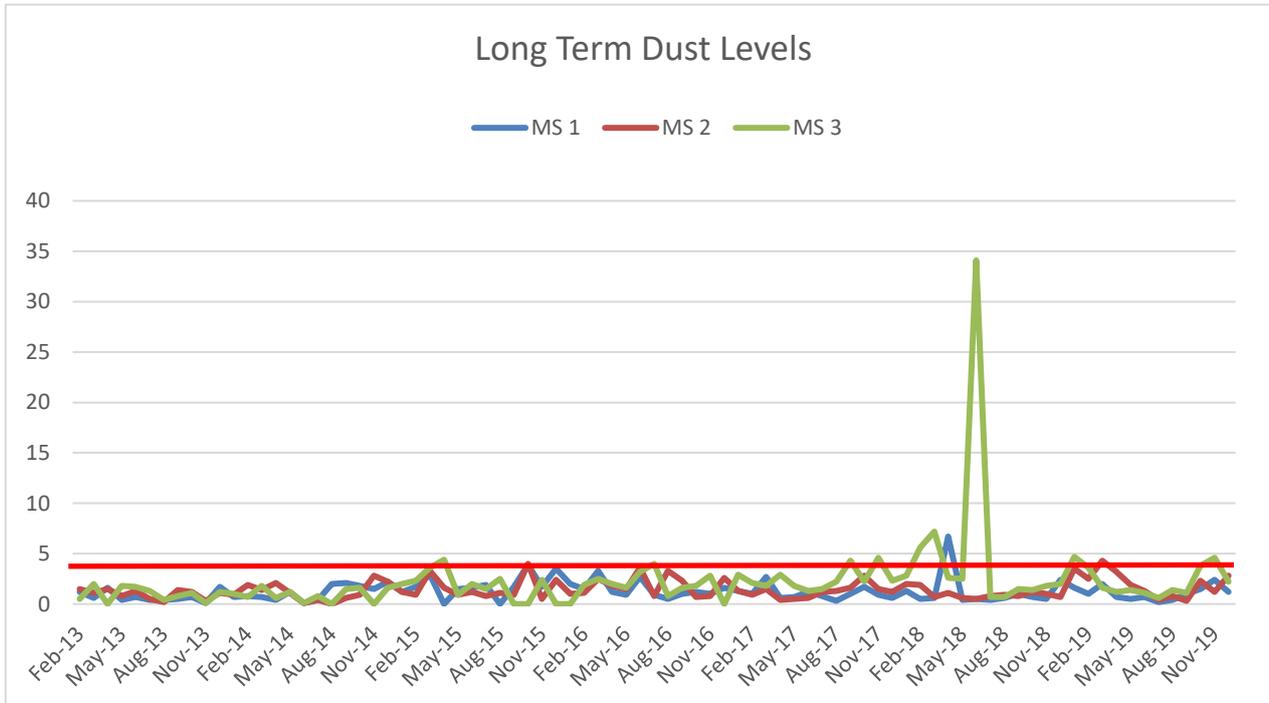
**Figure 9:** Results of routine dust deposition monitoring at stations MS1, MS2 and MS3 over 7 years. LHS scale represents Total Insoluble Material (TIM).

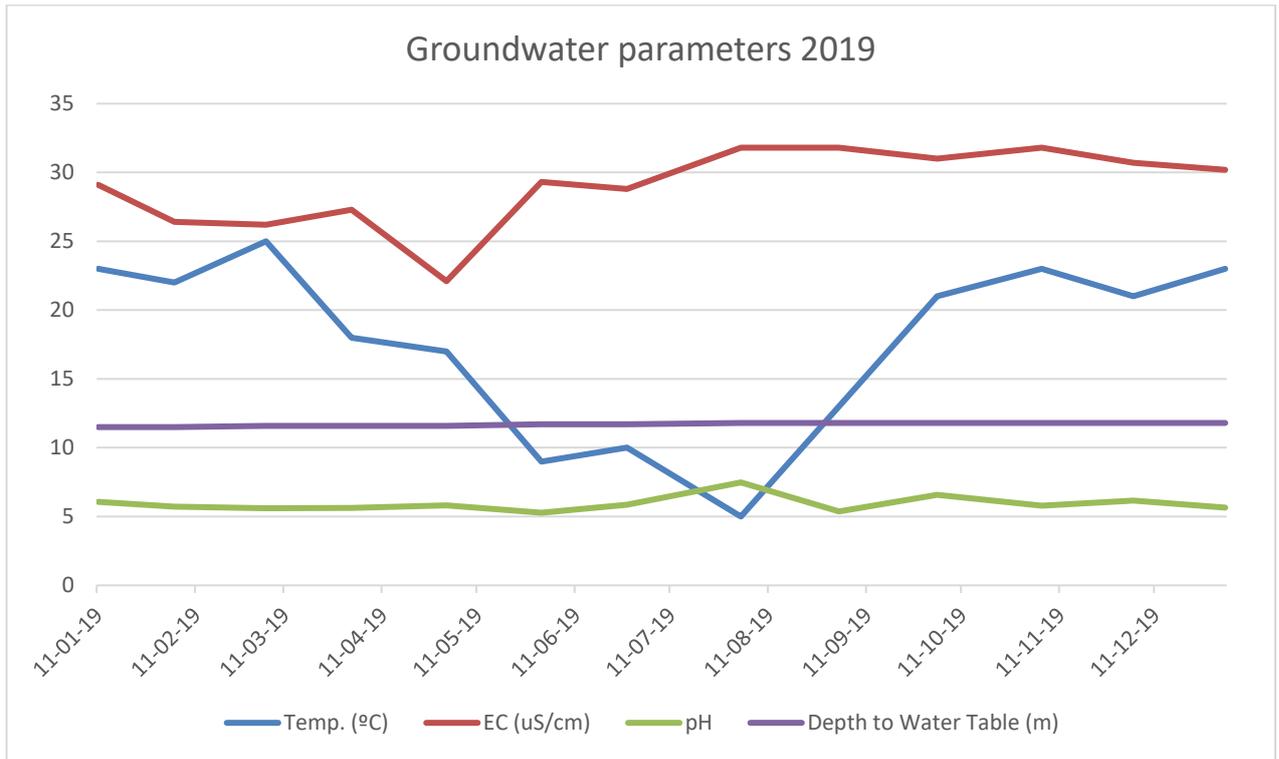
- All samples tested were below the nominated salinity target (EC < 800  $\mu$ S/cm) during 2019. Results reflect the continuing low levels of groundwater conductivity (EC) values over the last three years in contrast to higher values noted between 2013 and 2016;
- pH levels were found to occur within a relatively tight range (5.28 – 7.48) and has not altered significantly over the last 7 years; and
- Groundwater depths below ground level fluctuated between 11.50m and 11.80m depth, with a modest rise towards the end of the year perhaps reflecting prolonged drought conditions.

Figure 10: Results of 2019 Groundwater Monitoring (Actual EC values divided by 10)

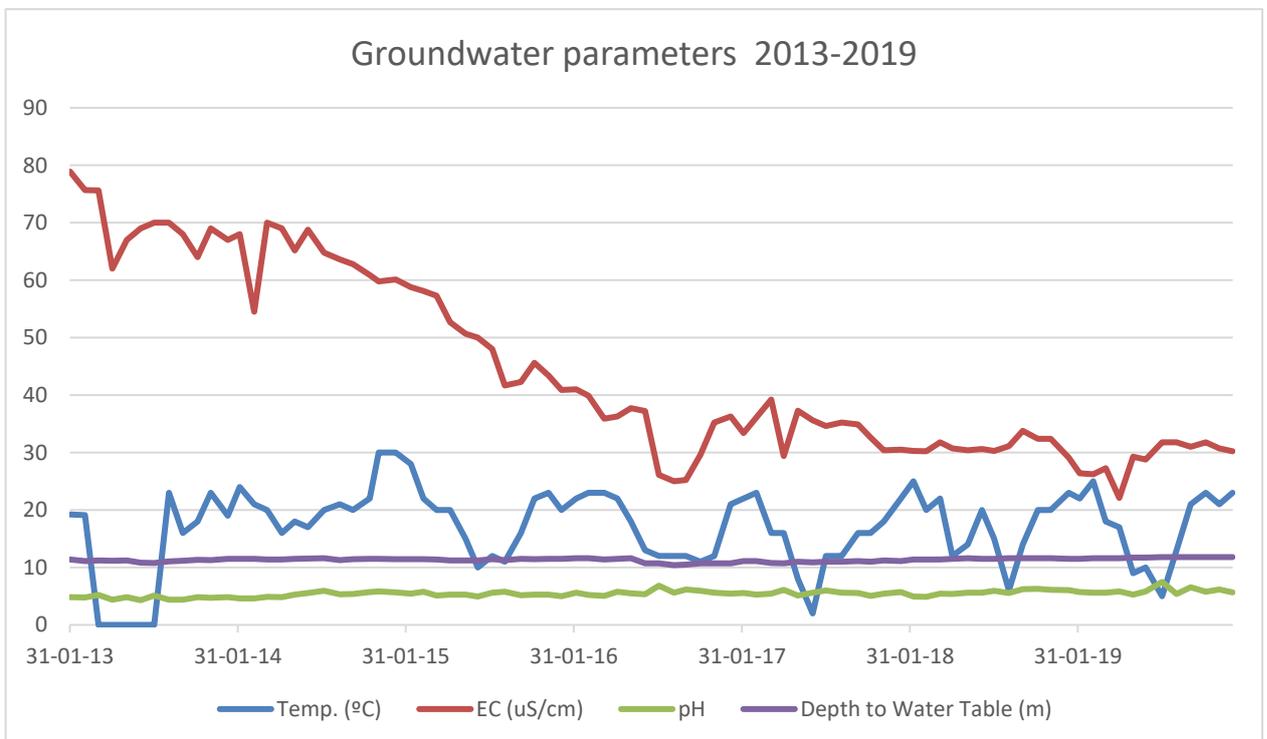
Figure 11: Results of Groundwater Monitoring over 7 years (Actual EC values divided by 10)

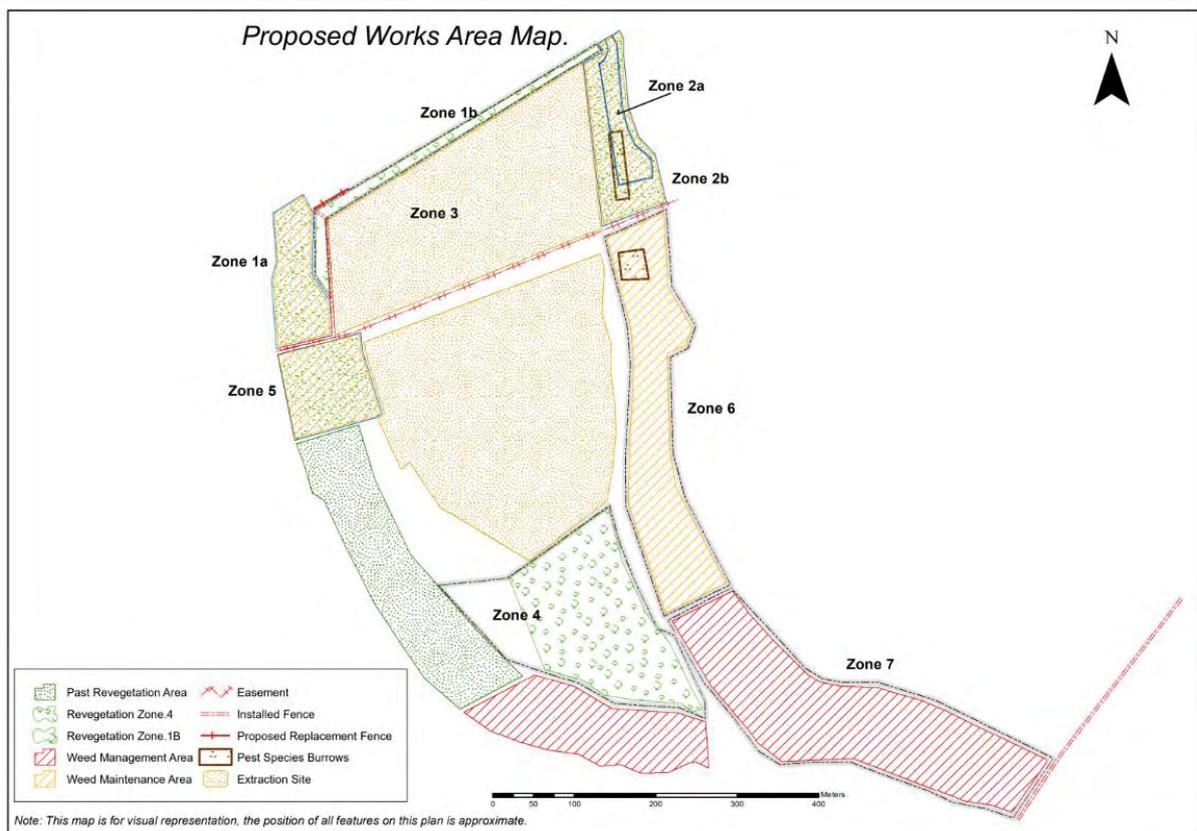
Map 2. Project zones (Environmental Management) within the Springfarm Project Site.

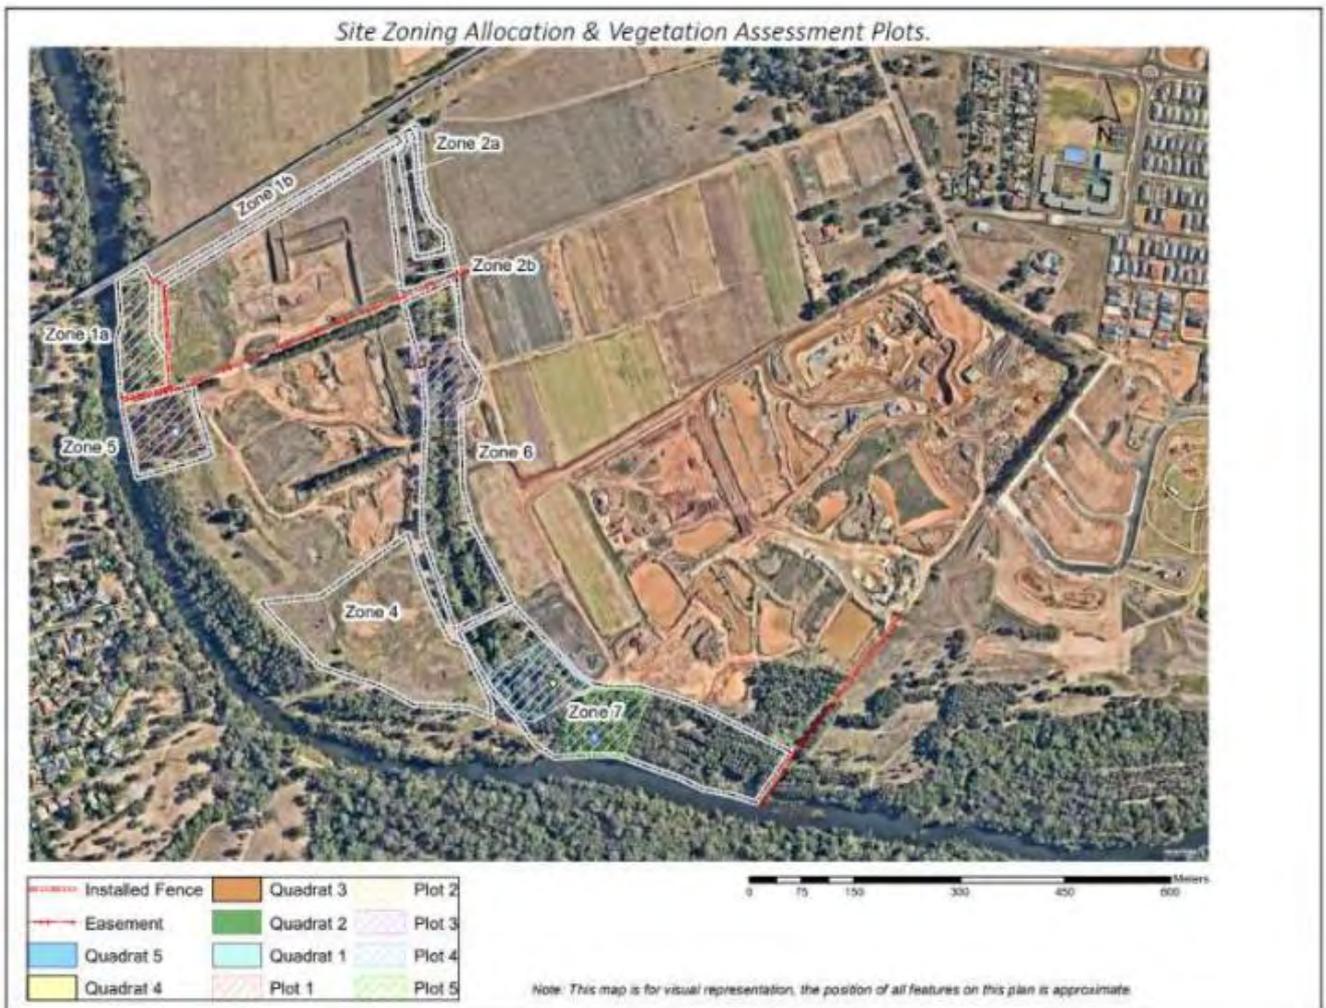
Map 3. Map showing site zoning and vegetation assessment plots.

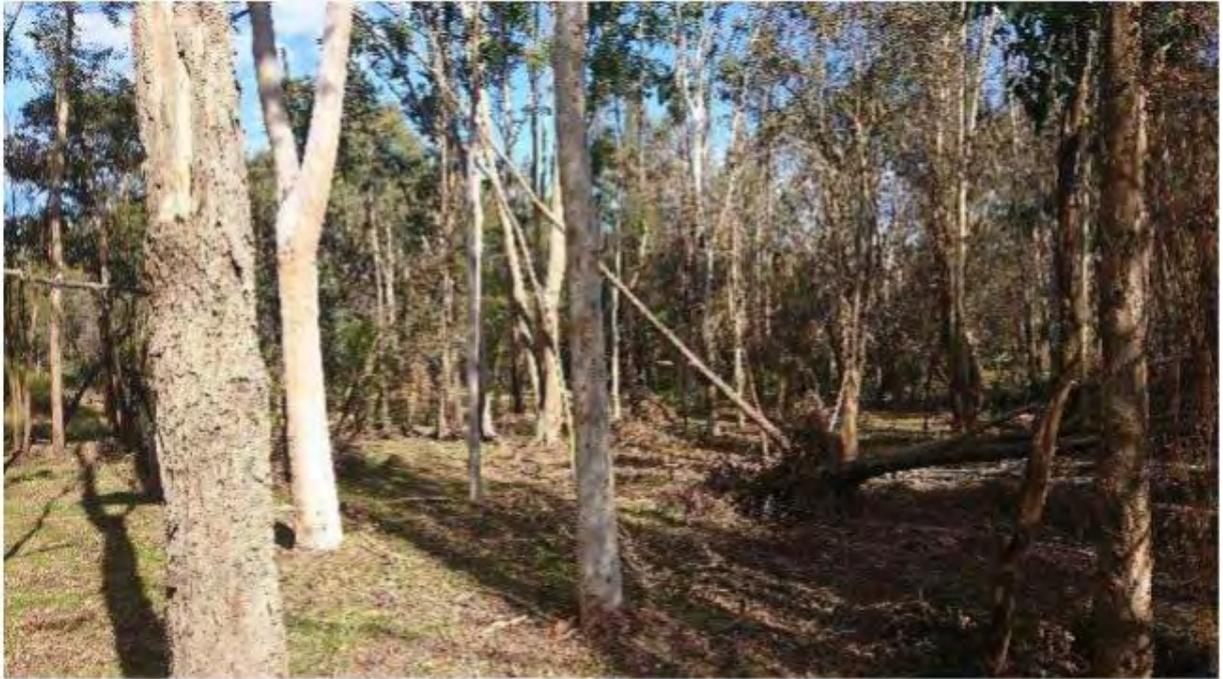
Image 1. Plot 1, Zone 5. July 2018

Morphological Type	Riverine Sediments	Landform Element	Riparian	Landform Pattern	Microrelief
Lithology	depositional	Soil surface Texture		Soil Colour	Dark rich loam
Slope	negligent	Aspect	stn west	Site drainage	low
				Distance to nearest water and type	50m River

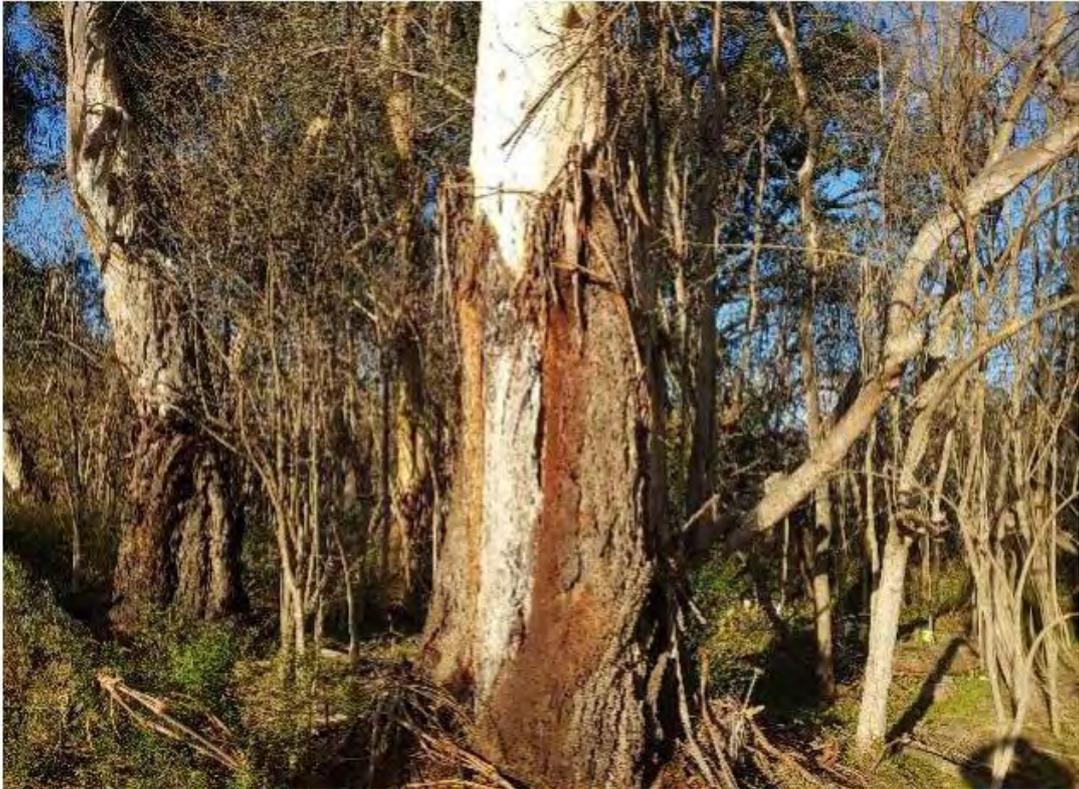
Image 3. Plot 2, Zone 1a. July 2018

Morphological Type Riverine sediments	Landform Element Riparian	Landform Pattern	Microrelief
Lithology Depositional	Soil surface Texture	Soil Colour Dark rich silt	Soil Depth
Slope	Aspect	Site drainage	Distance to nearest water and type 100m
