## **2019 ANNUAL ENVIRONMENTAL MANAGEMENT REPORT**

### **SPRING FARM SAND AND SOIL EXTRACTION AND PROCESSING OPERATION (DA 75/256)**

**MACARTHUR ROAD, SPRING FARM**

**25<sup>th</sup> March 2020**

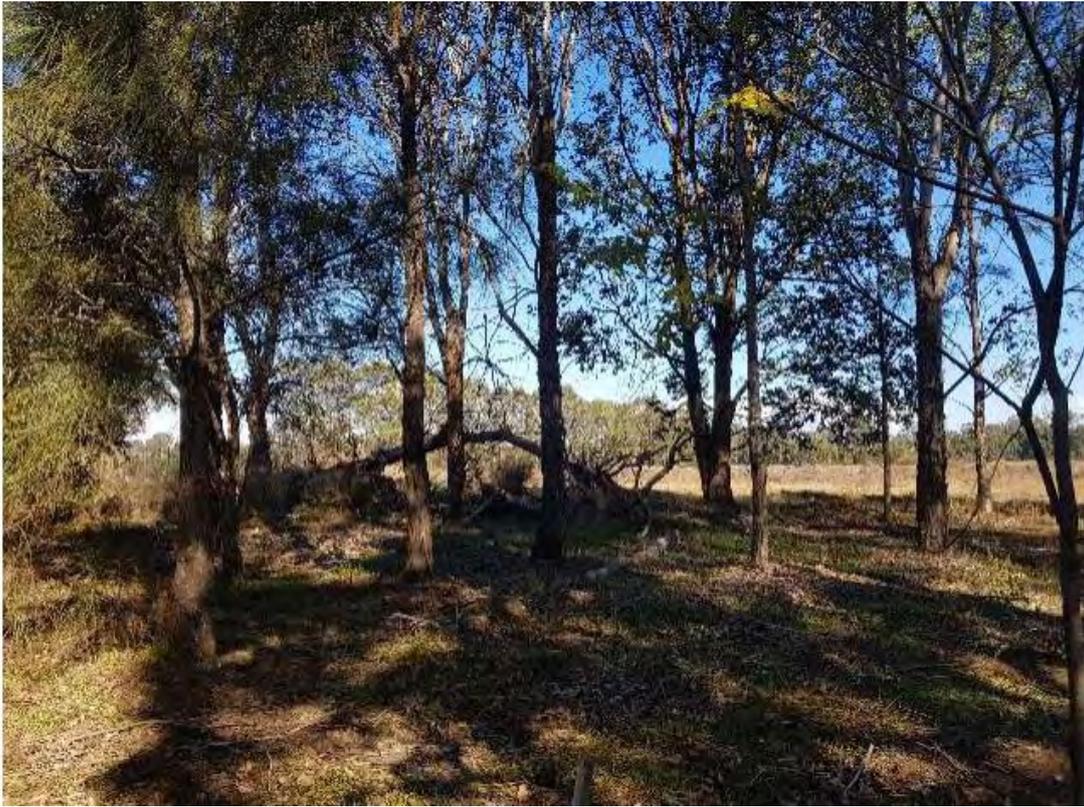
Image 5. Plot 3, Zone 6. July 2018

Morphological Type	Landform Element	Riparian	Landform Pattern	Microrelief
Lithology	Soil surface Texture		Soil Colour	Soil Depth
Slope	Aspect	str west	Dark rich silt	Distance to nearest water and type
				> 200m

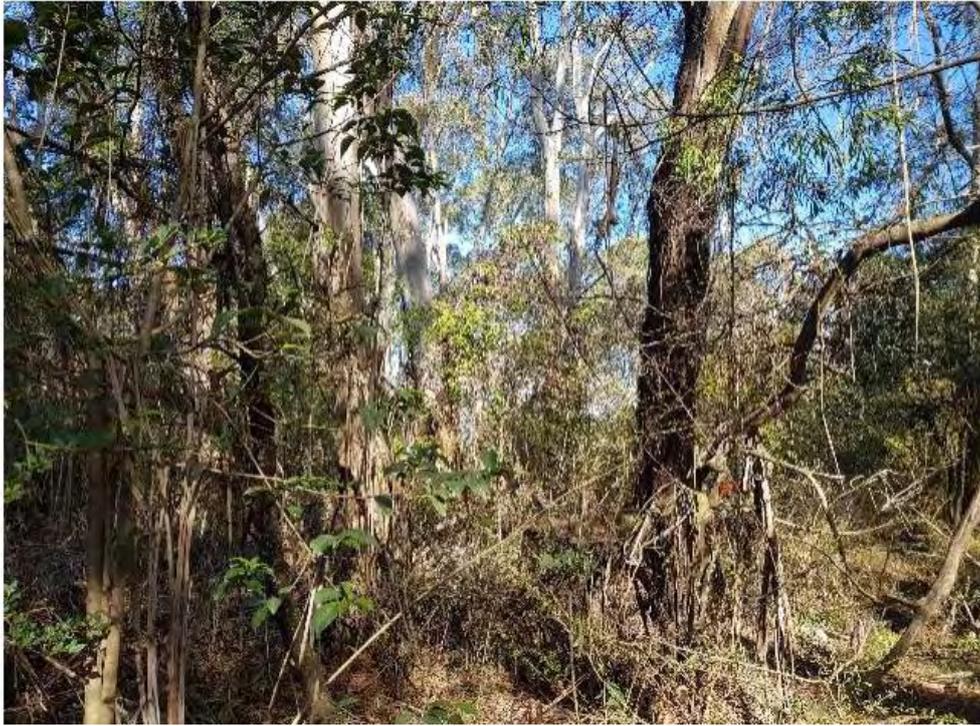
Image 7. Plot 4, Zone 7. July 2018.

Morphological Type <i>holocene</i>	Landform Element <i>Riparian</i>	Landform Pattern	Microrelief
Lithology <i>alluvium</i>	Soil surface Texture	Soil Colour <i>dark, rich</i>	Soil Depth
Slope	Aspect	Site drainage	Distance to nearest water and type <i>&lt; 50 m</i>

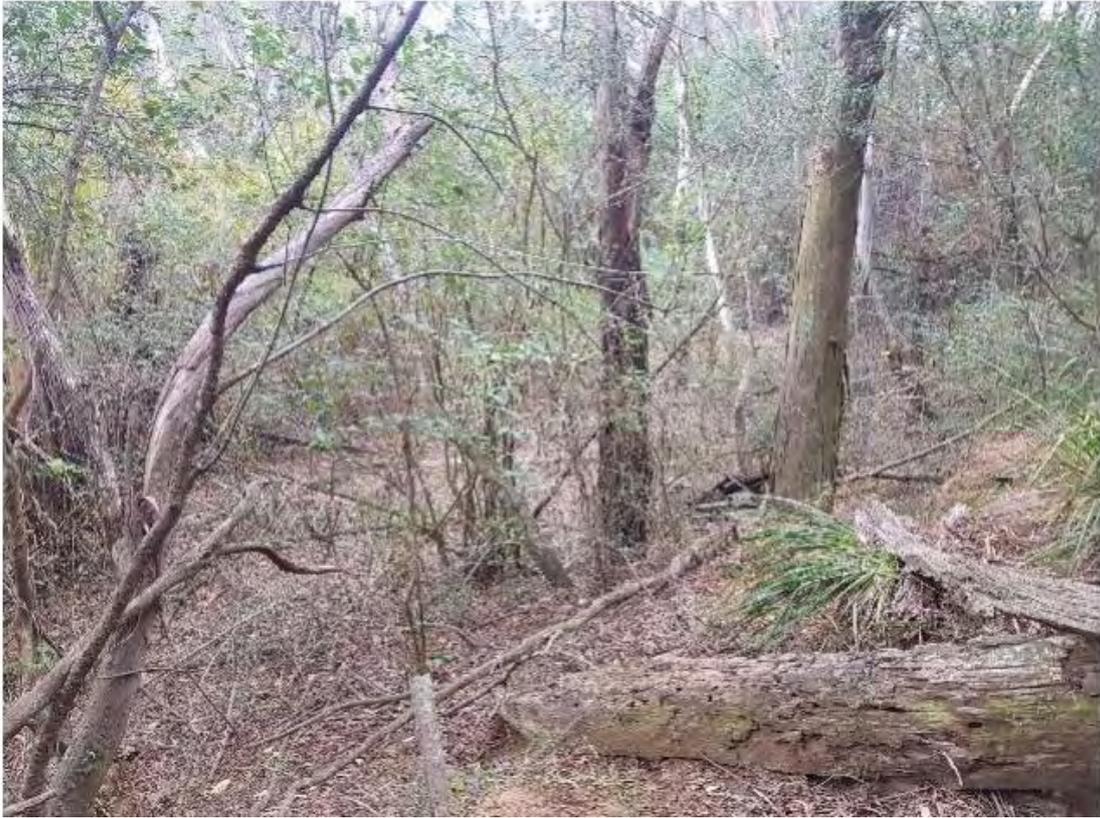
Image 9. Plot 5, Zone 7. July 2018.

Morphological Type	Landform Element	Landform Pattern	Microrelief
Lithology	Soil surface Texture	Soil Colour	Soil Depth
Slope	Aspect	Site drainage	Distance to nearest water and type
	Holocene alluvium	Dark rich silt	< 10m
	Stn west
