## **2022 ANNUAL ENVIRONMENTAL MANAGEMENT REPORT**

### **SPRING FARM SAND AND SOIL EXTRACTION AND PROCESSING OPERATION (DA 75/256)**

**MACARTHUR ROAD, SPRING FARM**

**26<sup>th</sup> May 2023**

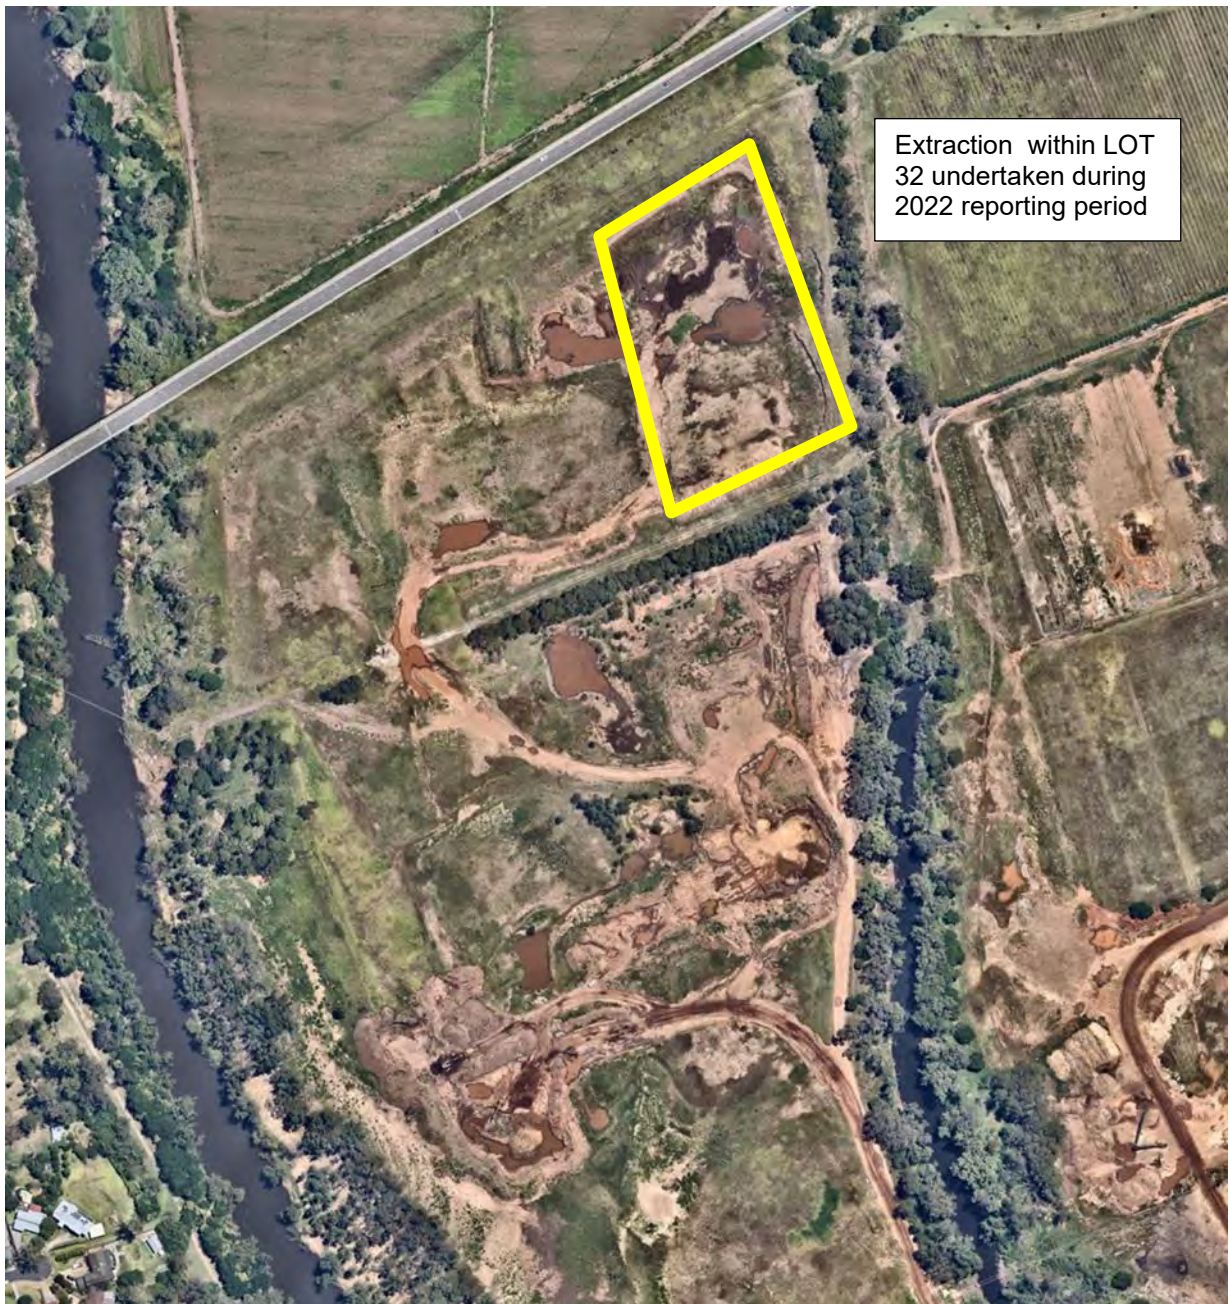
**Figure 3:** Extraction undertaken in 2022 within LOT 32 (NearMap™ image 9/3/2023)

Current and recent designated areas for extraction and rehabilitation are illustrated in Figure 2 and the aerial view for lot 22 and Lot 32 extraction and rehabilitation areas is found at Figure 3. Sand and soil was actively extracted from these portions between January and December 2022.

Approximately 76,685 tonnes were extracted from these lands during the period of this return.

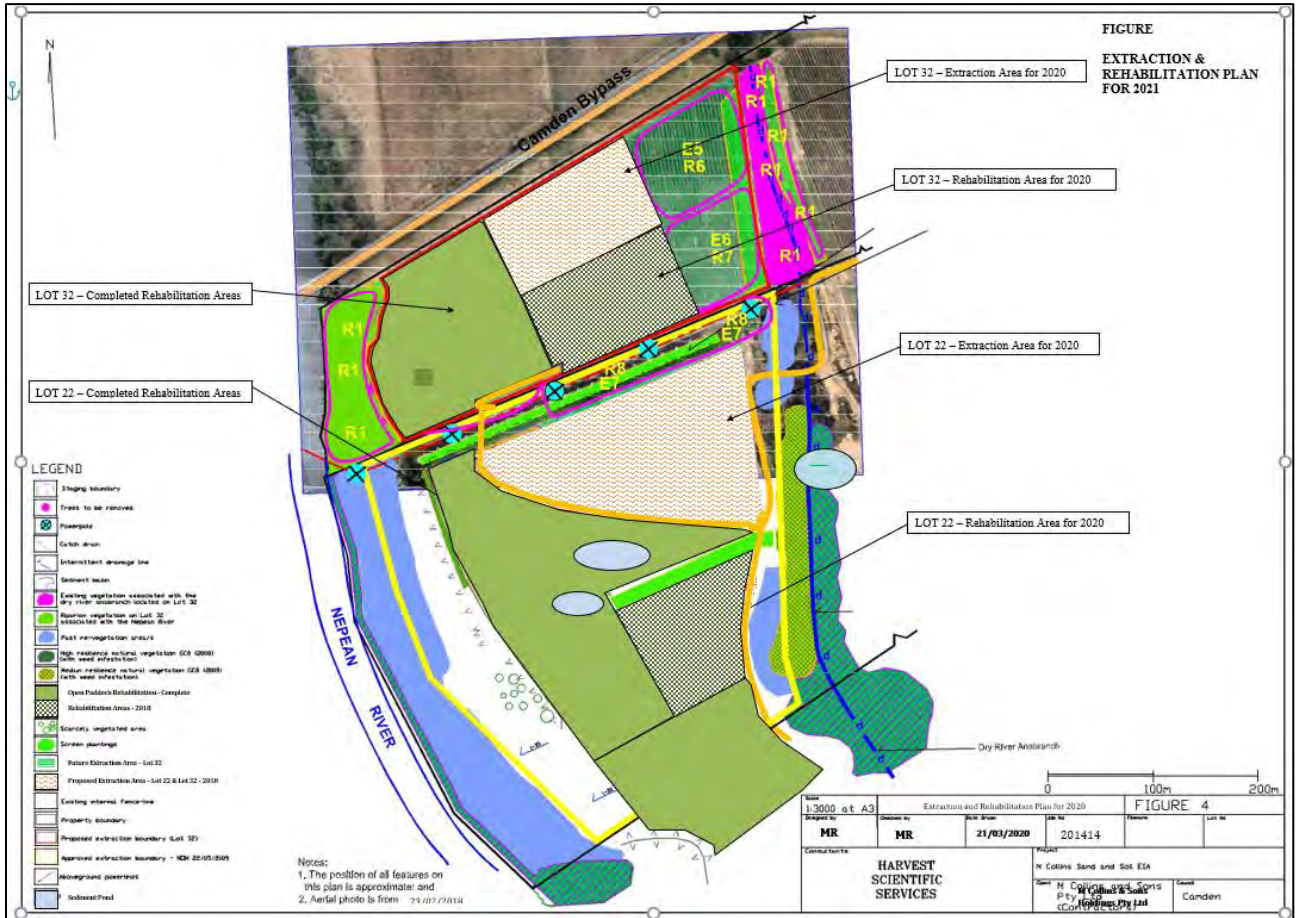
Figure 4: Location of Proposed Extraction and Rehabilitation Cells

- Complete extraction from within Lot 22 (DP 833317) as illustrated in Figure 4; and
- Complete extraction on Lot 32 (DP 635271) proceeding north as illustrated in Figure 4 .

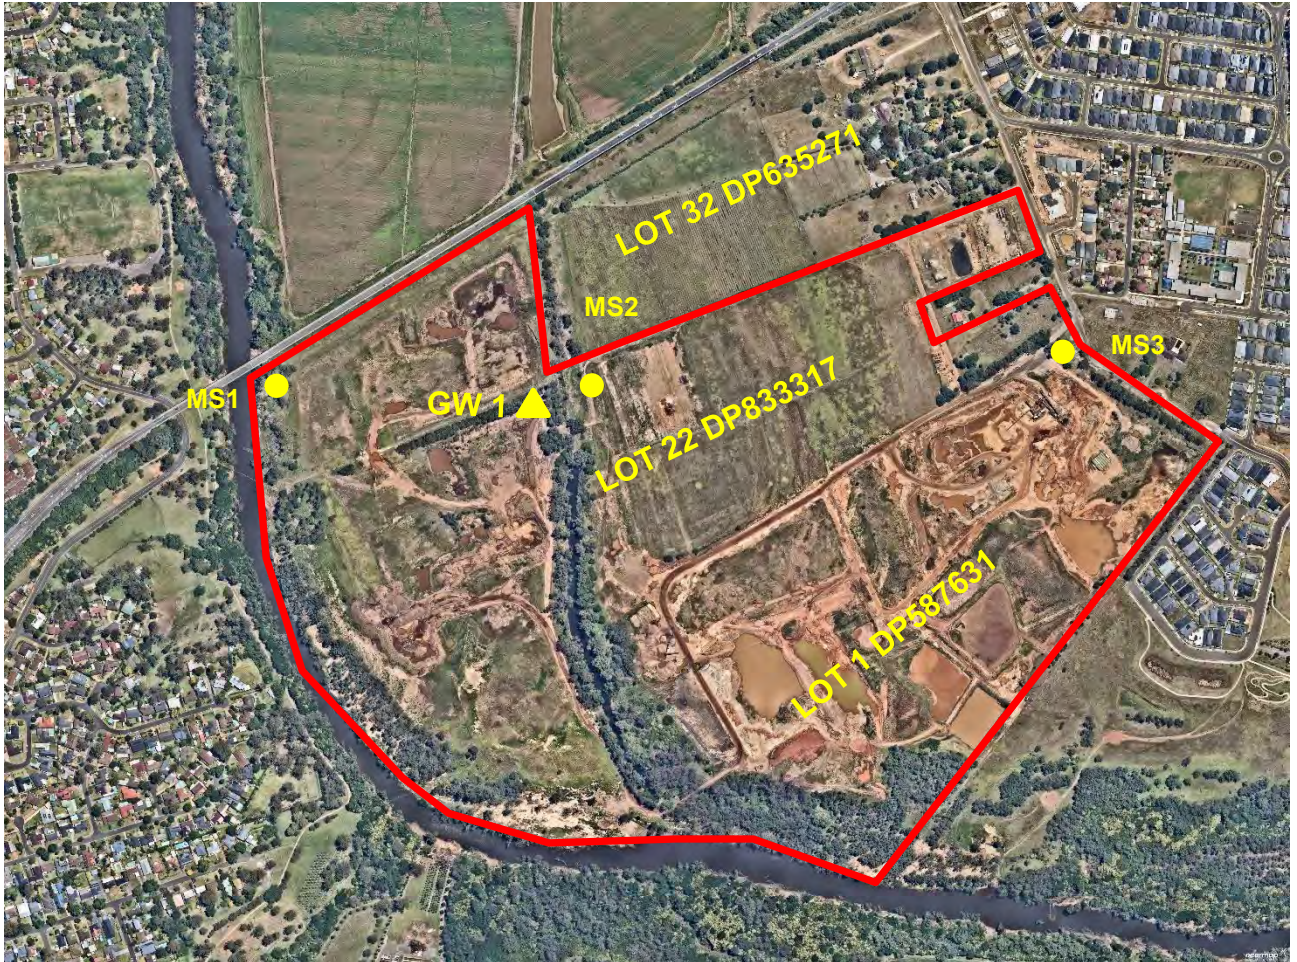
**Figure 7:** Collins Spring Farm Monitoring Sites in 2022 (Dust MS1, MS2 & MS3 and Groundwater GW1)

As per Item 17 of Schedule 5 of the NSW Department of Planning and Environment *Notice of Modification* (DA 75/256 Mod 4) dated 2 August 2018 and (DA 75/256 Mod 5) dated 23<sup>rd</sup> April 2021, there are three monitoring sites across the Collins Spring Farm Quarry; MS1 (*Penman*), MS2 (*Turf Farm*), and MS3 (*Wash Plant*). They can be identified on the western boundary of the site, central to the site and nearest the front gate respectively (Figure 7). Monitoring Stations MS1, MS2 and MS3 consist of a dust deposition samplers, whereas GW1 Station 2 consists of a groundwater monitoring bore.

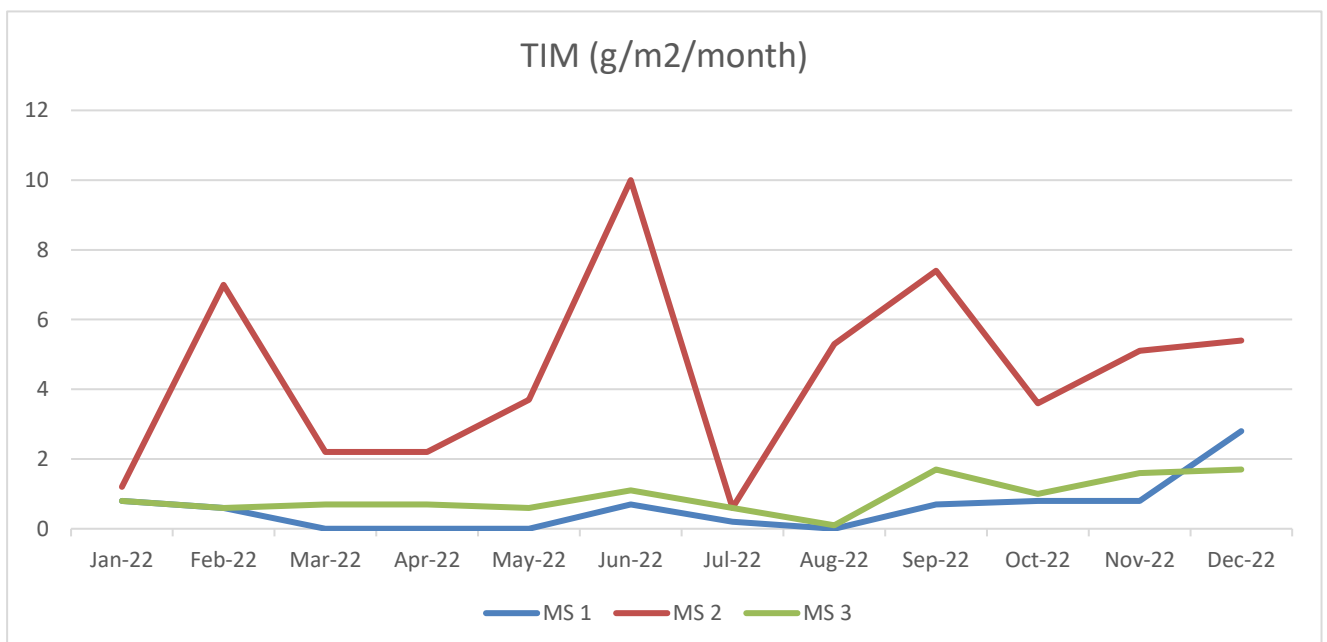
Figure 8: Dust results at MS1, MS2 & MS3 during 2022

| Table 4: Results of 2022 Routine Dust Deposition Monitoring (exceedances highlighted in red) | | | | |
|--|---|---|---|--|
| Nov 22 | 0.8 | 5.1 | 1.6 | Exceedance at Station MS 2 |
| Dec22 | 2.8 | 5.4 | 1.7 | Exceedance at Station MS 2 |

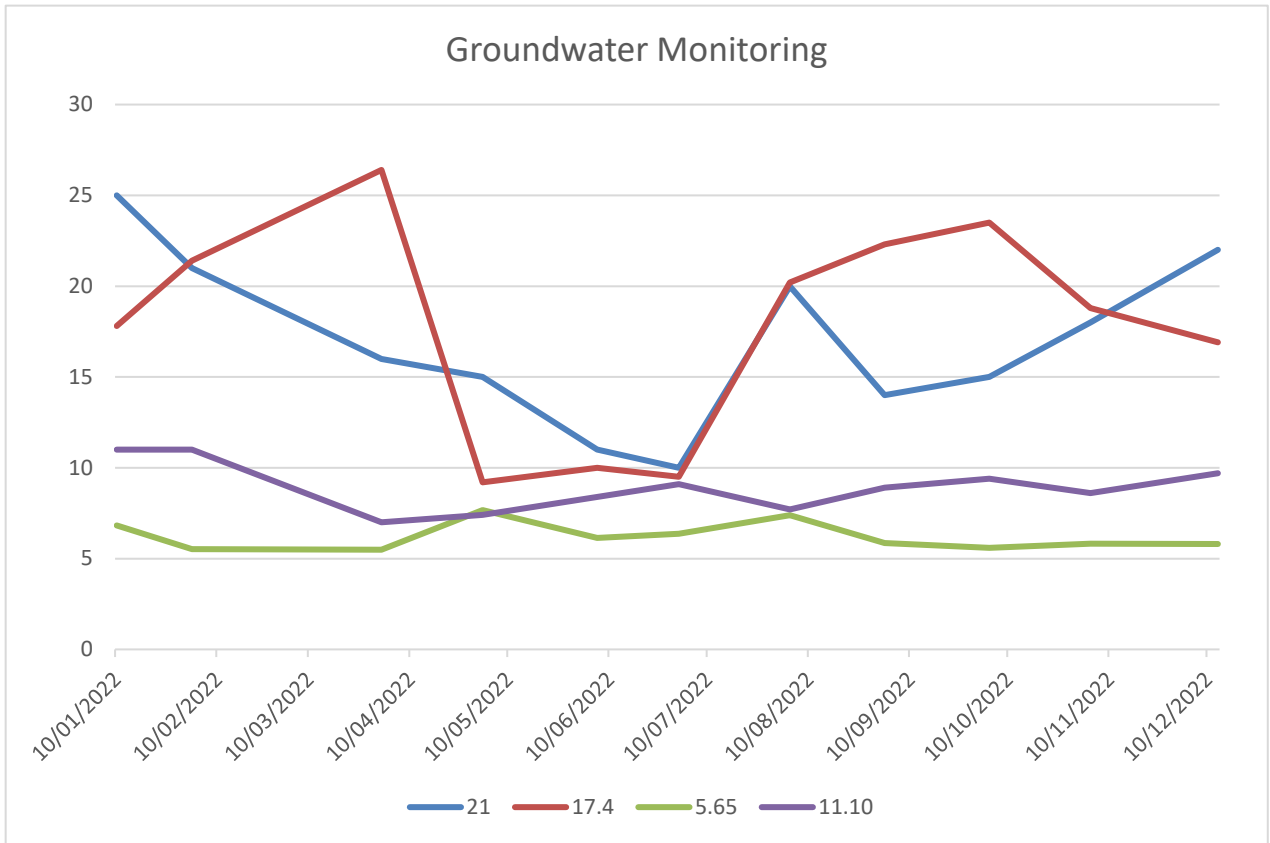
Figure 10: 2021 Groundwater Monitoring results during 2022 (Actual EC values divided by 10)

- All samples tested were below the nominated salinity target (EC < 800 µS/cm) during 2022. Results reflect the trend of groundwater conductivity (EC) values decreasing over time;
- pH levels were found to occur within a relatively tight range (5.49 – 7.67) and has not altered significantly over the last 7 years; and
- Groundwater depths below ground level fluctuated between 7.00 m and 11.00m depth. A rise in the water table depth during the year has clearly reflected the high rain fall occurring within the basin and the subsequent flooding events.

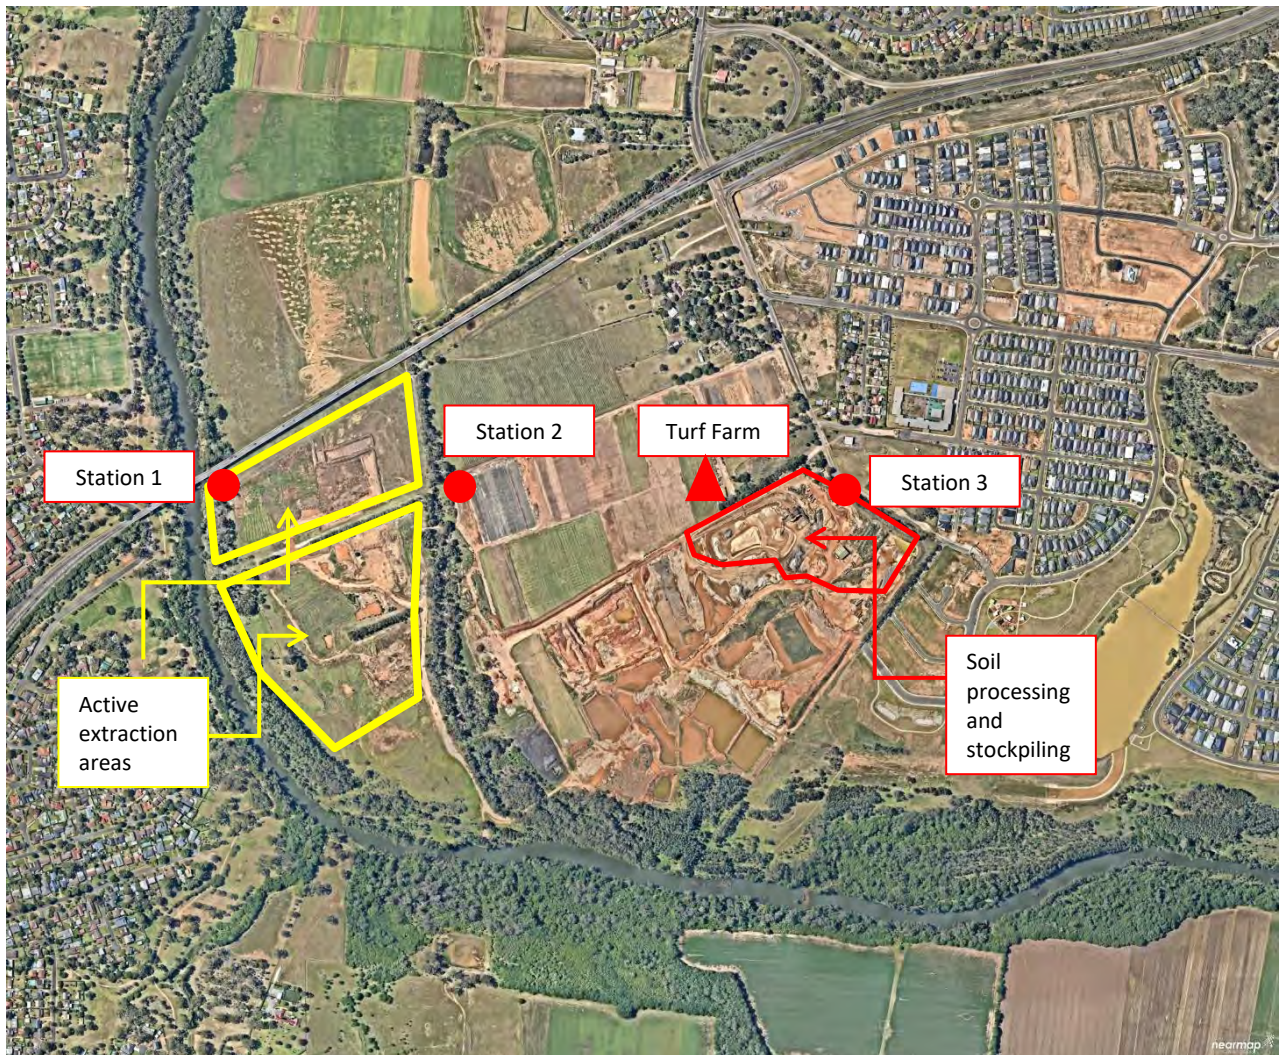
**Figure 1:** Aerial photograph of the Spring Farm extraction site and location of monthly dust monitoring points ● (May 2021) and the High Volume sampling site ▲.

The following report describes the sampling results undertaken during August/September 2022 at the Turf Farm Station – see Figure 1 for sampling locations.

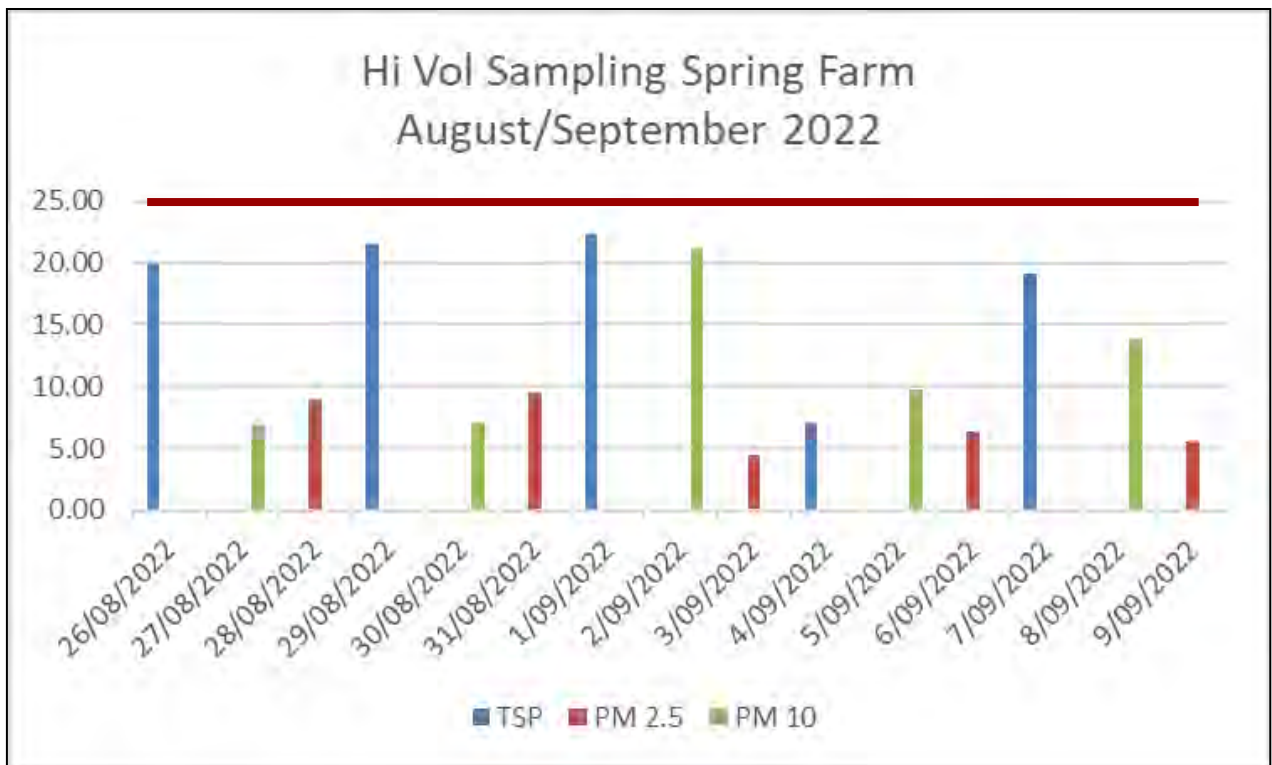
A graphical presentation of the data is given in Figure 2.
